WASHINGTON
TOWNSHIP SCHOOLS

Secondary School Master Plan

SECONDARY SCHOOL FACILITY CONDITION ASSESSMENTS

EXISTING CONDITIONS ASSESSMENT SUMMARIES

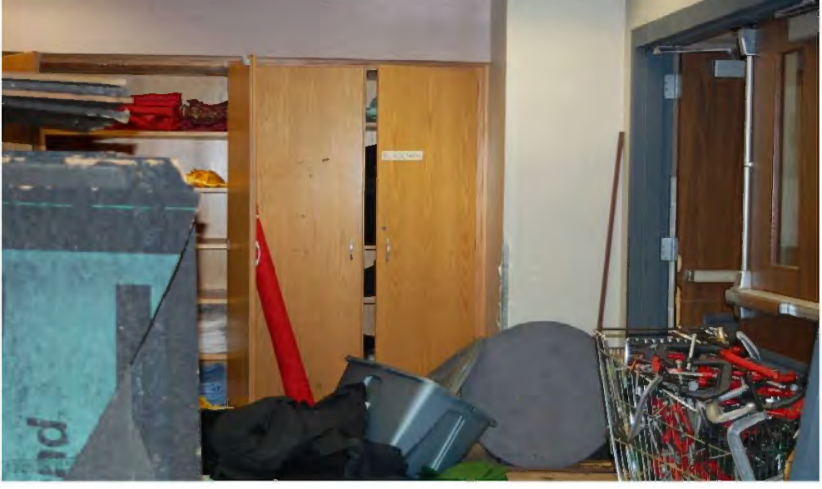
Inadequate storage solutions.
11

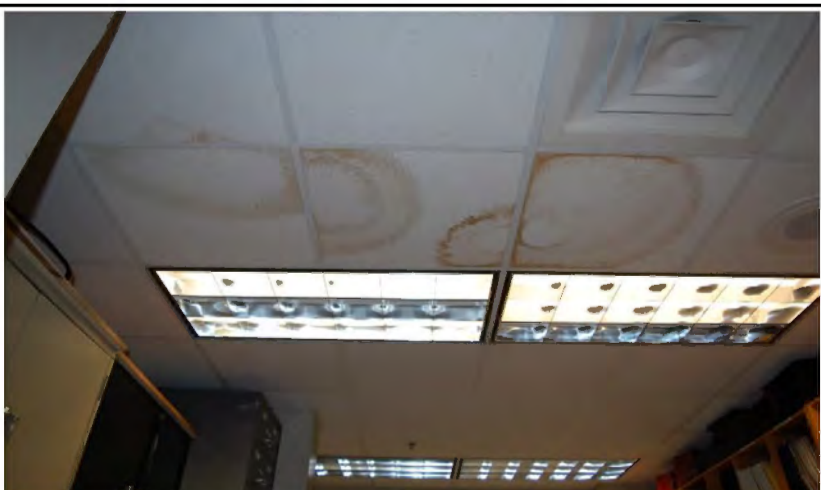
Damaged ceiling tile.

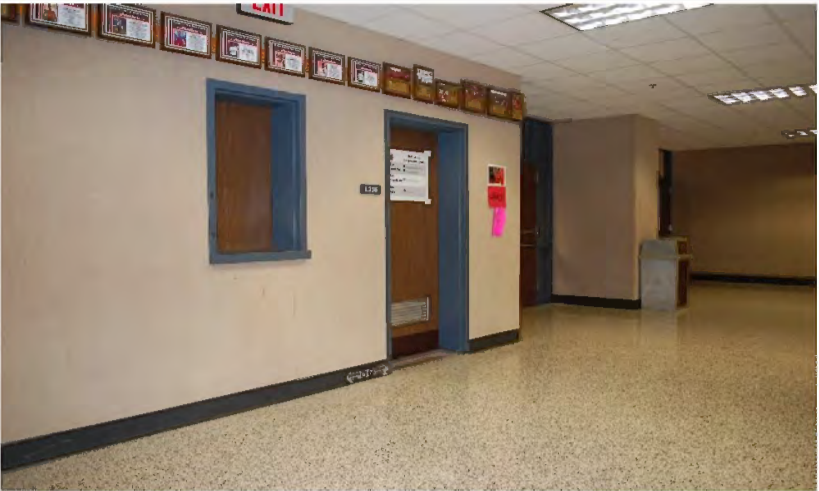
Inactive ticket window. Awards mounted to wood picture rail in Corridor.
26

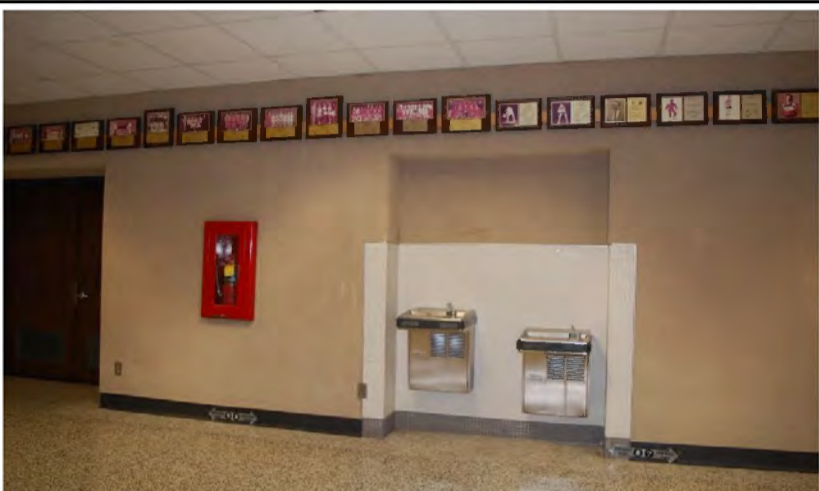
Damage to wall covering (acoustic wall fabric).
27

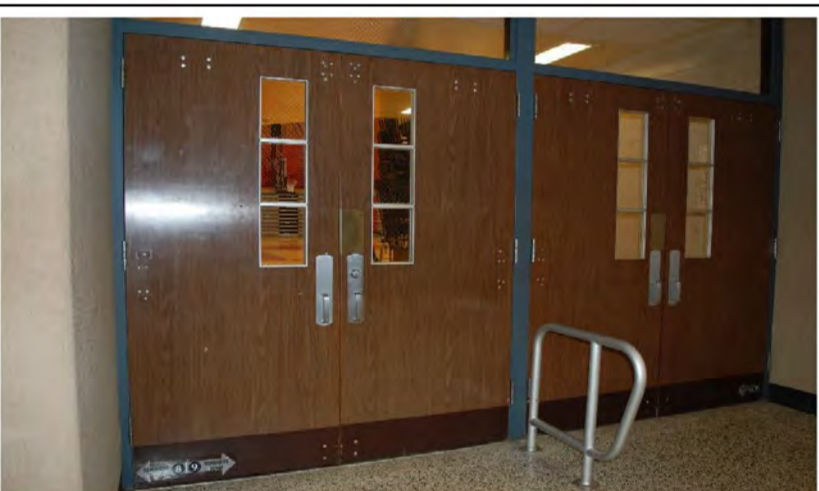
Doors have plates over location of old hardware & damaged ends. Doors are typically Laminate veneer. Some corridor doors are on magnetic hold opens.
28

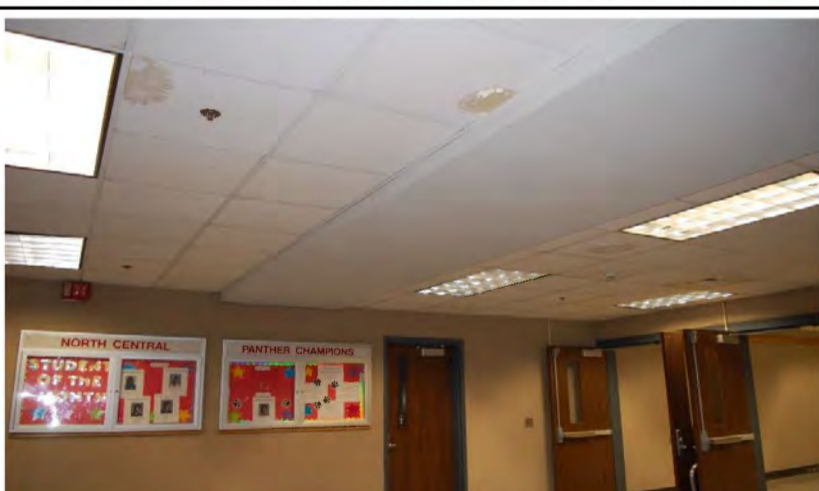
Damaged ceiling tile. Worn wall coverings.
29

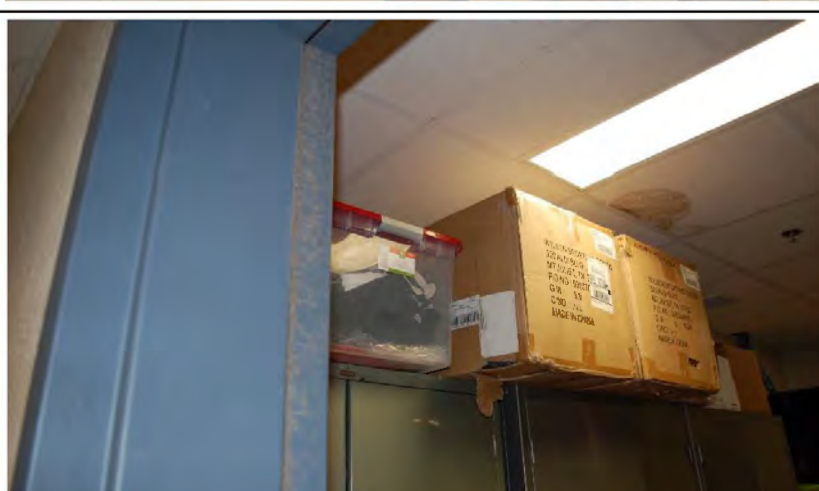
Corrosion on door frame. Damaged ceiling tile.

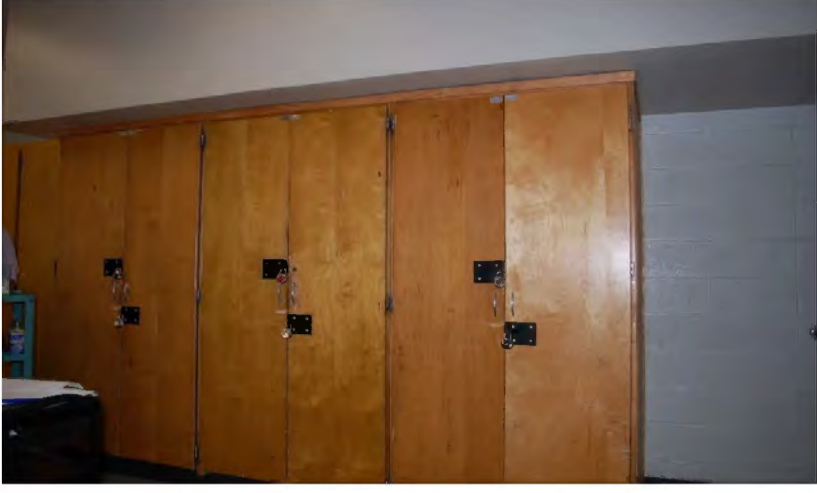
<p>Damaged, worn instrument storage.</p>
31

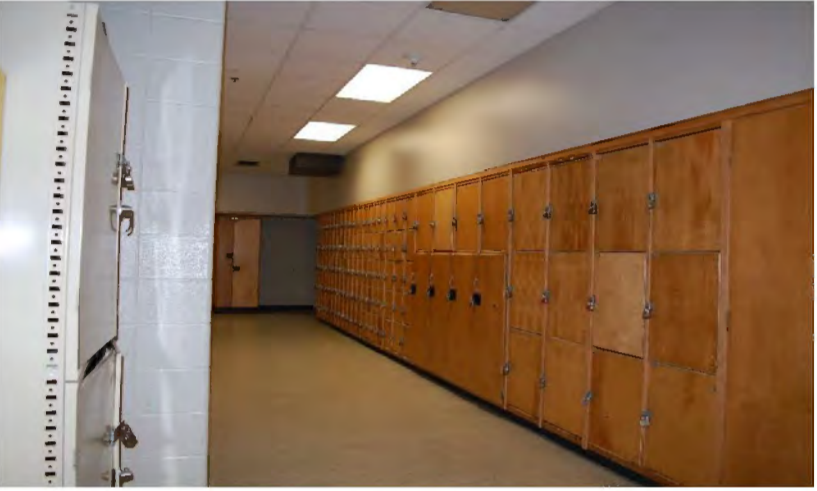
<p>Damaged, worn instrument storage.</p>
32

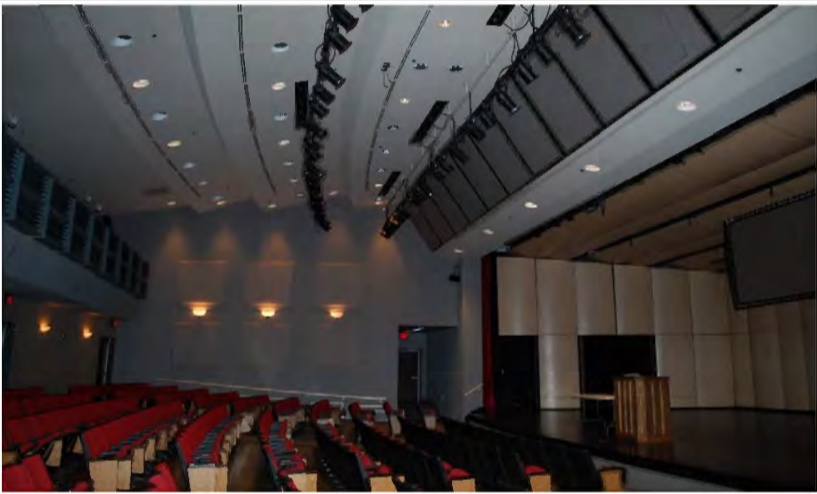
<p>Worn, delaminating wall covering. Carpet runners in poor condition. Concrete under chairs.</p>
33

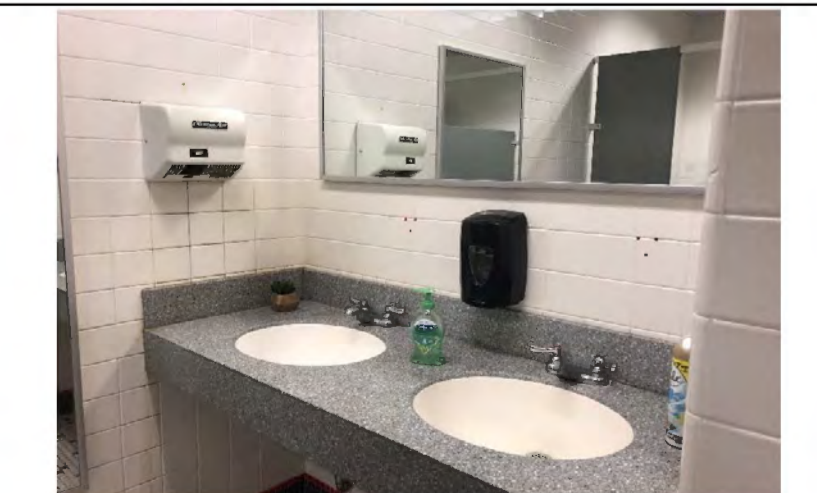
<p>Holes in tile. Stained grout. Mirror mounted above accessible heights. Chipped tile.</p>

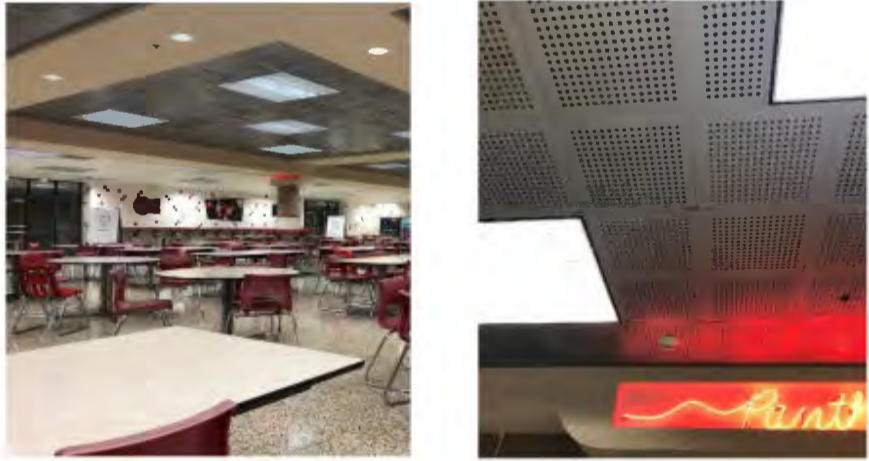
Some metal ceiling panels in the Cafeteria have rust.
119

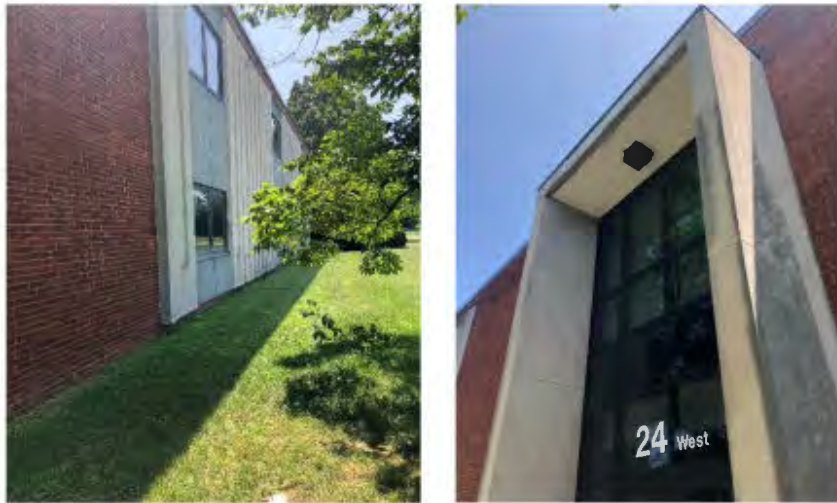
Exterior finish system is deteriorating.
11

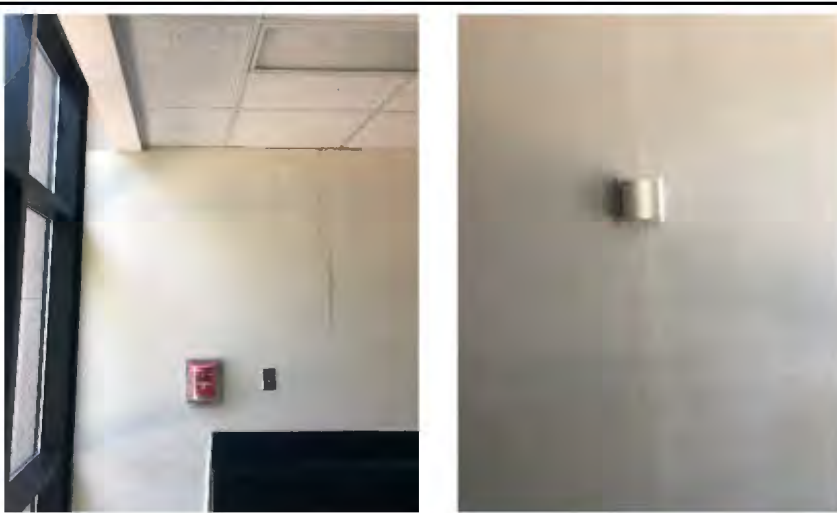
Interior leaks & damage to wall surfaces.
12

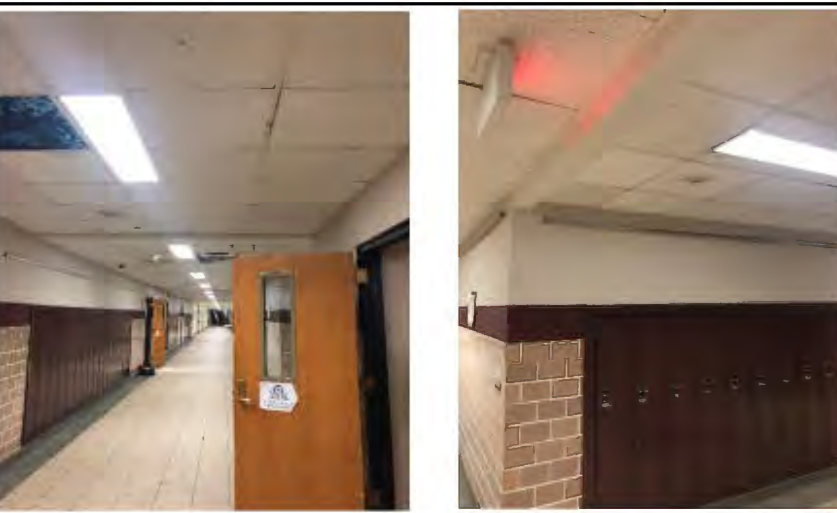
Corridor ceiling tiles are damaged and warped. 1ft strip light in center.
13

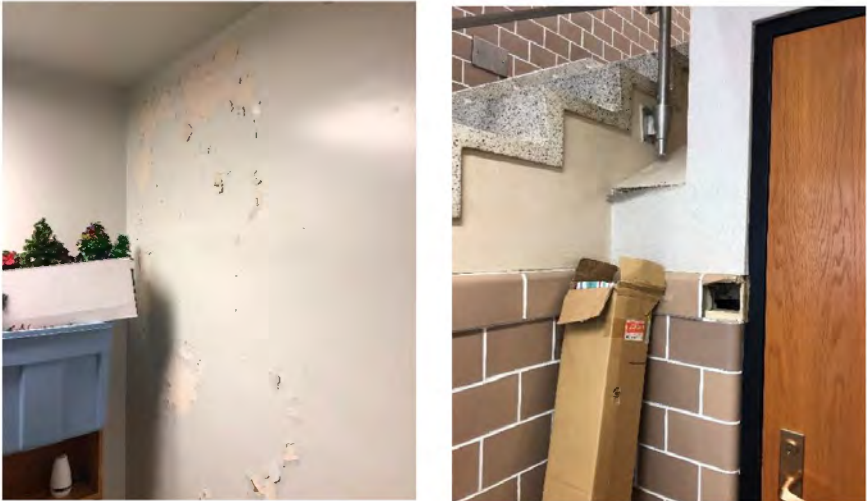
<p>Wall damage.</p>
23

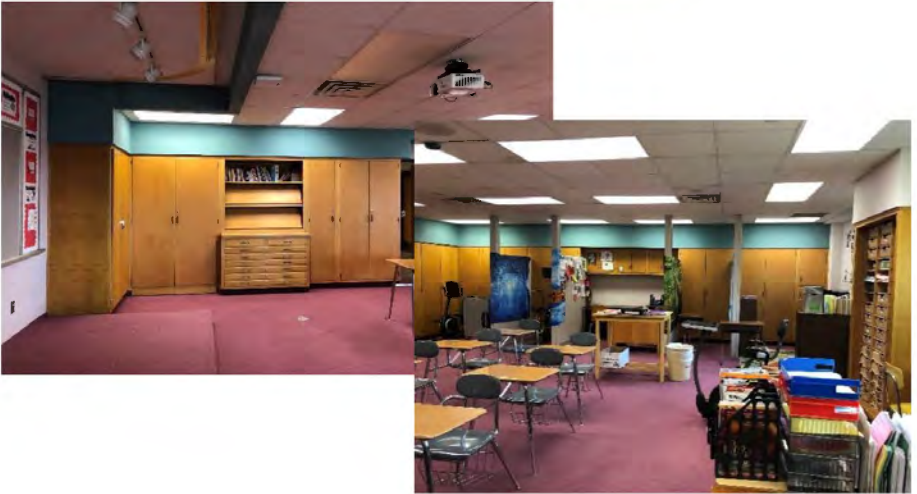
Worn carpet and the casework is not conducive to current classroom use.

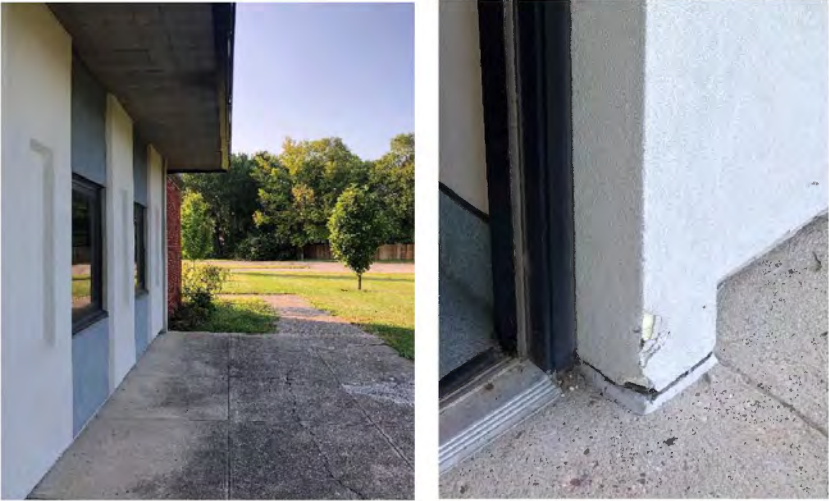
Exterior façade, soffit and concrete are in deteriorating condition.
33

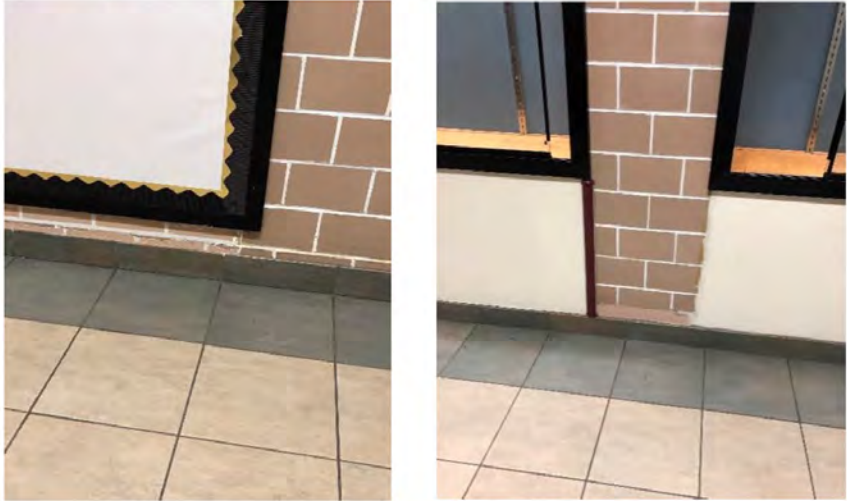
<p>Damage to wall at the base. Bad transitions between materials.</p>
38

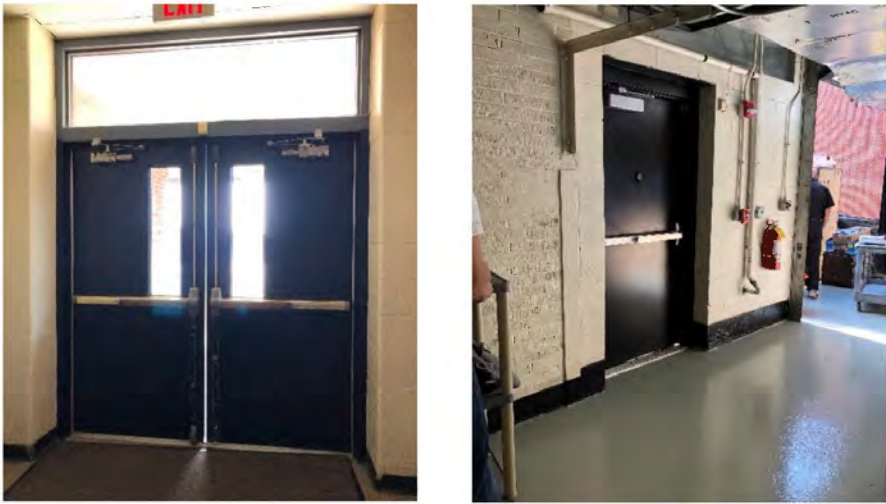
Exterior doors need new seals/ replacement to prevent air infiltration.
41

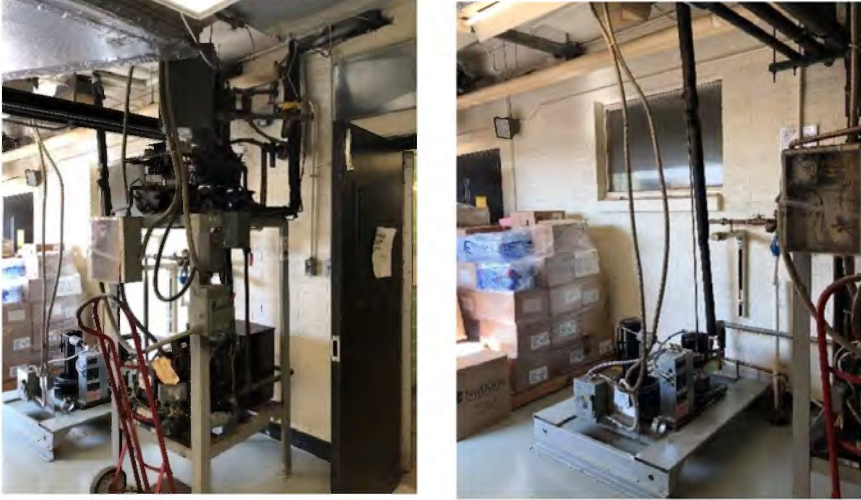
Exposed equipment in Receiving area is unprotected.
43

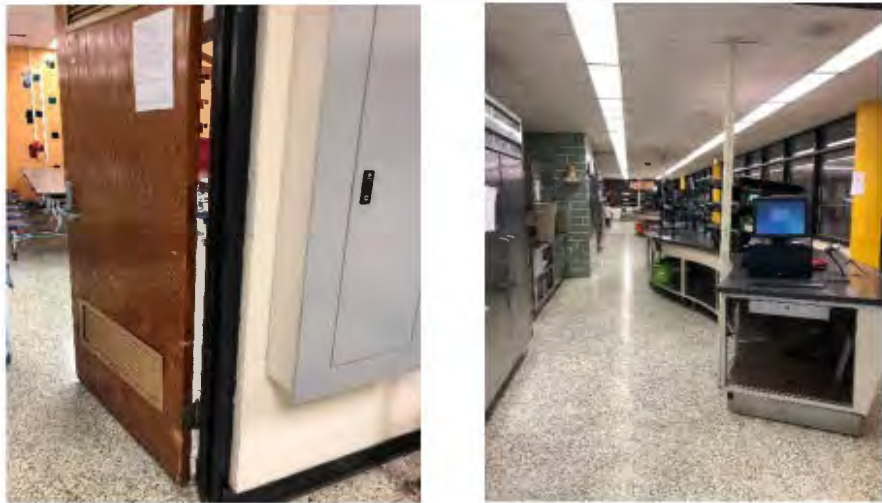
<p>Serving Line door is worn and in bad condition. Power poles in the serving line.</p>
46

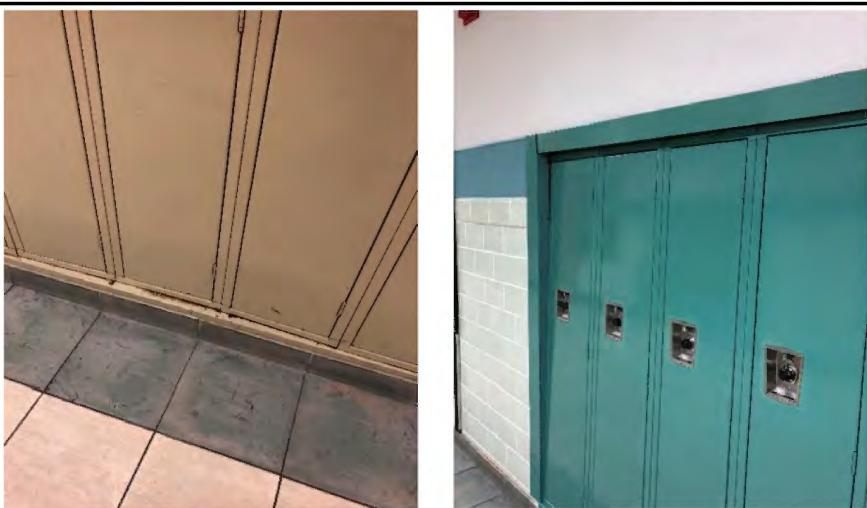
Lockers have rust at the bottom. Lockers are bowed inward in places.
53

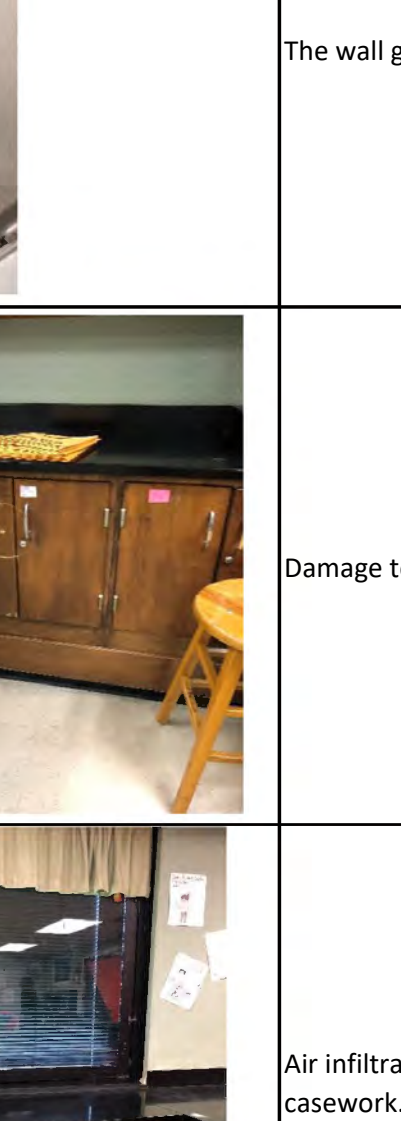
Air infiltration through existing windows. This is typical. Damage to Lab casework.
58	 	Fume hood exhaust. Water stain at the ceiling.
59

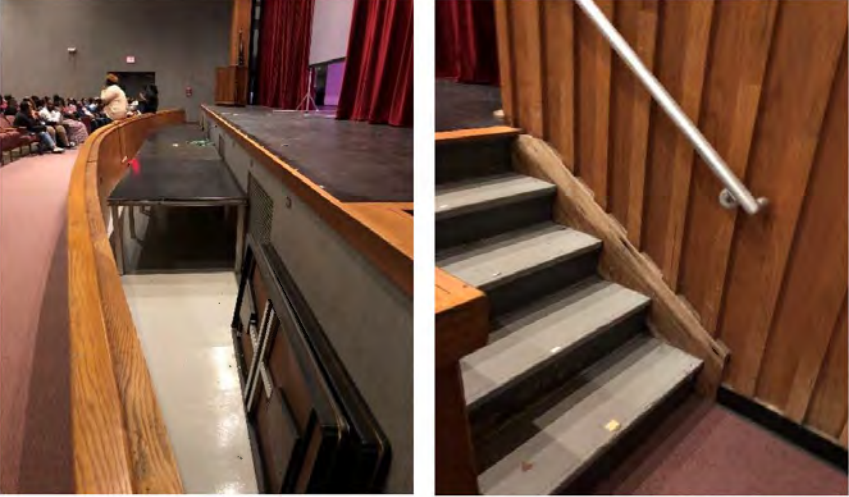
<p>Worn treads on the steps to the stage. The Orchestral Pit has no cover.</p>
62

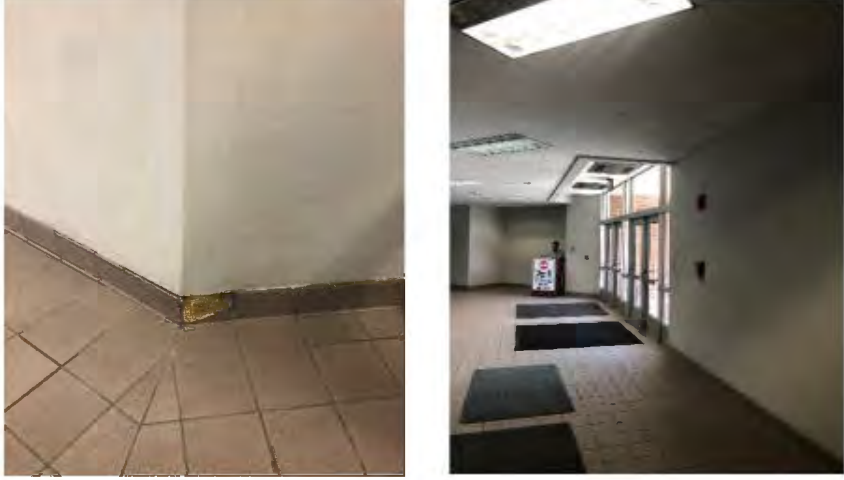
Bulkhead over entry doors. Tile base is missing. Slip resistant procelain tile is holding dirt. In-set walk off mat. Dirty walls.
9

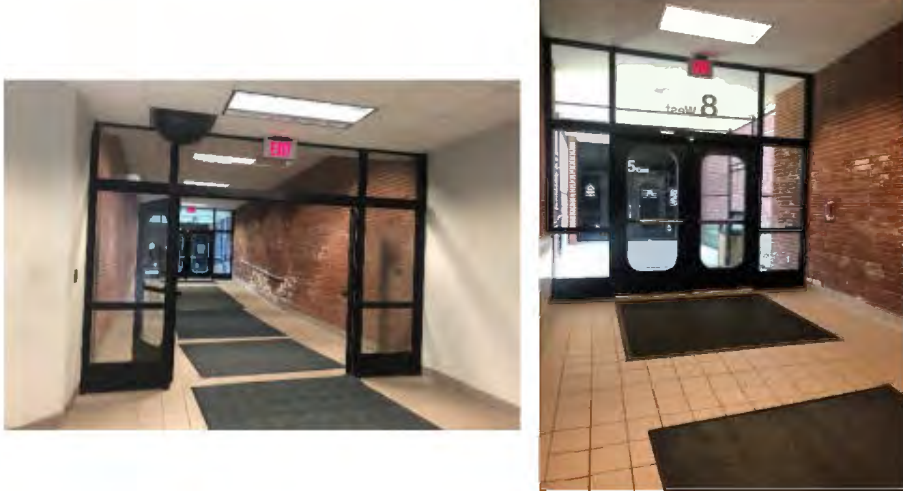
Efflorescence on brick wall indicates moisture in the wall cavity. Ceiling stains also indicate water infiltration.

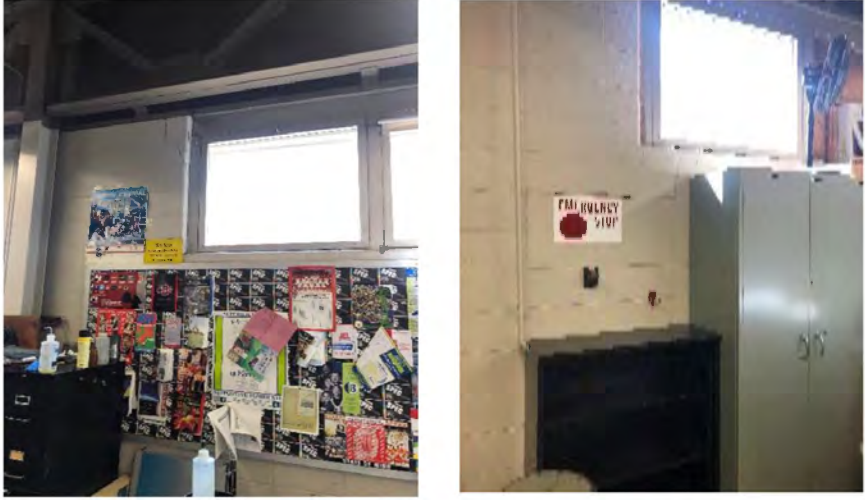
Exterior CMU wall is cracked at the window heads and sills.
31

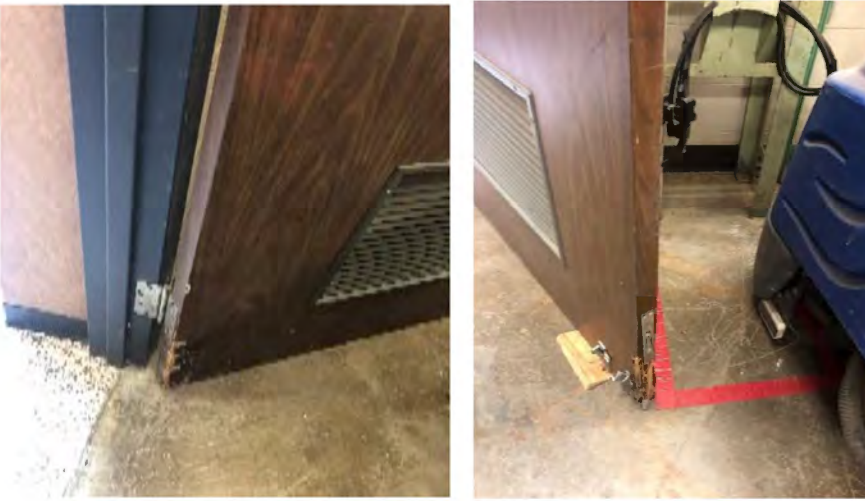
Typical wear on doors.
32

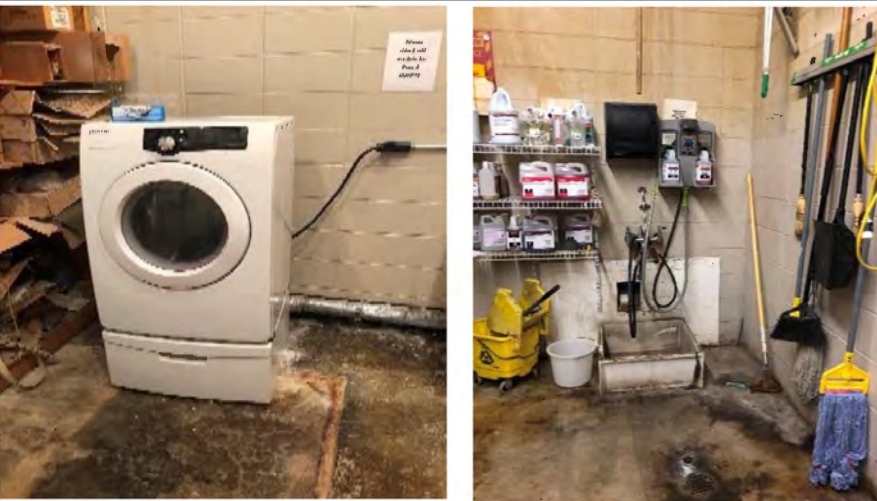
Stains on the concrete.

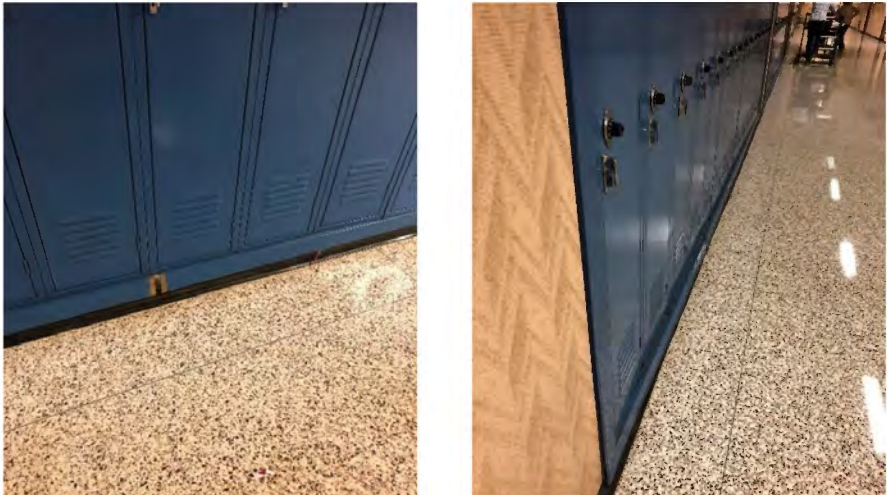
Damage to locker trim. Lockers are bowed in.
38

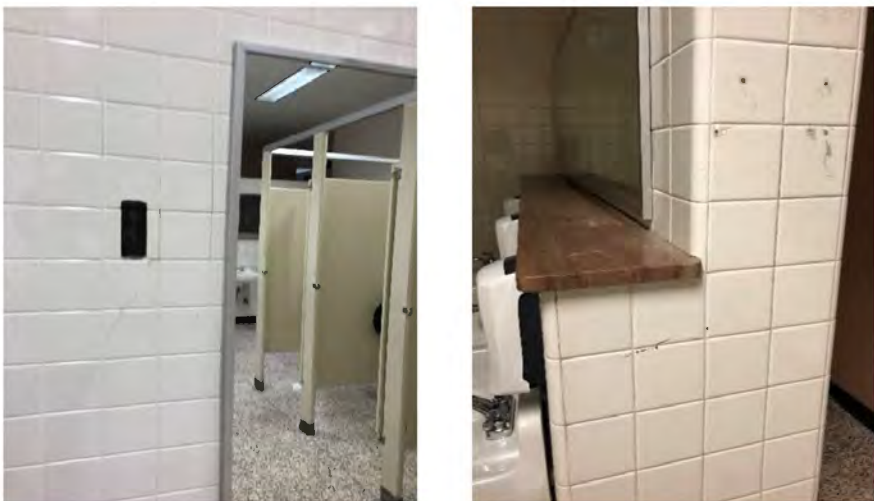
Cracked tiles.
39

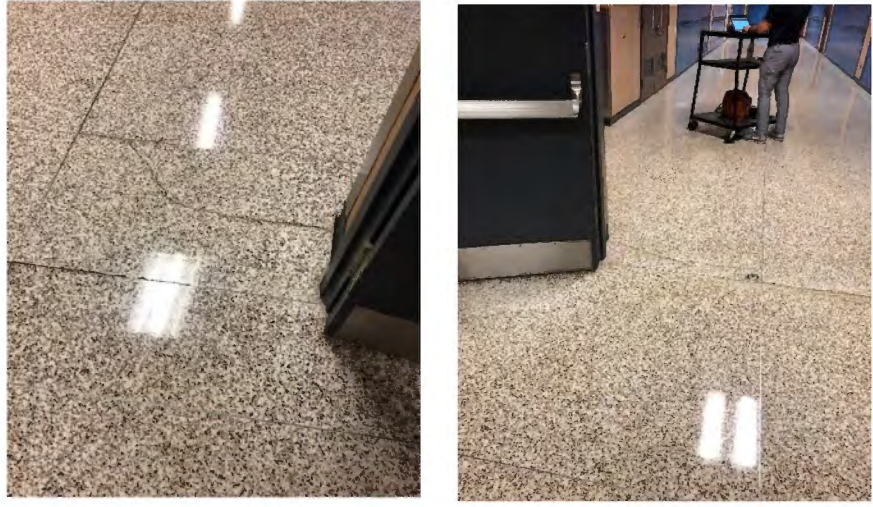
Cracked terrazzo.
41

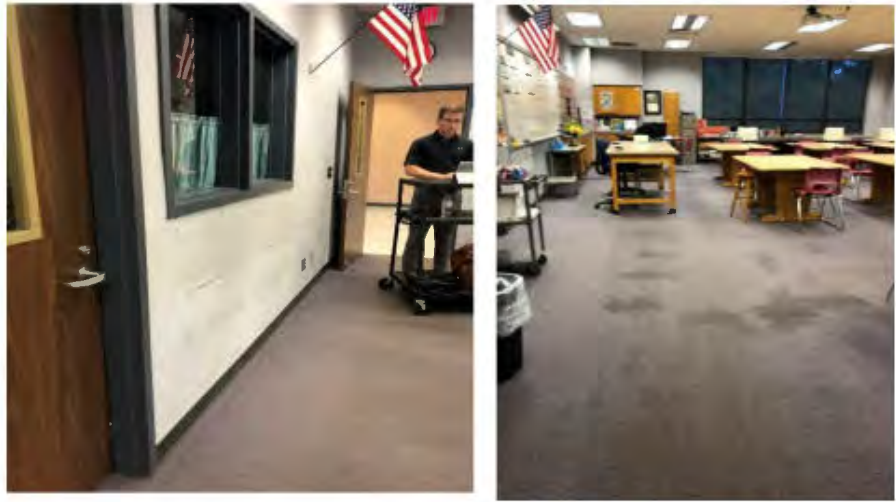
Damage to wall and floor finishes.
56

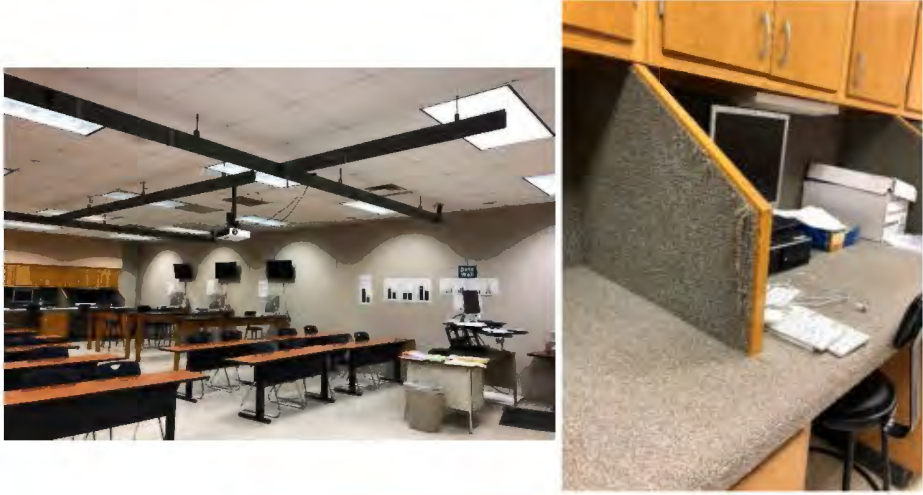
Built-in student lab tables and study carrols not at an accessible height. Fraying finish on study carrols.
57

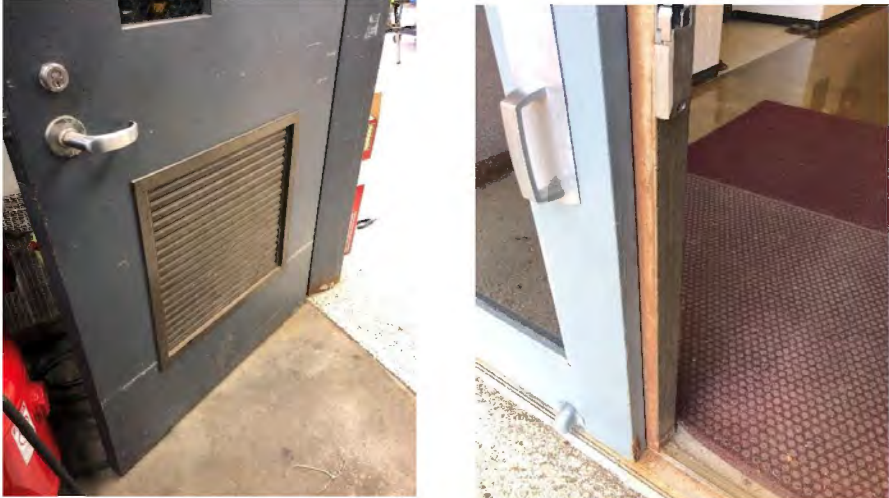
<p>Rusted door frame and damaged door.</p>
68

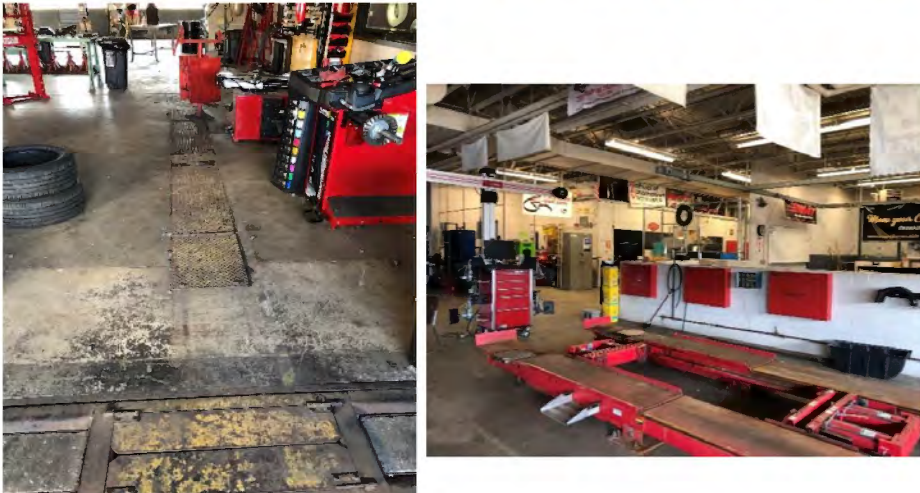
<p>Trenches and equipment are embedded in the concrete. There are some areas of patched concrete where equipment was removed.</p>
69

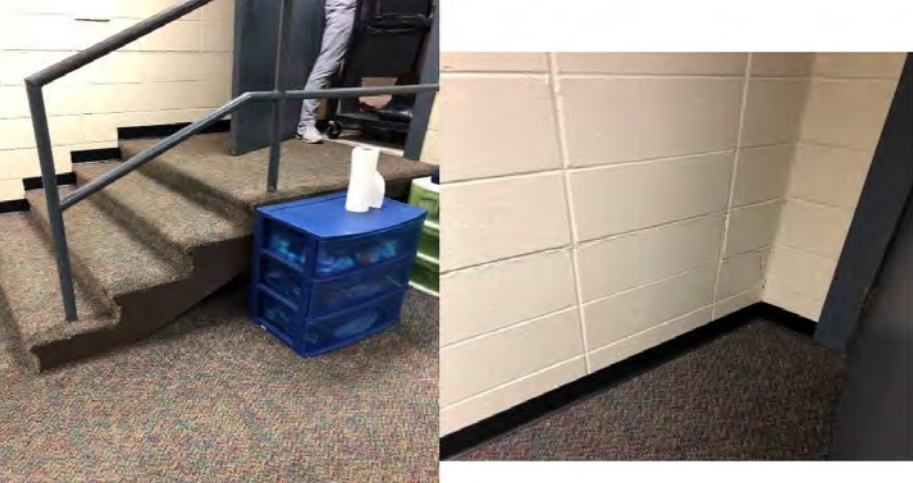
Steps into the room. Cracks in CMU wall.

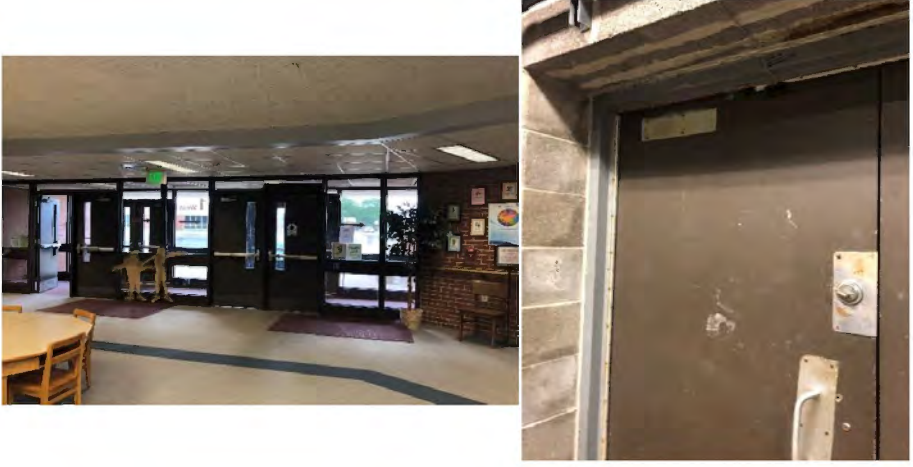
<p>Rust and corrosion on exterior doors. Distance between the doors in the vestibule does not meet current clearance requirements.</p>
9

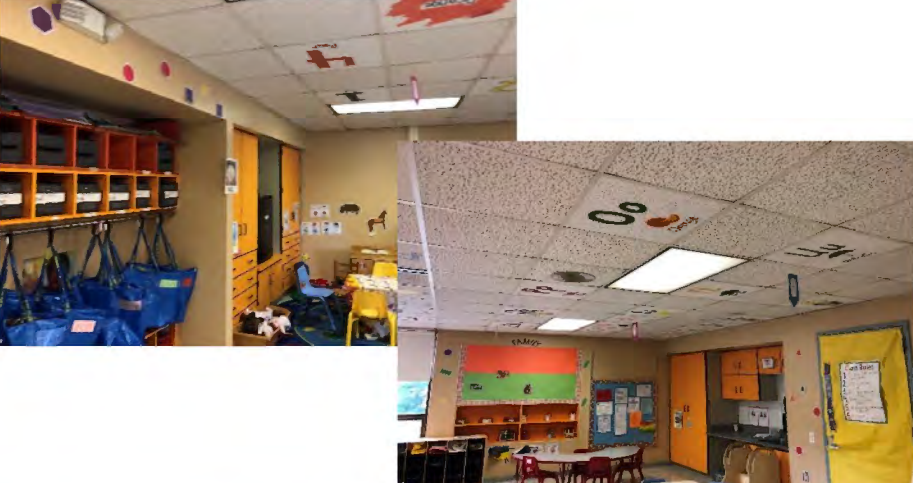
Variety of laminated colors on the casework. The casework is specific to the preschool classrooms. Laminate and seals at the casework sinks are failing. Missing locks on the casework.
14

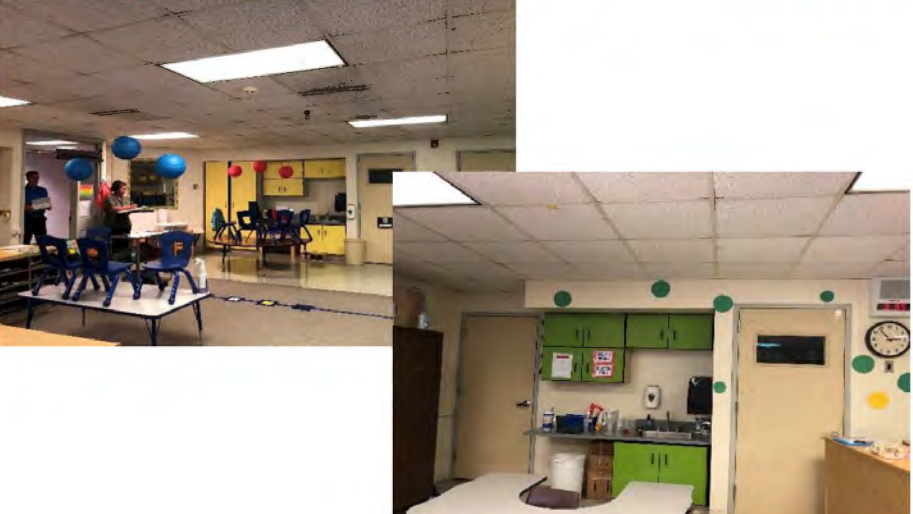
Variety of laminated colors on the casework. The casework is specific to the preschool classrooms. Laminate and seals at the casework sinks are failing. Missing locks on the casework.

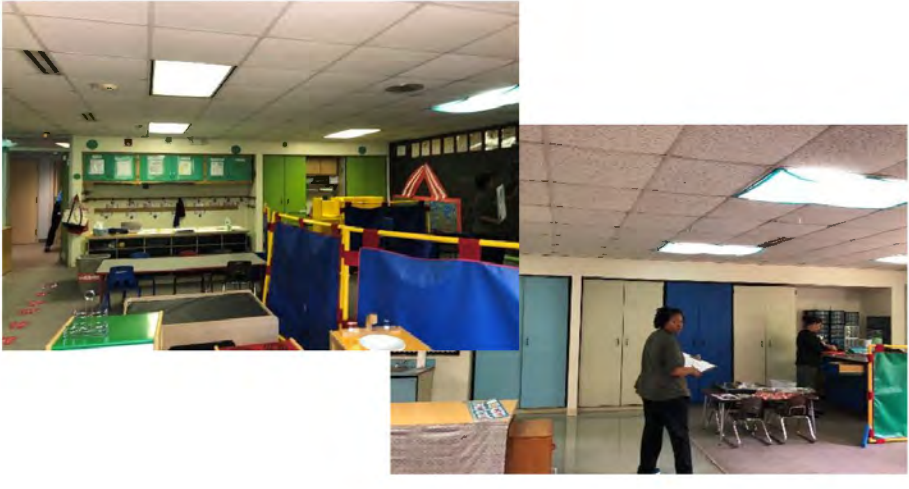
<p>Variety of laminated colors on the casework. The casework is specific to the preschool classrooms. Laminate and seals at the casework sinks are failing. Missing locks on the casework.</p>
16

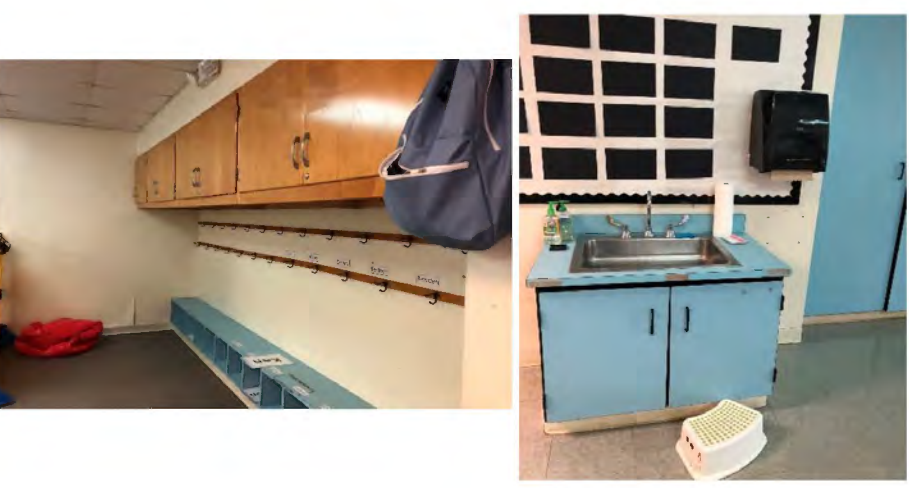
<p>Variety of laminated colors on the casework. The casework is specific to the preschool classrooms. Laminate and seals at the casework sinks are failing. Missing locks on the casework.</p>
17

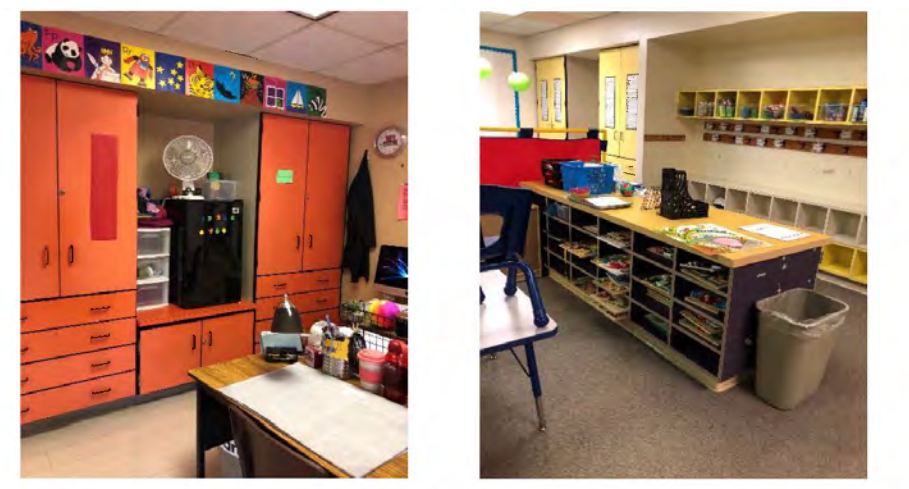
<p>Variety of laminated colors on the casework. The casework is specific to the preschool classrooms. Laminate and seals at the casework sinks are failing. Missing locks on the casework.</p>
18

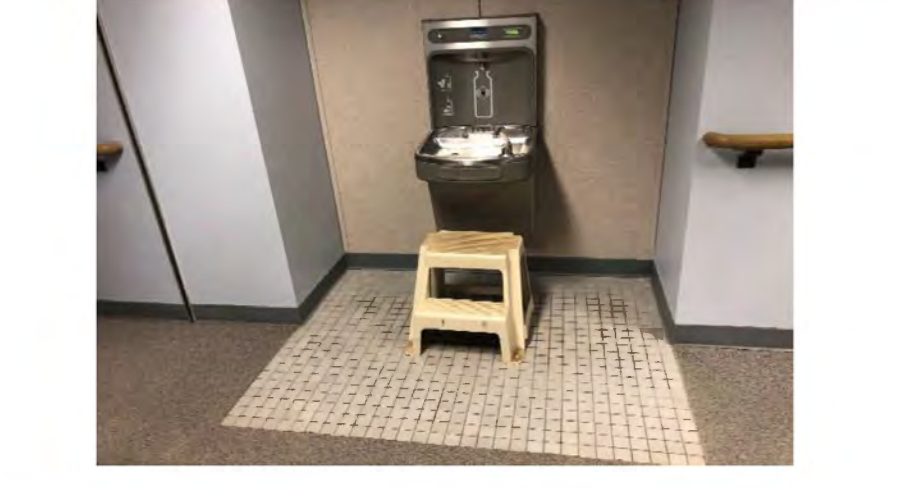
<p>Tile and grout are worn at the drinking fountain.</p>
19

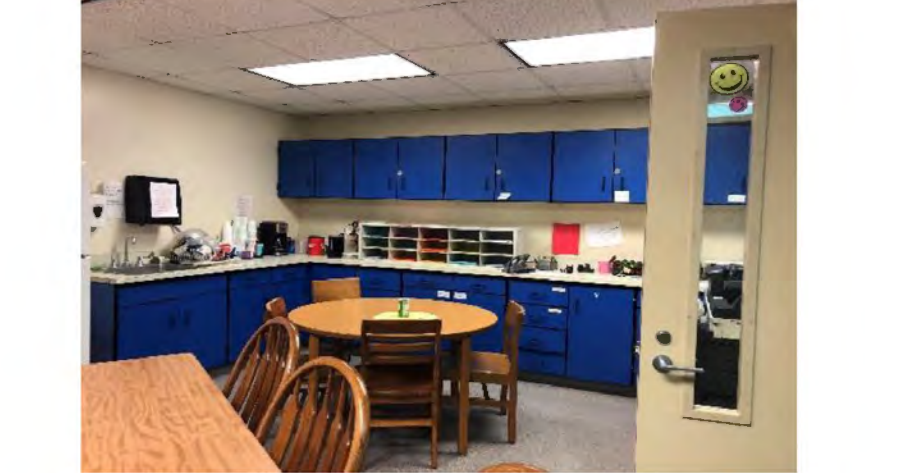
<p>Staff break room casework is not accessible.</p>

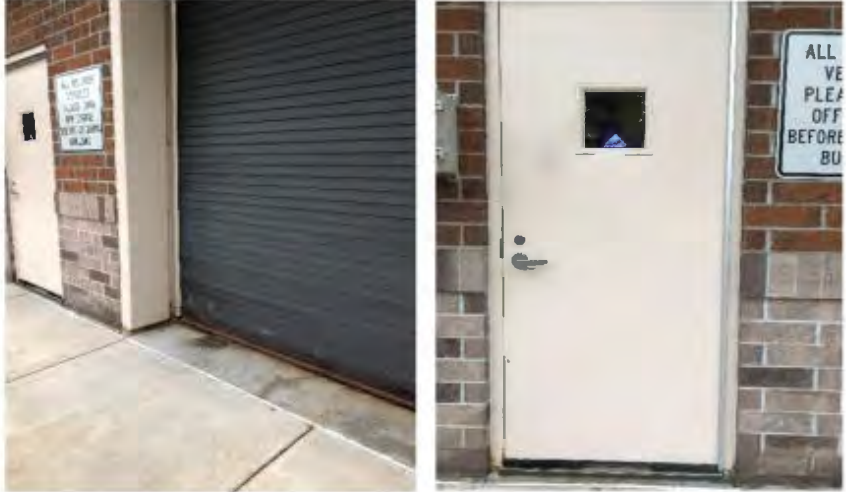
<p>Rust at hollow metal frame and overhead door as well as the main door.</p>
6

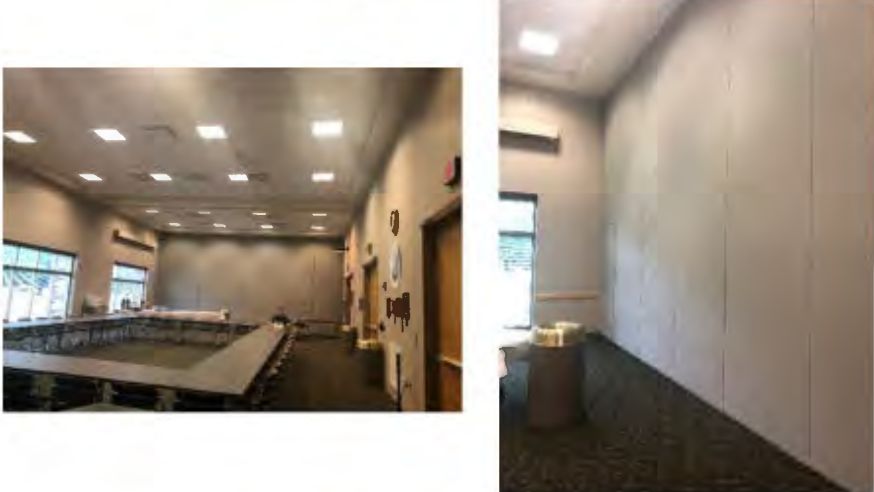
<p>Large operable partitions in the Meeting Rooms don't seal tightly for sound control. The vinyl wall covering is damaged on the partitions. Some window blinds are damaged in the Meeting Room.</p>
9

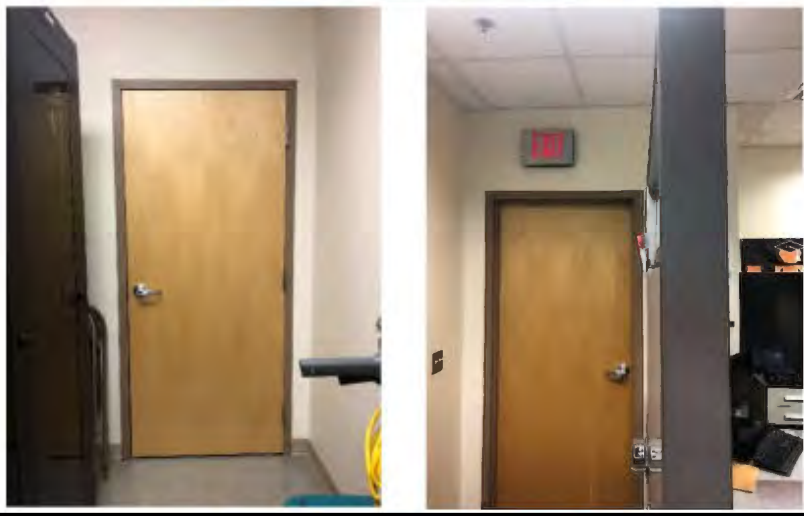
<p>Clearance at door does not meet current code.</p>
22

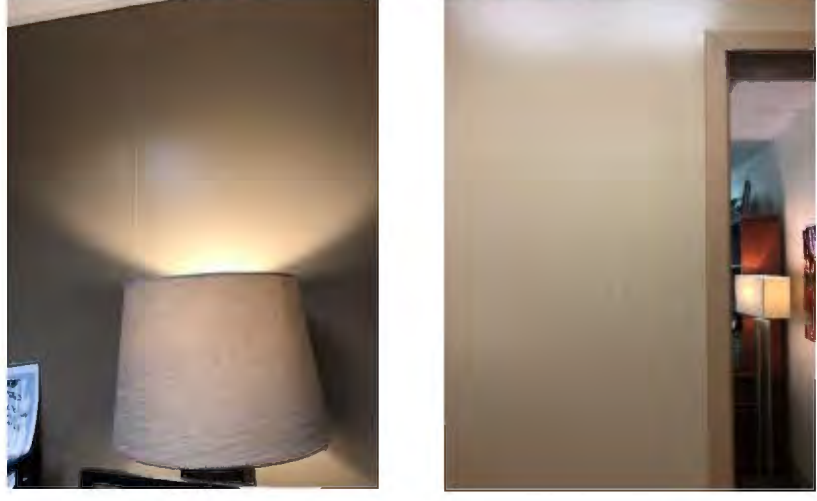
Crack in the wall.

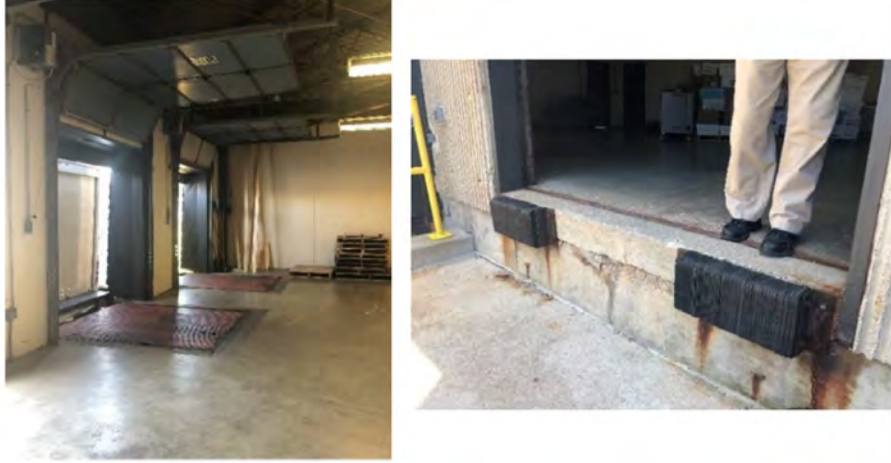
Dock overhead doors, bumpers and pads are in poor condition.
2
