WASHINGTON
TOWNSHIP SCHOOLS

Secondary School Master Plan

SECONDARY SCHOOL FACILITY CONDITION ASSESSMENTS

EXISTING CONDITIONS ASSESSMENT SUMMARIES

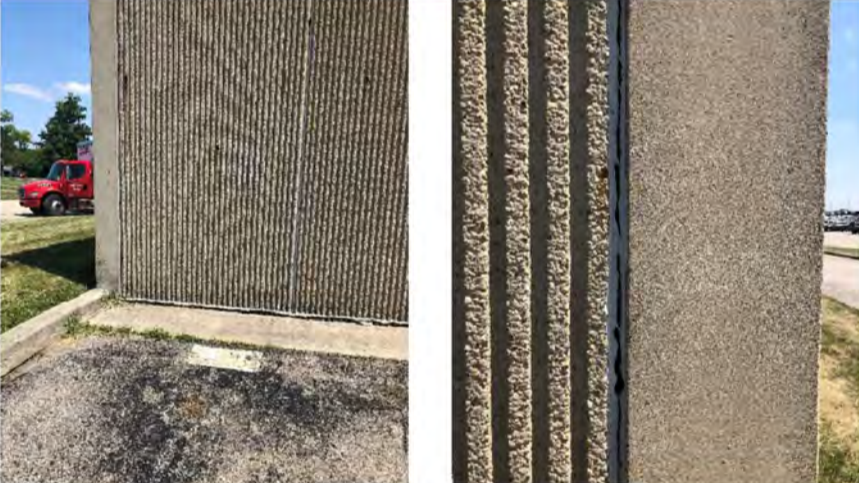
Caulk at precast joints is failing.
4

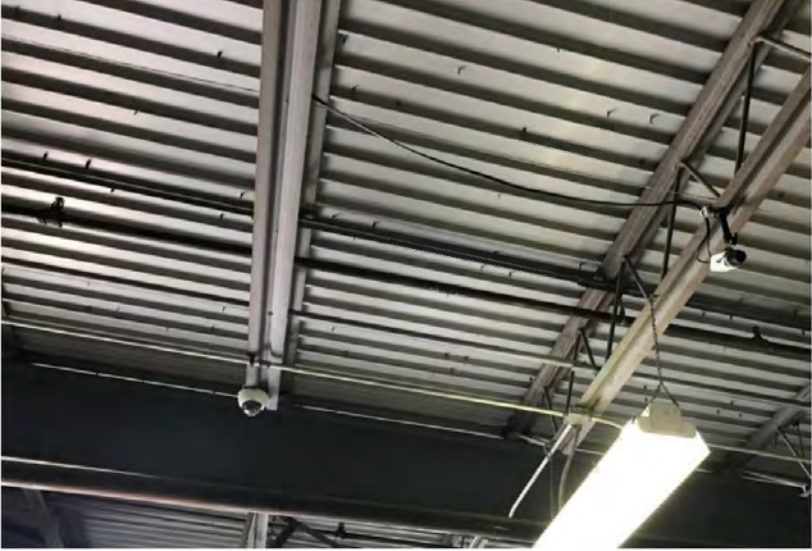
<p>The two types of security cameras found inside the building. Cameras are from two different installs at two different times. The older cameras being on an analog system while the newer ones operate digitally.</p>

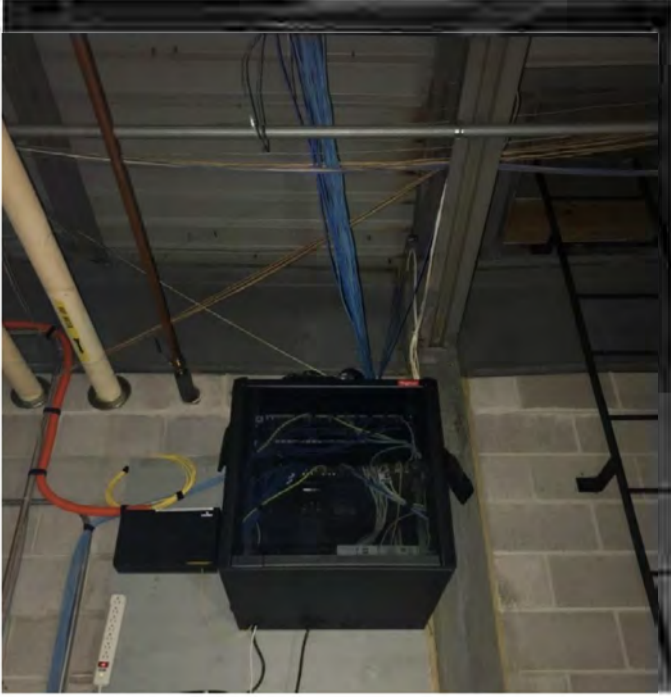
<p>MDF location in the building. MDF is mounted roughly 12 feet high, accessible by ladder and key. Water leaks from the roof onto the MDF location when it rains, so workers placed a trash bag to help protect the cabinet.</p>

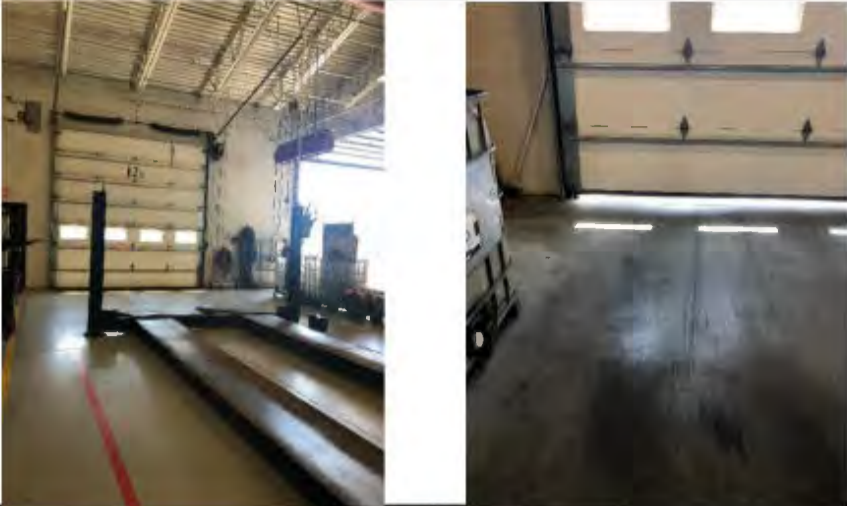
<p>There are no weather seals at exterior overhead doors.</p>
11

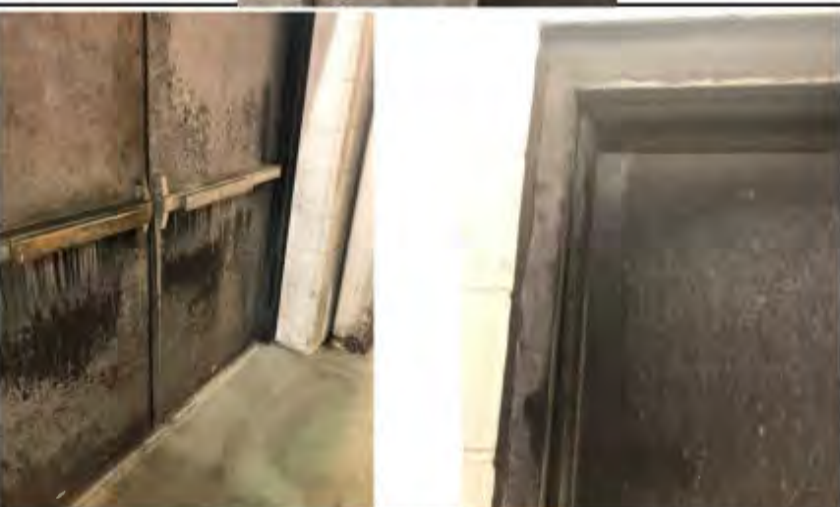
<p>Wash bay hollow metal doors and frames are rusted and corroded.</p>
13

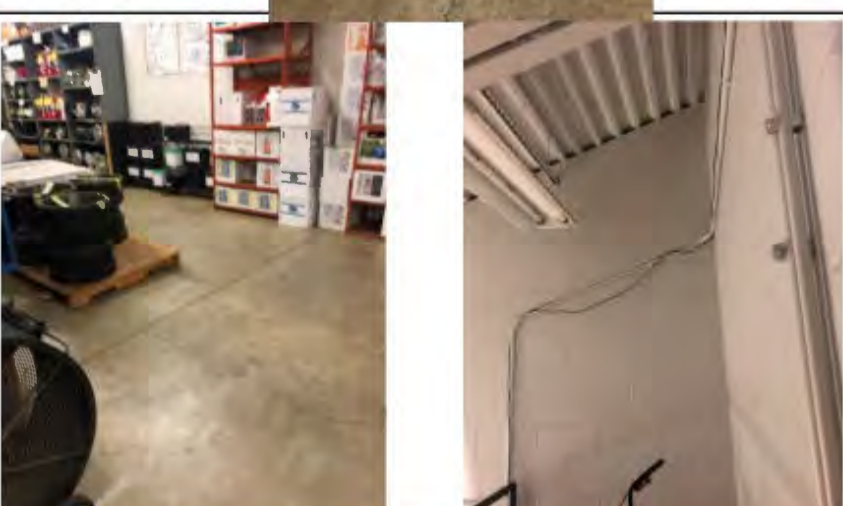
<p>Cracking in the supply room concrete slab and concrete block walls of the adjacent stair.</p>

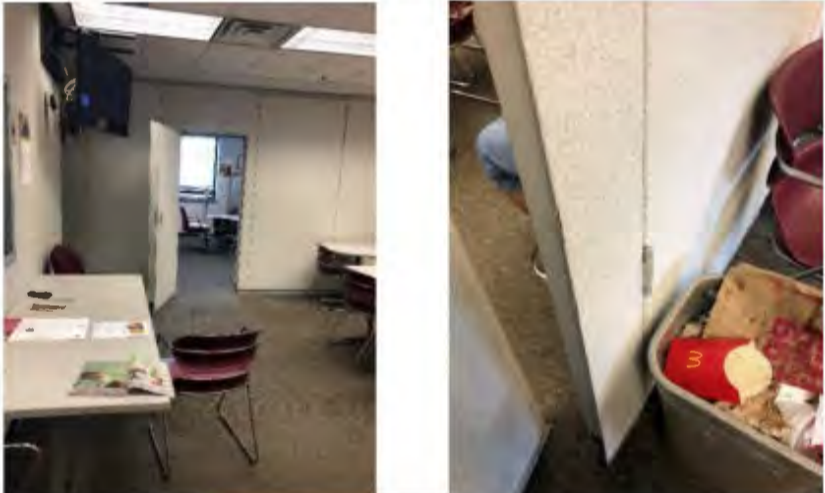
<p>The wall-covering on the operable wall is failing. Door locking mechanism is missing.</p>

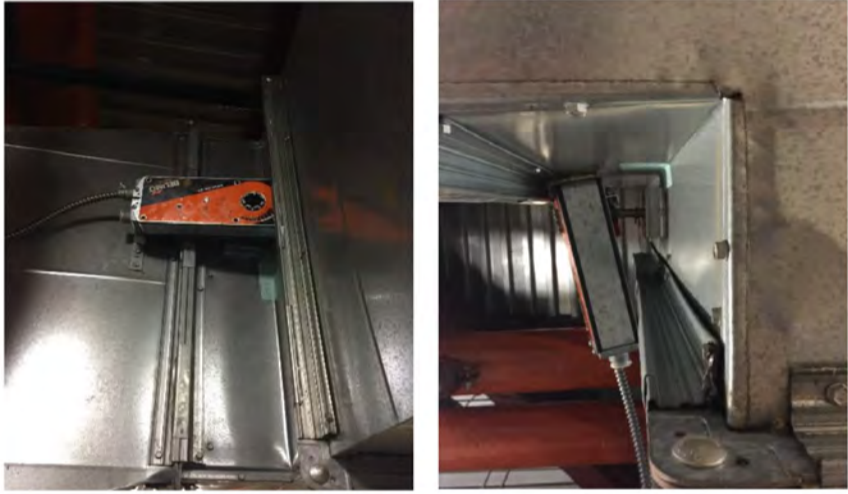
Outdoor air damper actuator is not completely mounted on the damper shaft.
