Ecological Assessment of the 91st Street and College Avenue Property

For Schmidt Associates

Ecological Assessment of the 91st and College Property

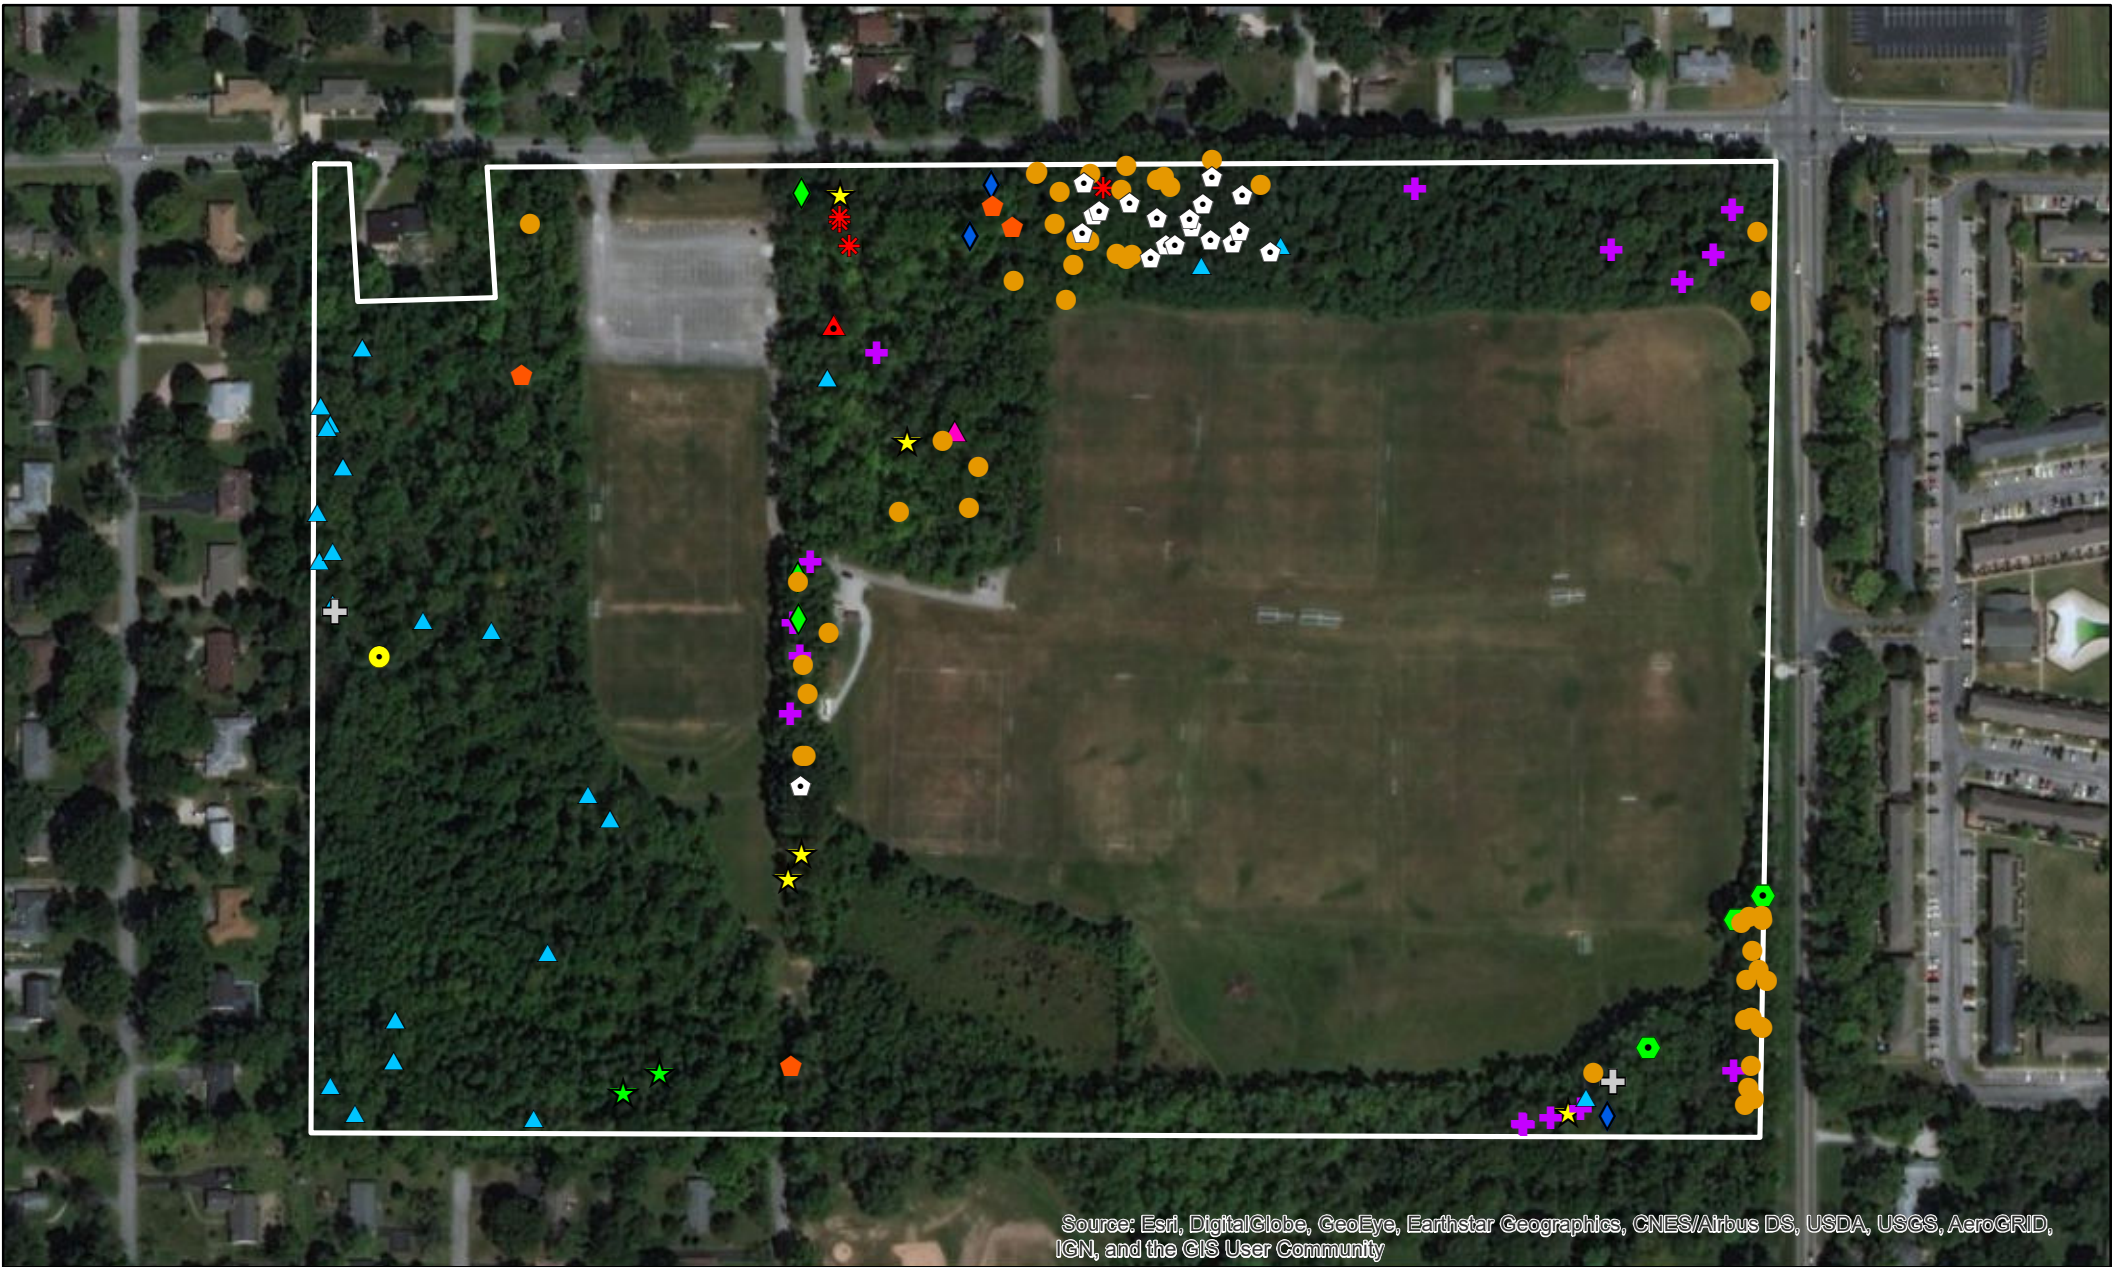
91st and College Property All Heritage Trees

The majority of the woodlands on this property are in an early successional state, mostly containing trees less than 75 year old and in many cases, less than 50 years old. However, the fertile soil and high moisture availability enable rapid tree growth. A small area of remnant woodland does occur in the north central portion of the property and contains some older trees. All together, 137 trees on the property qualified as heritage trees. These trees were primarily concentrated in the north central part of the property where the remnant woodland exists and in the southeastern corner of the property where a grove of black walnuts is present. The numbered list of the heritage trees that is attached to this report corresponds with the numbered markers contained on the regional heritage tree maps that are also attached.

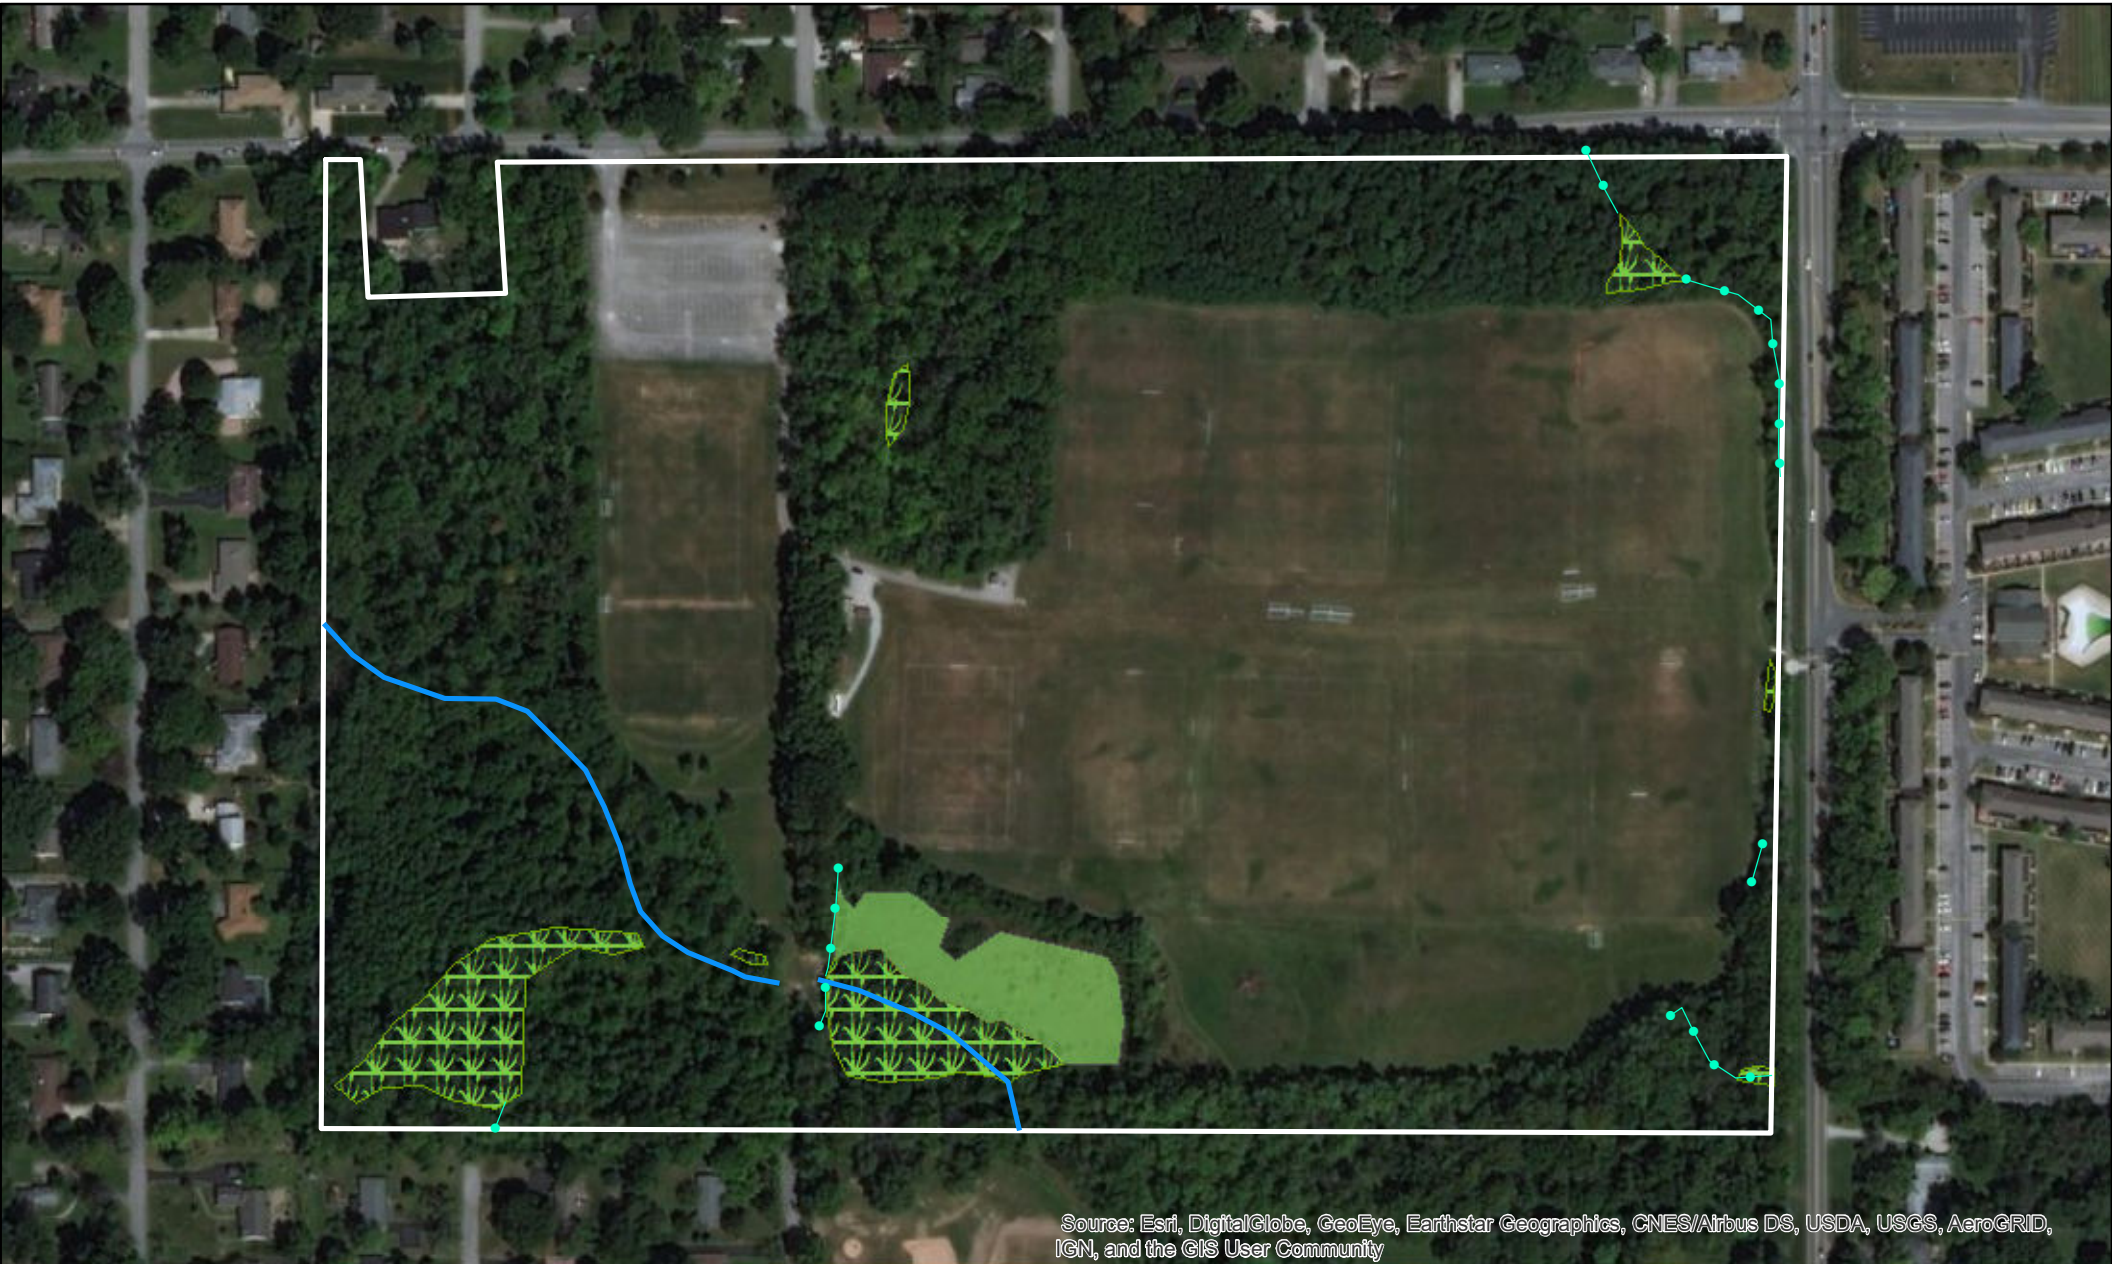
91st and College Property Wetlands and Streams

While this report does not include a formal wetland delineation or mapping of the streams for section 401 and 404 permitting via the Clean Water Act, I have indicated probable and possible wetland areas on an attached map. Other wetland areas may exist, particularly in the areas of Treaty soils.

A perennial stream exits a culvert on the west property boundary, flowing southeast through the property and exiting south of the detention basin as shown on the map. Other small channels that convey water during periods of wet weather are also indicated on the map.

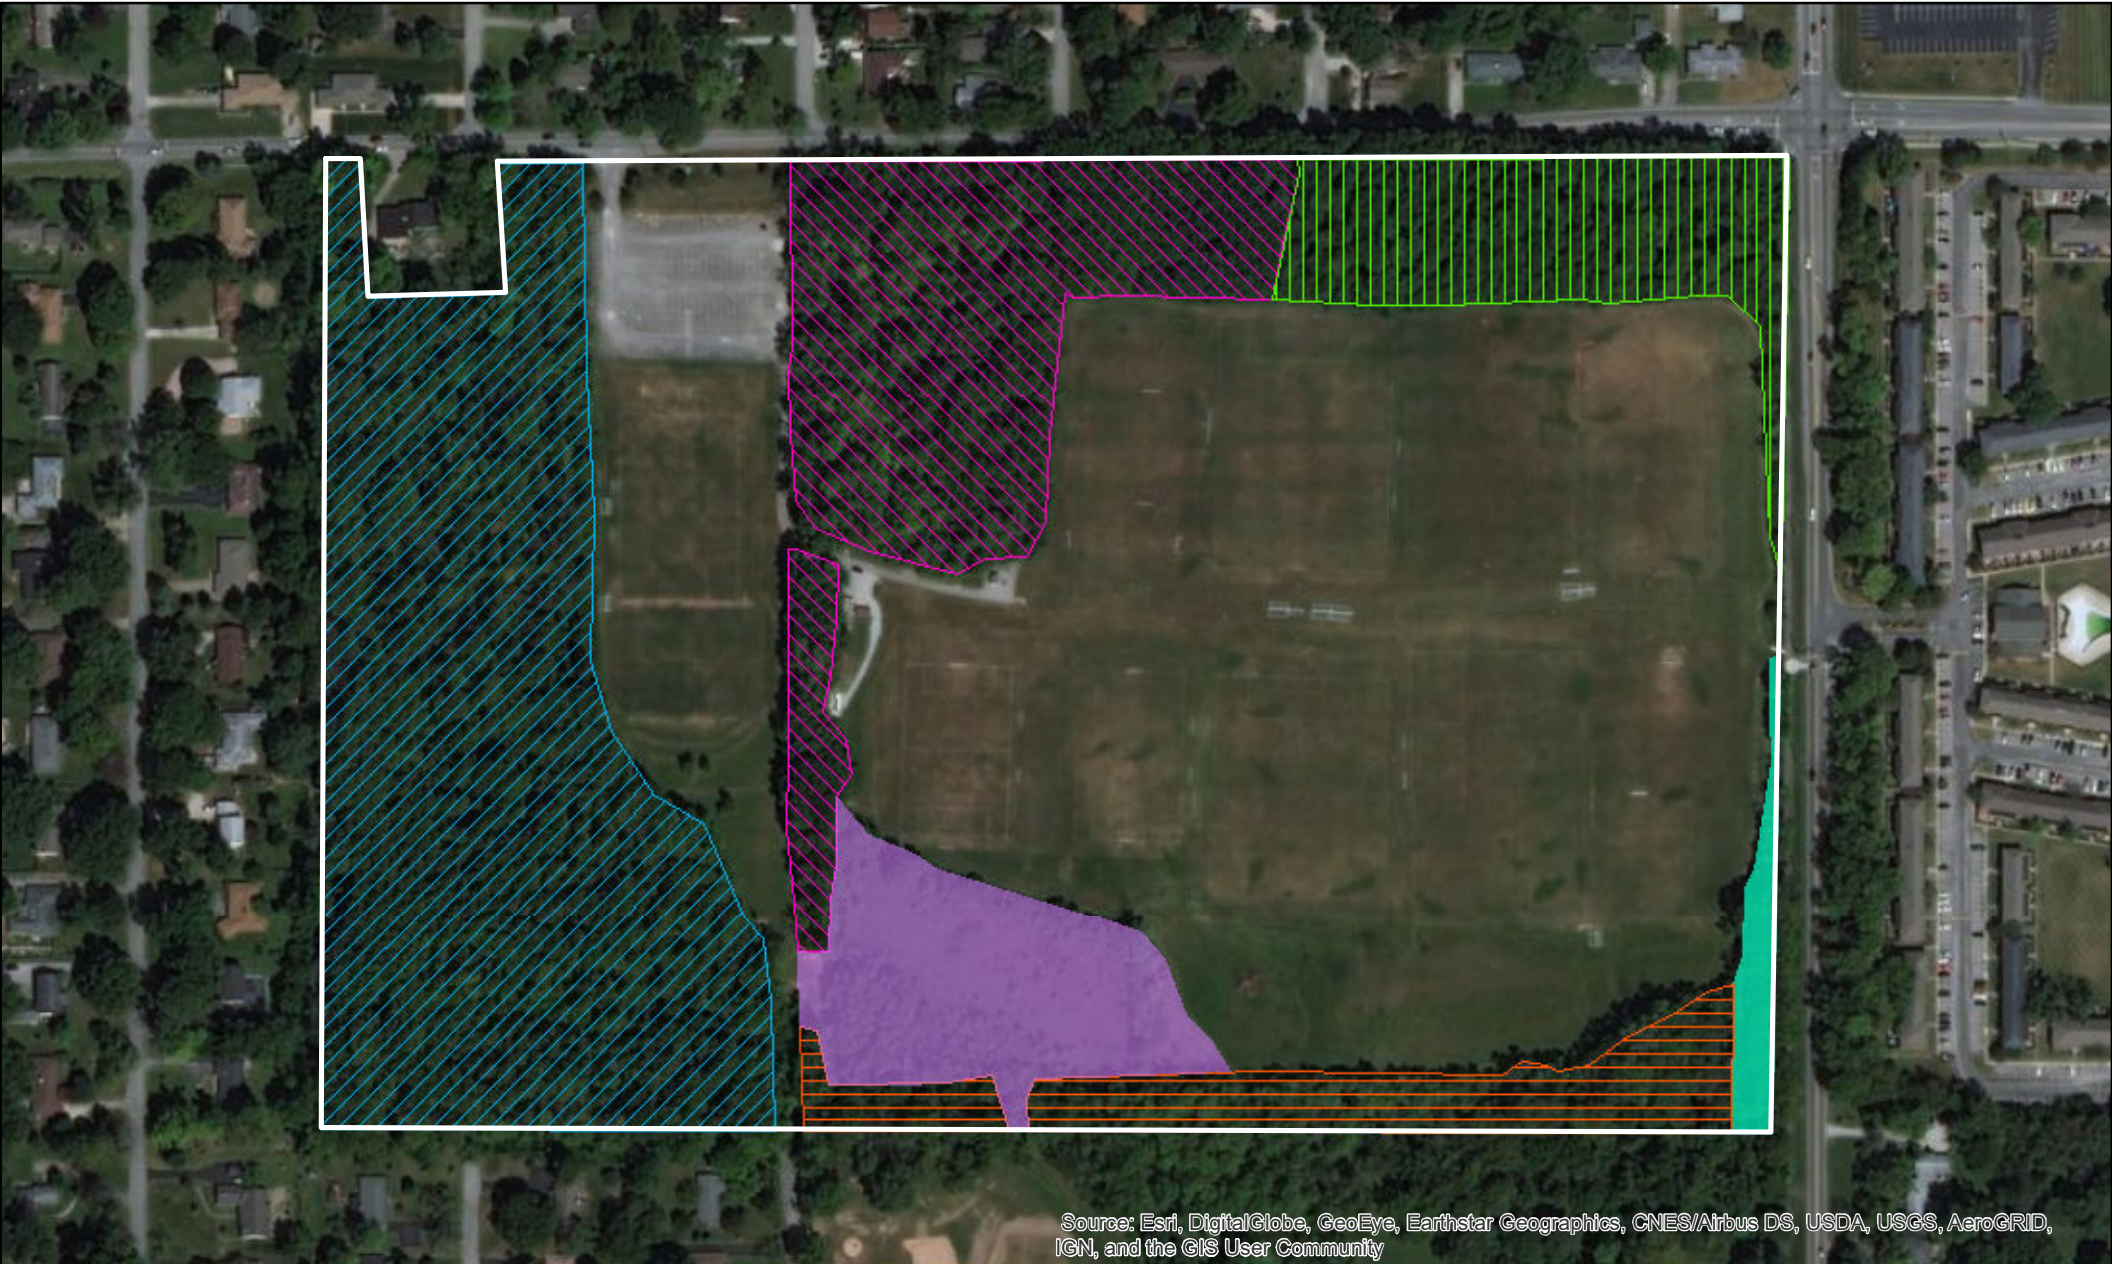
91st and College Property Plant Communities

The unmanaged areas of the property were divided into several plant communities based on their location on the property as well as, their stage of succession and their component tree species. These communities are delineated on an attached map.

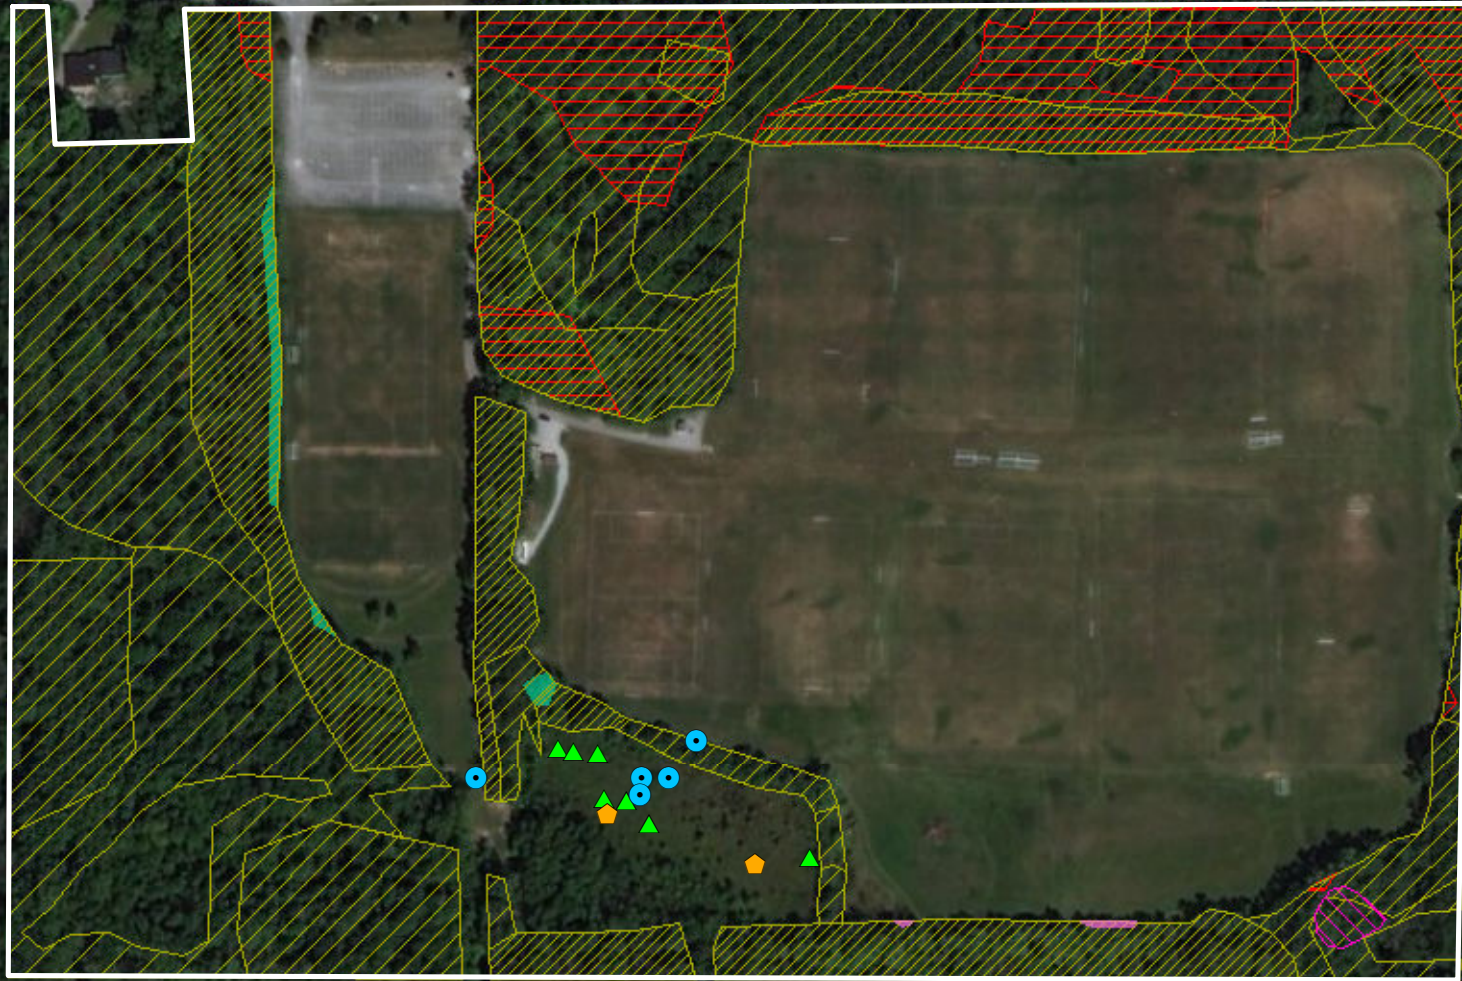
91st and College Property Invasive Plants

Typical for urban areas, the understories of the woodlands of this property are heavily infested with invasive woody species. By far the most abundant invasive plant species on the property is Amur honeysuckle (*Lonicera maackii*). It is abundant in all except the wettest portions of the woodlands. The second most troubling invasive plant on the property is the wintercreeper (*Euonymus fortunei*). It is abundant in most of the northern woodlands on the property where it forms a creeping groundcover as well as climbing the trees as a clinging vine. Other invasive shrubs and vines that have invaded the woodlands and woodland edges include Japanese honeysuckle (*Lonicera japonica*), common buckthorn (*Rhamnus cathartica*), and multiflora rose (*Rosa multiflora*).

The sunny condition of the detention basin has allowed establishment of species largely absent from the shaded woodland areas. These include callery pear (*Pyrus calleryana*), European black alder (*Alnus glutinosa*), and autumn olive (*Elaeagnus umbellata*). A map showing the locations and densities of the invasive plants on the property is attached to the report.
