WASHINGTON
TOWNSHIP SCHOOLS

Secondary School Master Plan

SECONDARY SCHOOL FACILITY CONDITION ASSESSMENTS

EXISTING CONDITIONS ASSESSMENT SUMMARIES

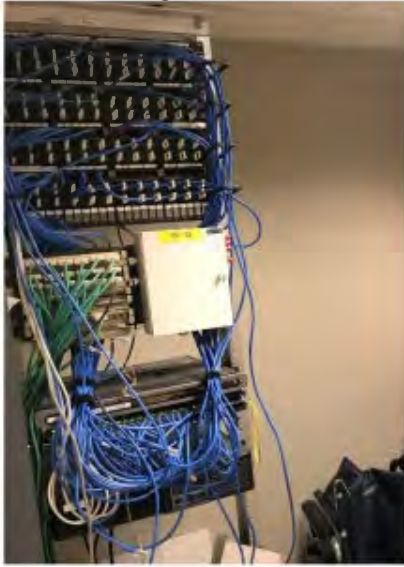
IDF 2 – Storage Room A105C

IDF 2 is located on the 1st floor in a storage closet connected to a classroom. The room contains the 2-post telecom rack as well storage supplies for the classroom and an ACT ceiling. The IDF has approximately 100 ports that have been terminated.

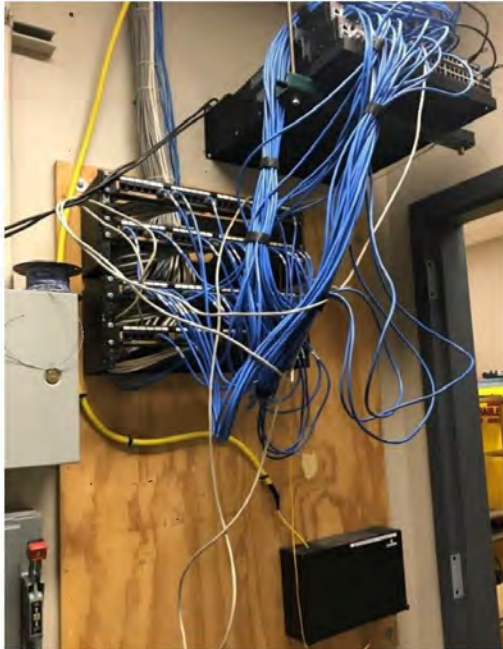
IDF 12 – Electrical Room B119A

IDF 12 is located on the 1st floor in an electrical room located at the back of a storage room. The room contains electrical panels with TR plywood for mounting of the telecom equipment. The IDF itself consists of patch panels and a single mode fiber enclosure that are directly mounted to the plywood with a shelf above it housing network switches. The IDF has approximately 50 ports that have been terminated.

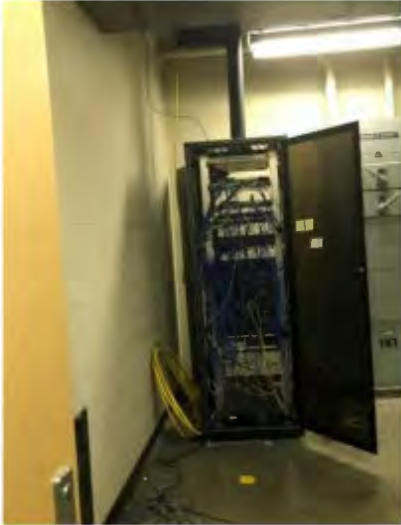
IDF-2 – Electrical Room Unit F / G by Corridor G-105 (H???)

IDF-2 located in an electrical room within classroom in unit G

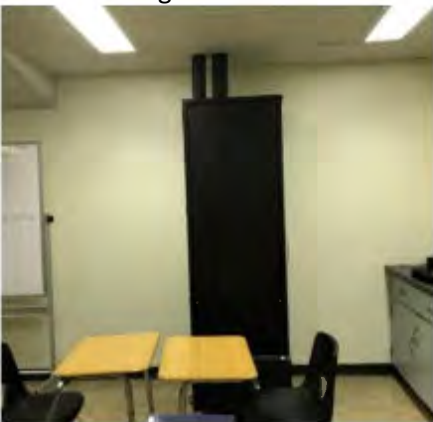
IDF-3 – Storage G-121

IDF-3 located in “storage room” converted into a classroom in unit G.

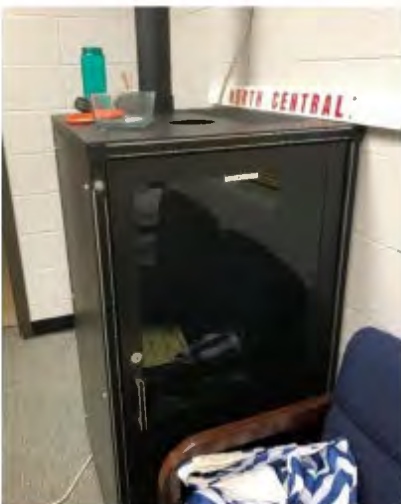
IDF-4 – Office E-152

IDF-4 located in gym teachers office off of auxiliary gymnasium.

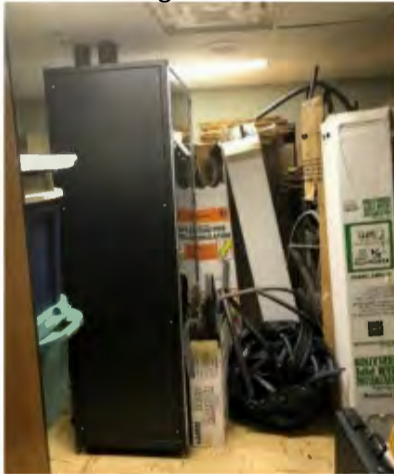
IDF-5 – Storage B-244

IDF-5 located in storage room on second level of the building. Room used for general storage.

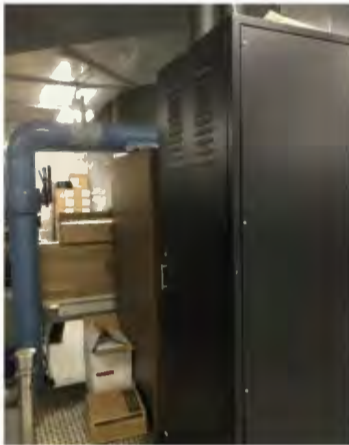
IDF-6 – Mechanical B-234

IDF-6 located in large mechanical room on the second floor.

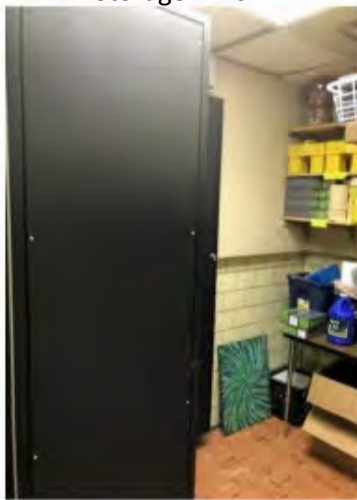
IDF-7 – Storage A-207

IDF-7 located in storage room on second level. Room used for general storage.
