WASHINGTON
TOWNSHIP SCHOOLS

Secondary School Master Plan

SECONDARY SCHOOL FACILITY CONDITION ASSESSMENTS

EXISTING CONDITIONS ASSESSMENT SUMMARIES

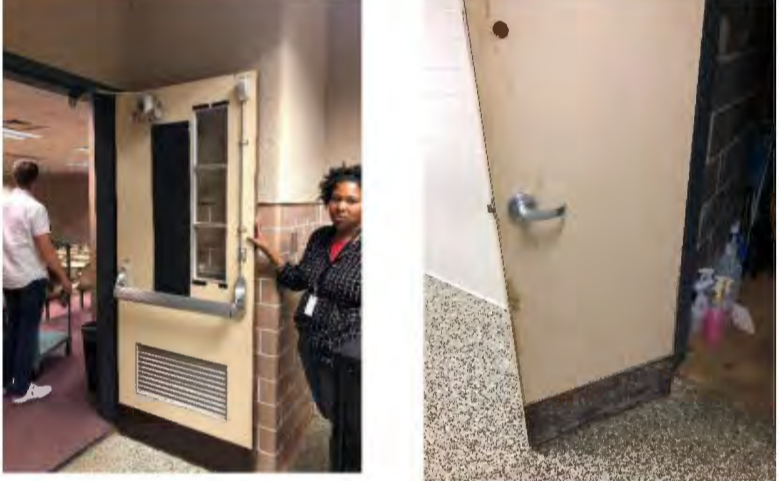
<p>Varying door types and colors and lites. Tan.</p>
3

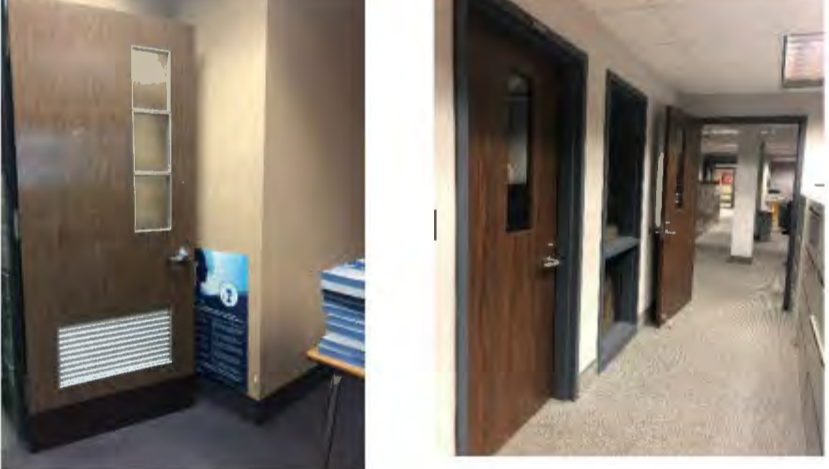
<p>Varying door types and colors and lites. Wood grain.</p>
4

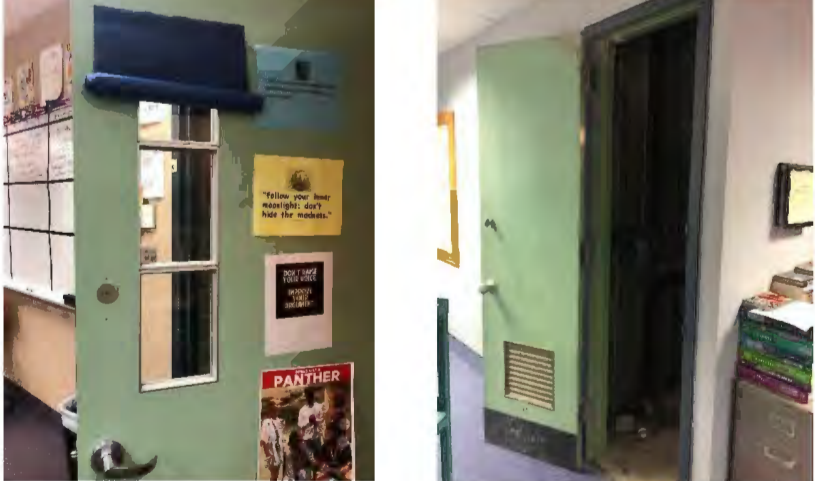
<p>Laminate doors of varying types and colors. Edges are showing age and distress.</p>

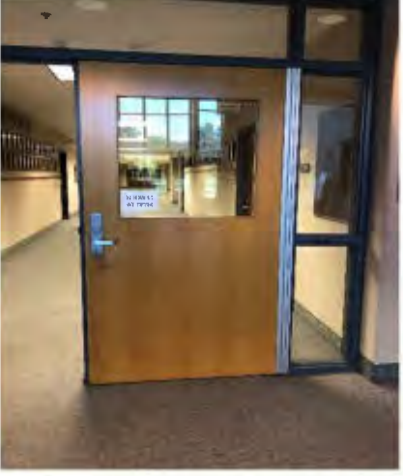
<p>Laminate doors of varying types and colors. Woodgrain laminate on the left. Wood door on the right.</p>
6

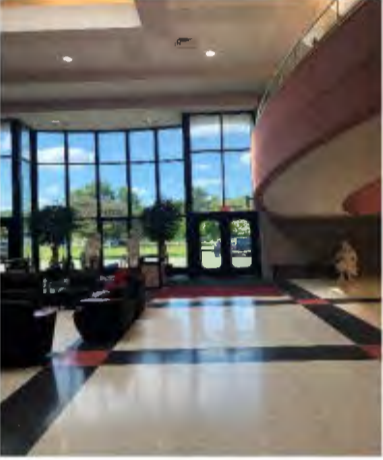
<p>Main entry has no secure vestibule.</p>
7

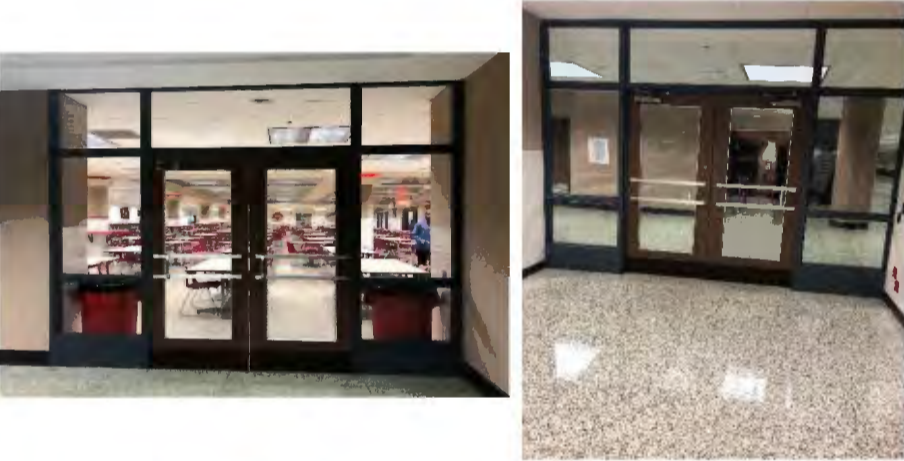
<p>Cafeteria entry.</p>
8

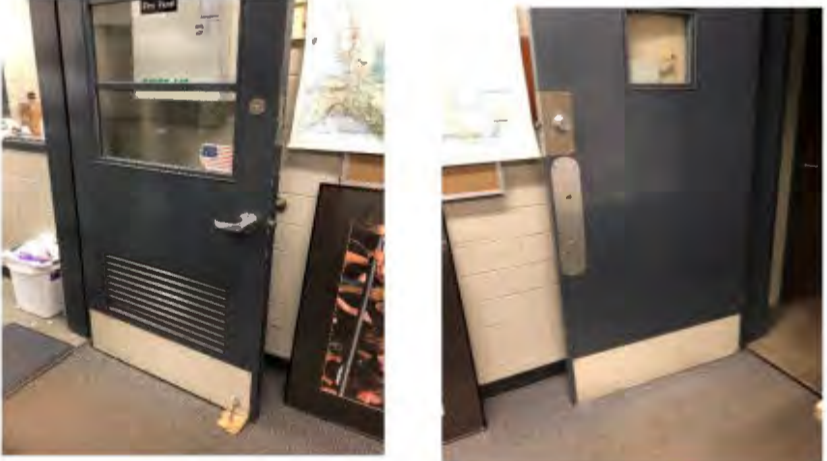
<p>Doors of varying types and colors.</p>
9

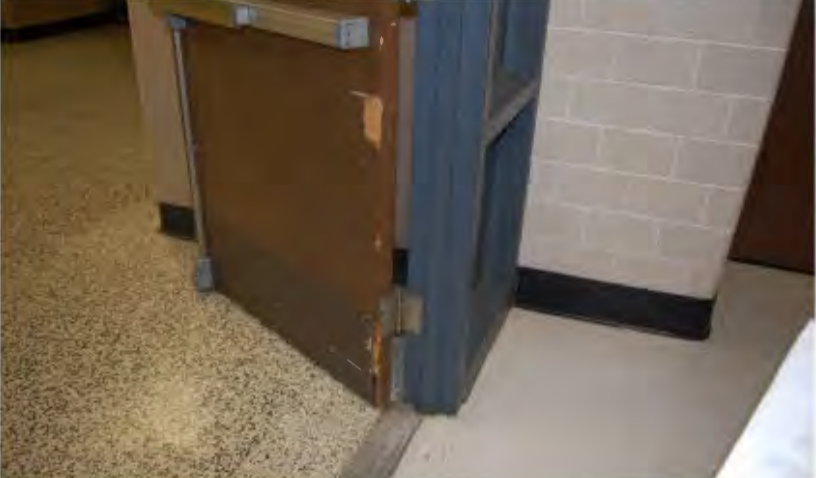
<p>Door has damage and wear.</p>

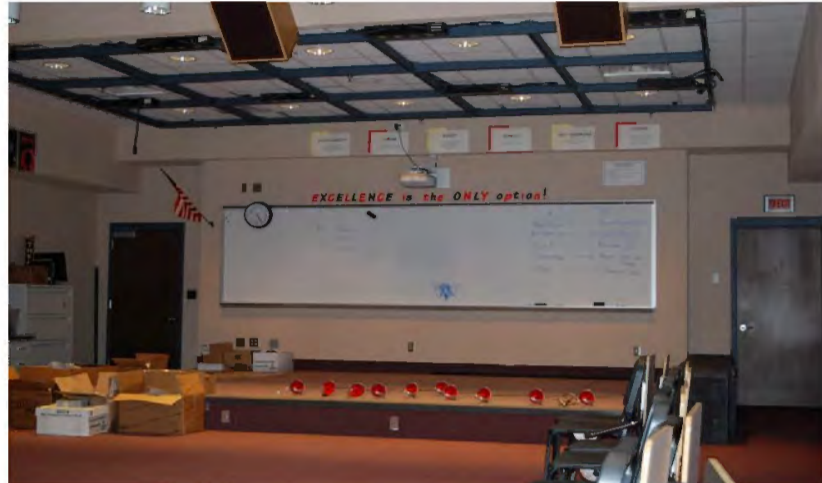
Raised platform, light grid at front of room. (3 rooms) Drinking fountain, specialized equipment.
12

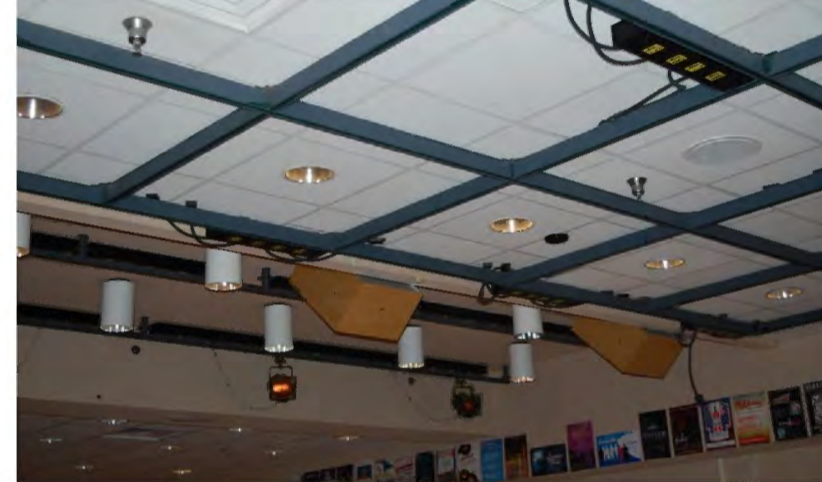
Specialized ceiling, bulkheads, light grid.
13

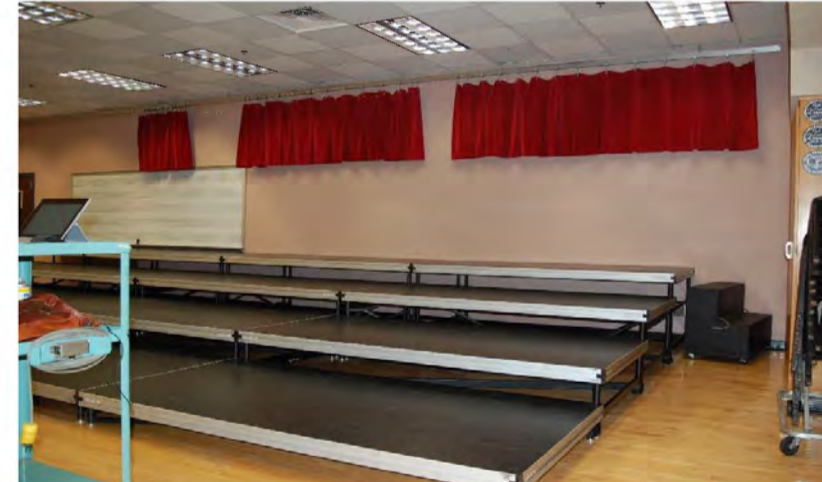
Wood floor indicates recessed slab.
14

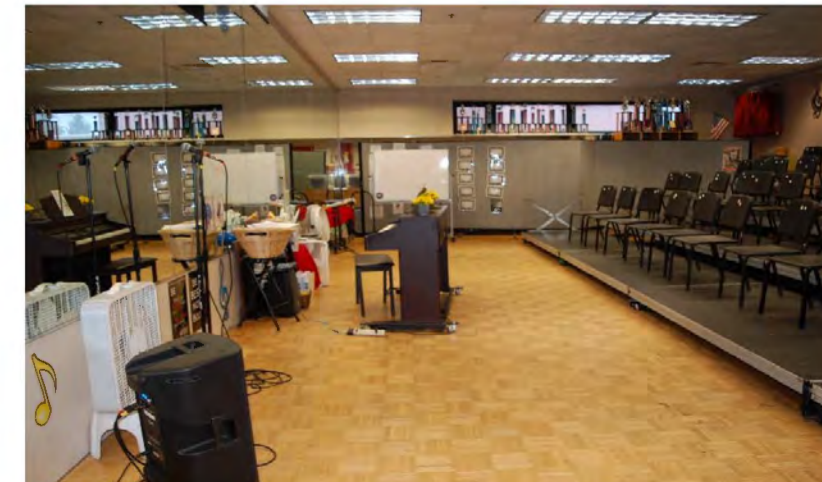
Parque wood floor over recessed slab.

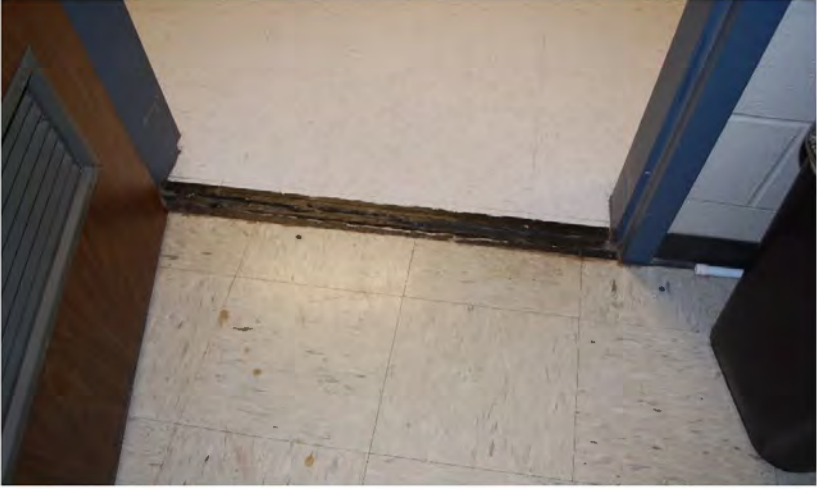
Need threshold trim at door to cover join between flooring materials.
16

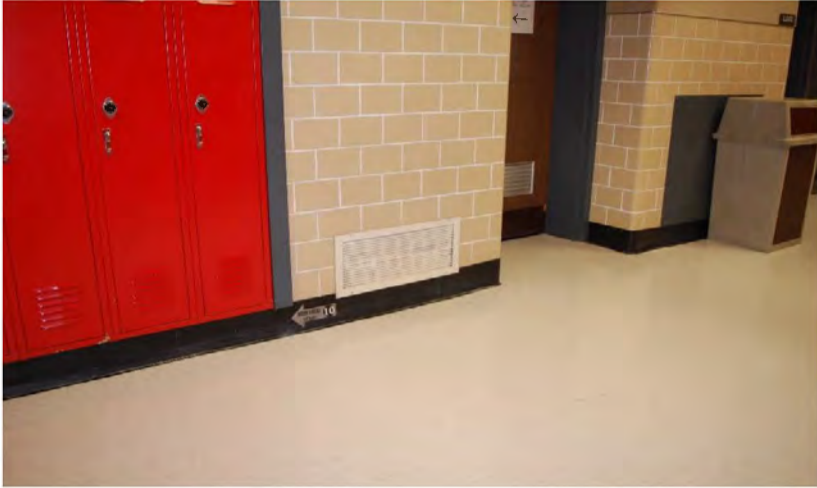
Mechanical vents in corridors are damaged, typical. Note special wayfinding for stage.
17

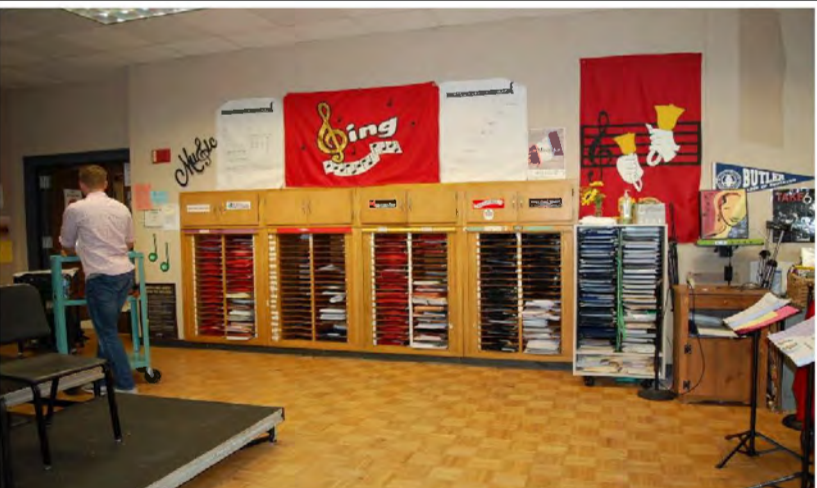
Built-in music storage casework.
19

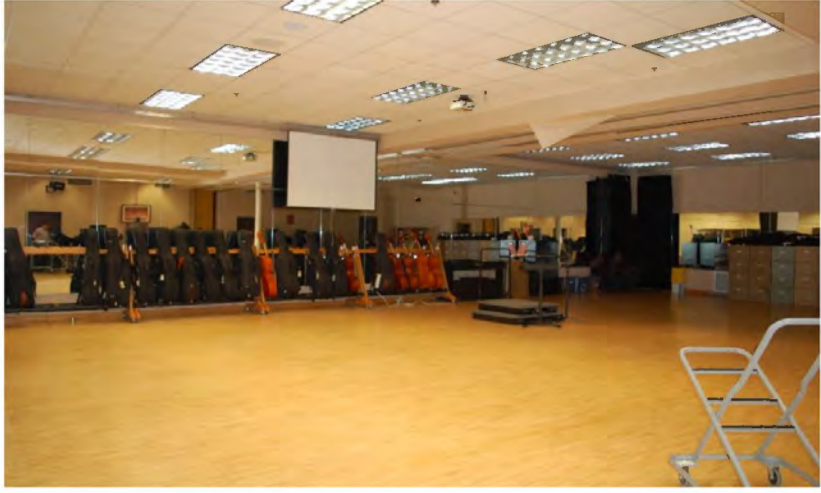
Operable partition track, no partition. Wall covering delaminating. Wood floor. Mirrors on walls, Drinking fountain.
21

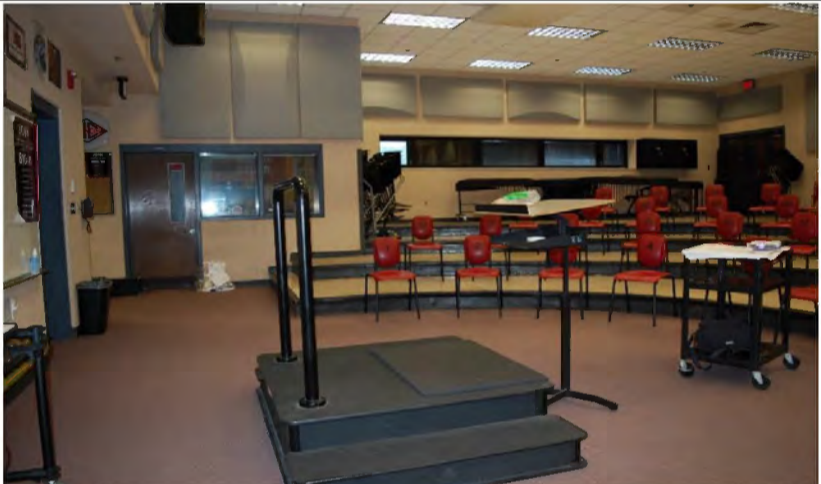
Inaccessible band tiers. Rear door missing exit device.
23

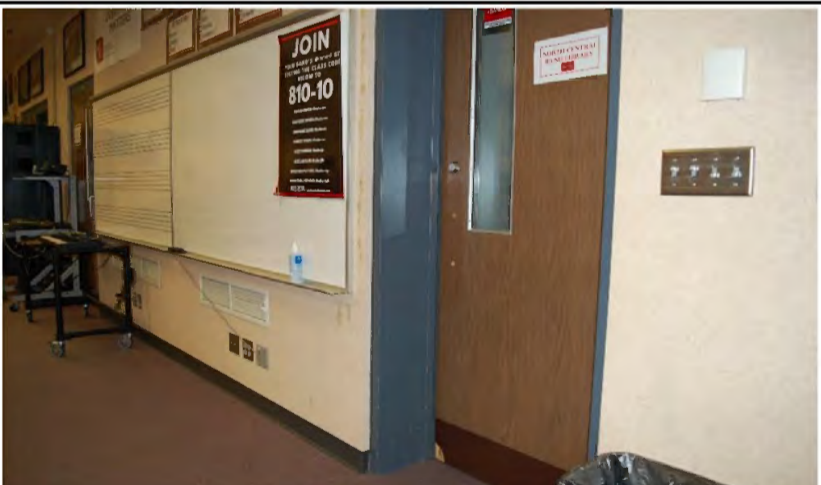
Wall covering damage. Door & frame damage. No push plate or handle on door. Band room doors and frames damaged, missing paint.
24

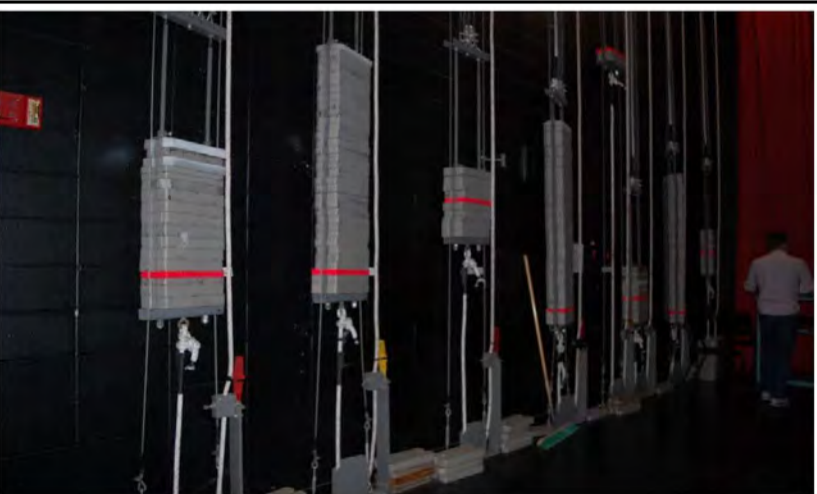
<p>Small Auditorium rigging.</p>
34

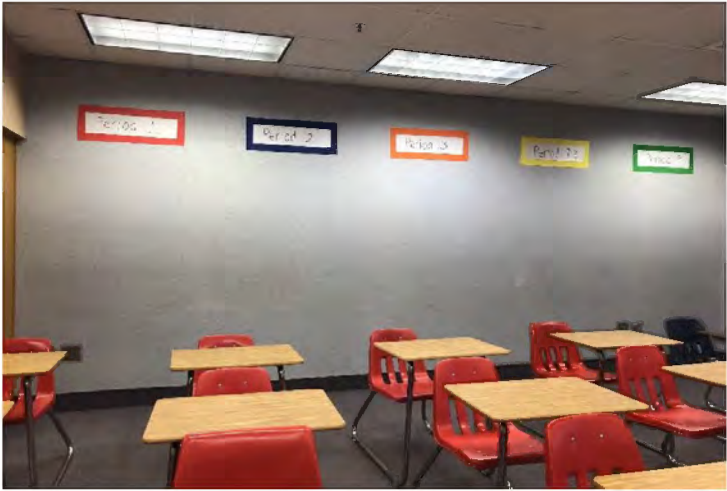
<p>A photograph of a classroom wall. Several colorful signs are mounted on the wall at approximately chair or head height. The signs are labeled 'Technology', 'Sports', 'Religion', 'Family', and 'Arts'. The wall shows signs of wear, particularly at the height of the signs.</p>	<p>Wall covering worn at chair/head height in most classrooms.</p>
36

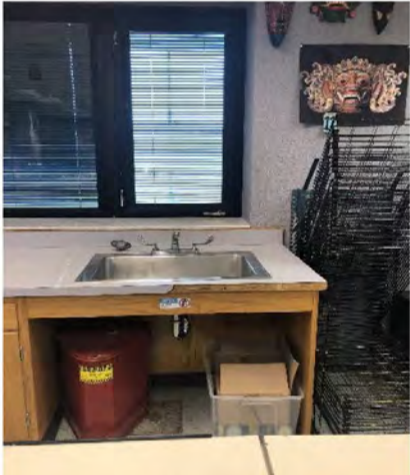
<p>A photograph of a kitchen sink area. The laminate counter edge is missing. A sink trap is visible, which is not protected for ADA roll-in condition. A red trash bin is under the counter.</p>	<p>Laminate counter edge missing. Sink trap not protected for ADA roll-in condition.</p>

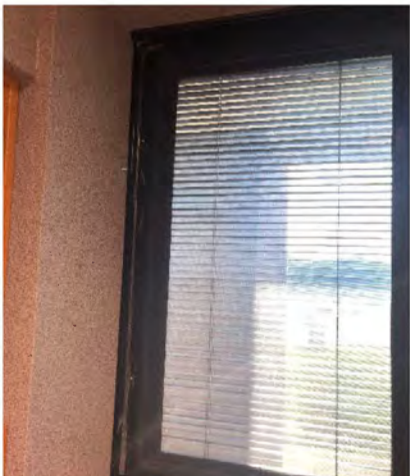
<p>A photograph of a window with horizontal blinds. The window frame has tape around the perimeter, indicating missing caulk or failed seals.</p>	<p>Window has tape around perimeter, indicating missing caulk or failed seals.</p>
39

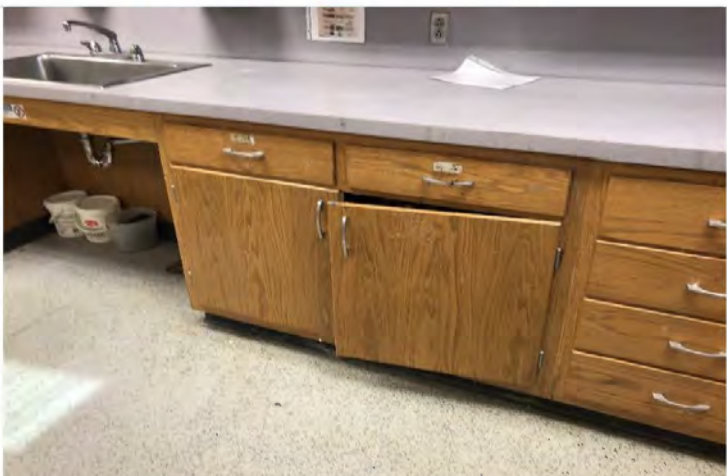
<p>A photograph of kitchen cabinets. The casework is worn, and a door hinge is failing.</p>	<p>Casework worn, door hinge failing.</p>

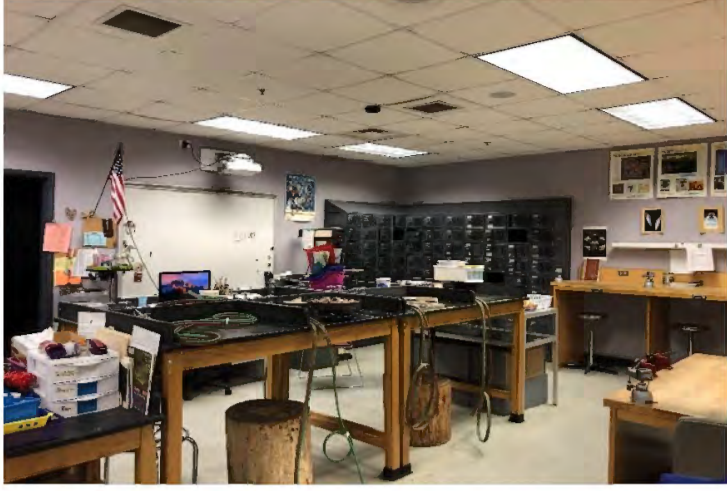
Specialized jewellery-making equipment with air.
41

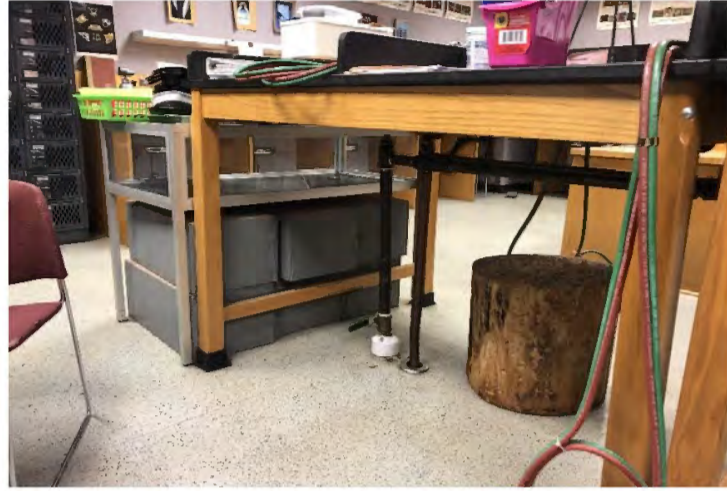
Hard plumbed utility connection to casework.
42

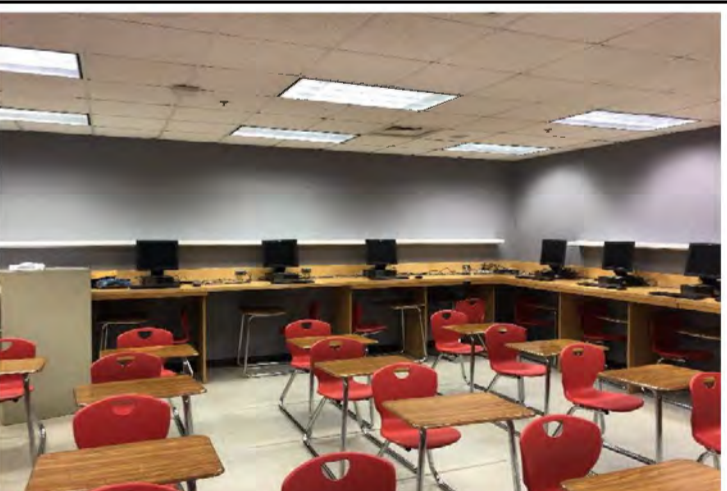
Computer tables & shelves not at accessible height.
44

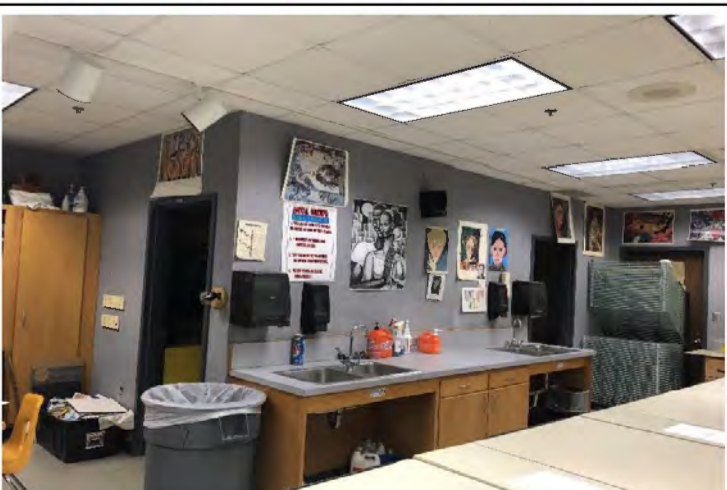
Some classrooms have tackable walls, assuming cork under the vwc.

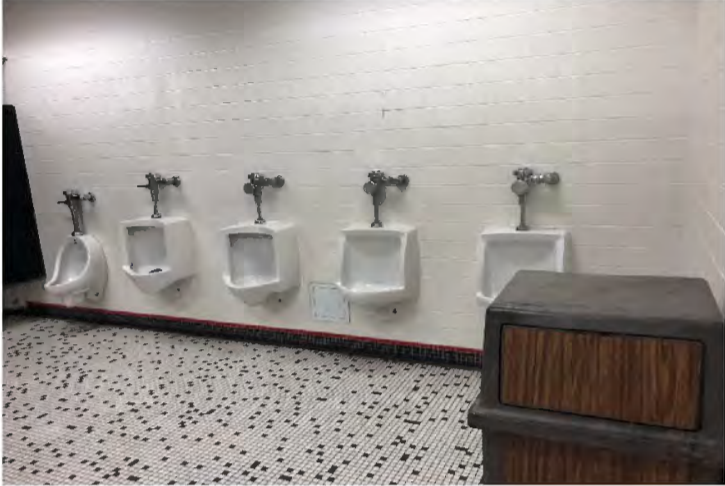
No urinal screens. Cracked wall tile. Holes in tile where previous accessories were removed.
47

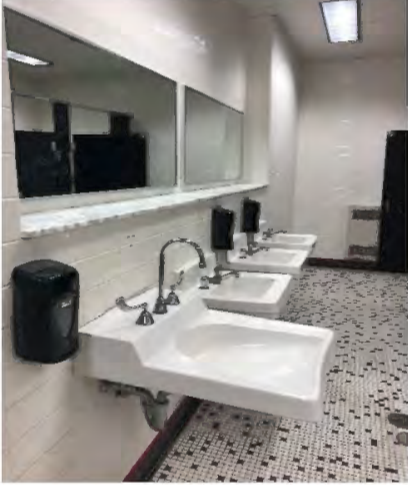
Accessible sink pulling away from wall.
48

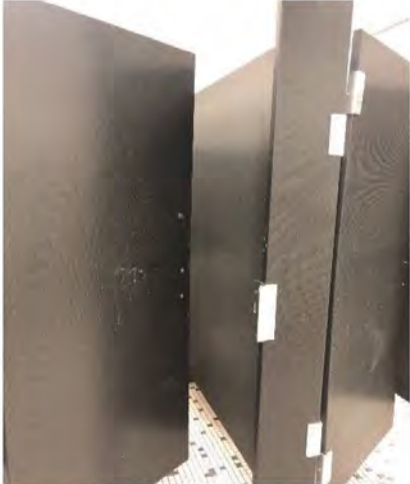
Toilet partition collecting dirt/grime.
49

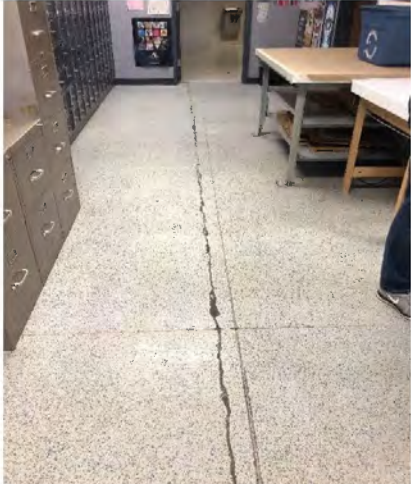
Photo #	Photo Image	Description
50

Crack in the Art Room floor. Design/Textile H185.

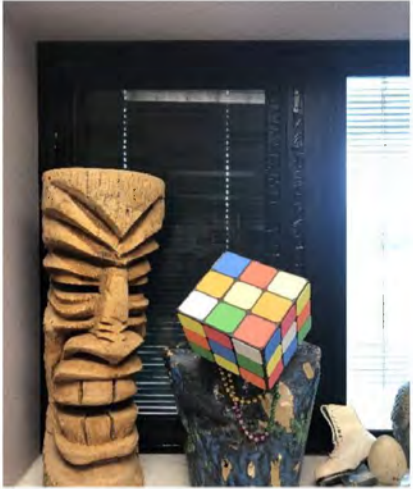
<p>Window has tape around perimeter, indicating missing caulk or failed seals.</p>
51

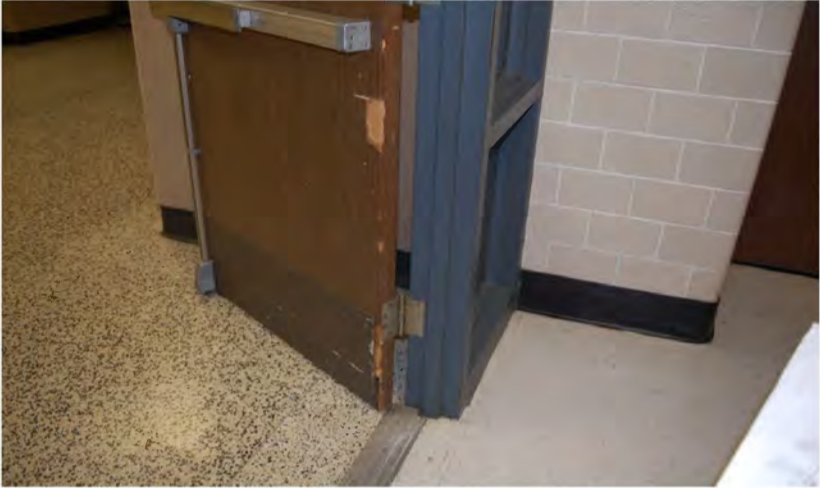
<p>Door has damage and wear.</p>
52

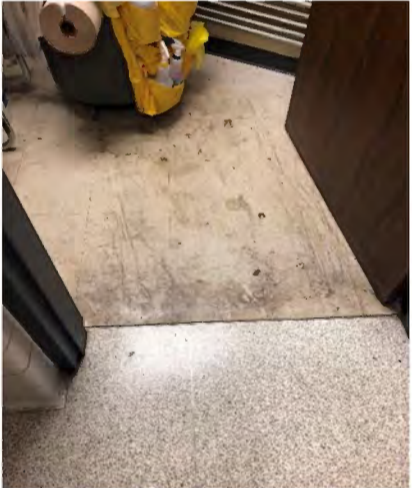
<p>Floor in the custodian closet is worn and damaged.</p>
53

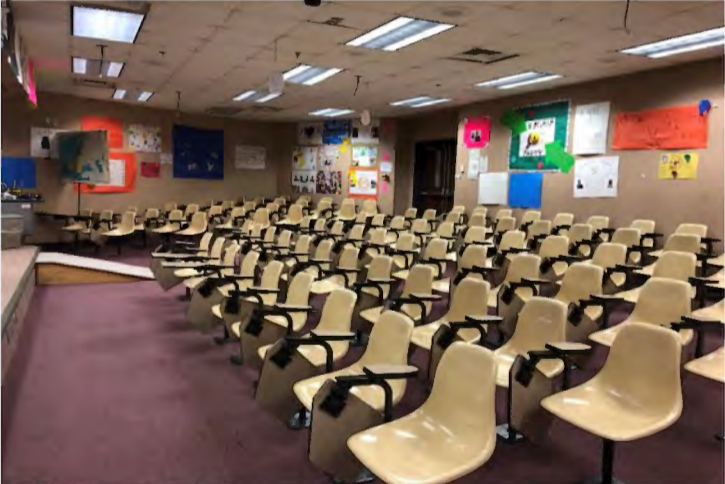
<p>Sloped floor with fixed seating, no accessible seating. Tablet arms broken. Access to raised platform is not accessible.</p>
54

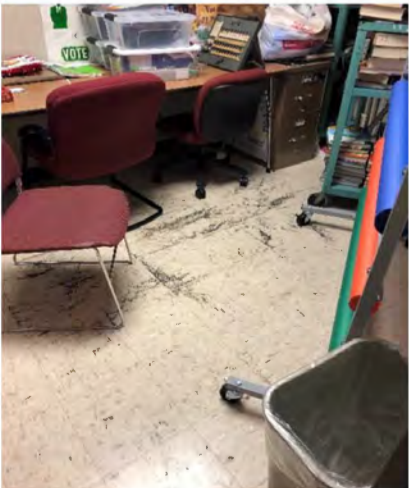
Photo #	Photo Image	Description
55

<p>Floor in poor condition.</p>

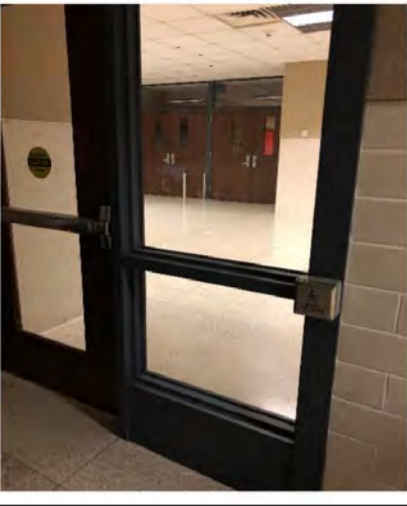
<p>Doors into elevator vestibule are 3'-0". This limits the size of furniture etc. that can be transported on the elevator.</p>
56

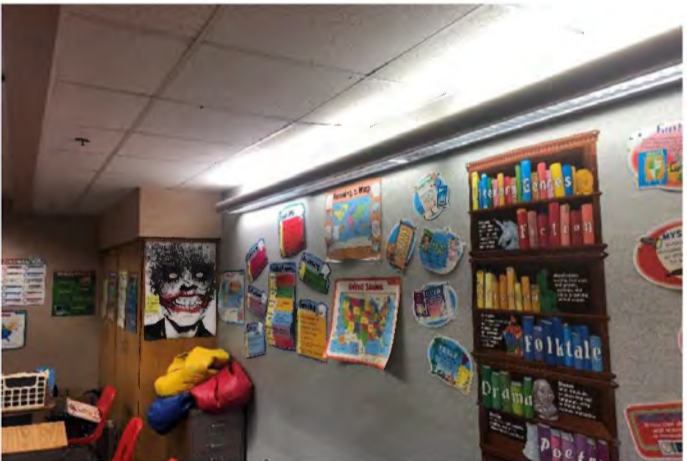
<p>Cove light and bulkhead example. Bulkheads wrapped in vinyl wall covering. Grid and ceiling tiles damaged in some locations.</p>
59

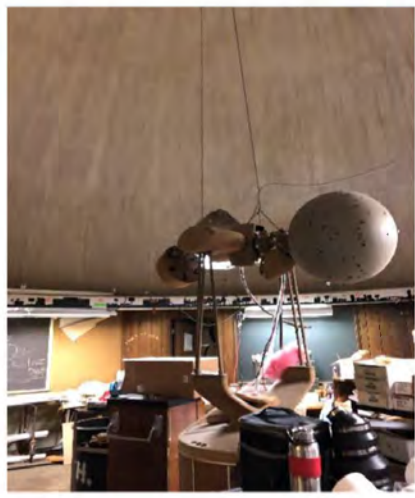
<p>Planetarium space is being used as custodian's shop/storage. Existing planetarium equipment remains.</p>

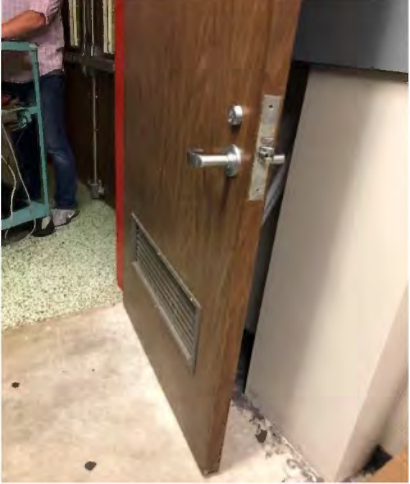
<p>Non-sealed concrete in electrical and custodial closets. Residue on floor, no wall base.</p>
61

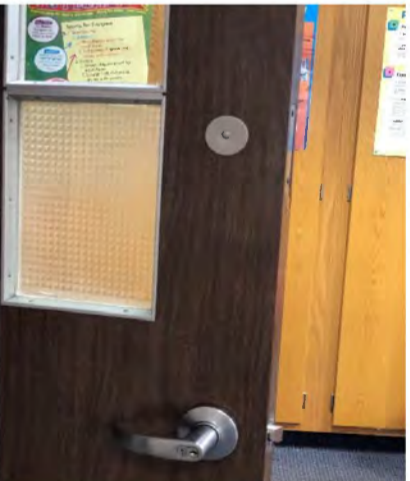
<p>Corridor side of door has escutcheon plate over hole. Not all classrooms can be locked from inside the classroom.</p>
64

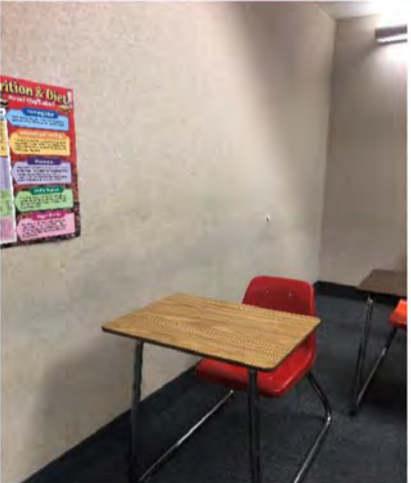
Classroom vinyl wall covering showing wear around perimeter of rooms.
67

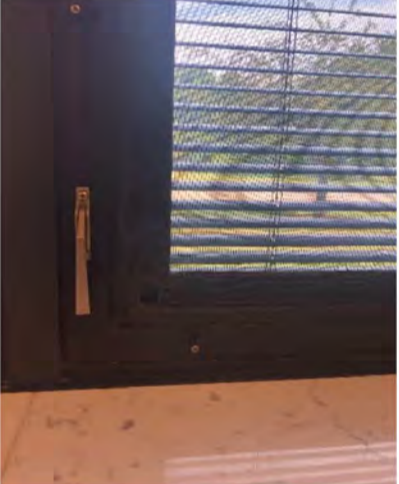
Several window screens have holes.
68

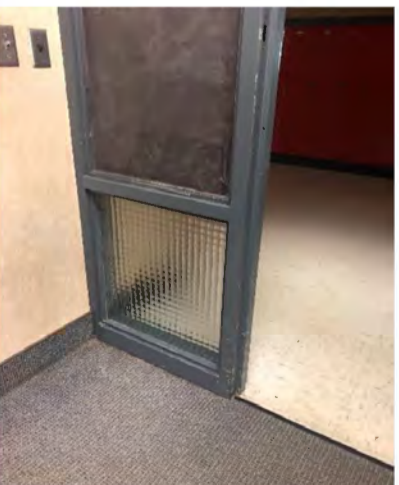
Photo #	Photo Image	Description
70

Mismatched glass in interior storefront.

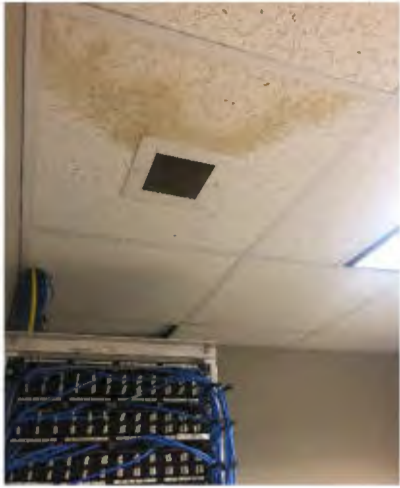
Example of damaged ceiling tile.
71

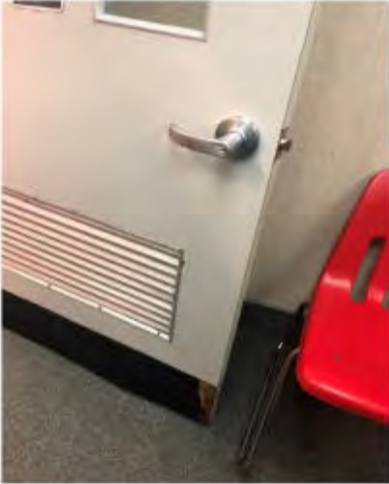
Door has damage and wear.
73

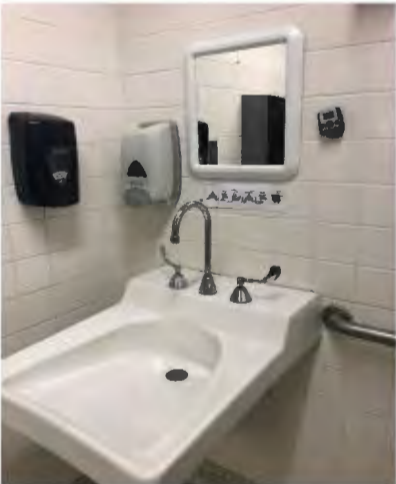
Mirror over the sink is not at an accessible height.
74

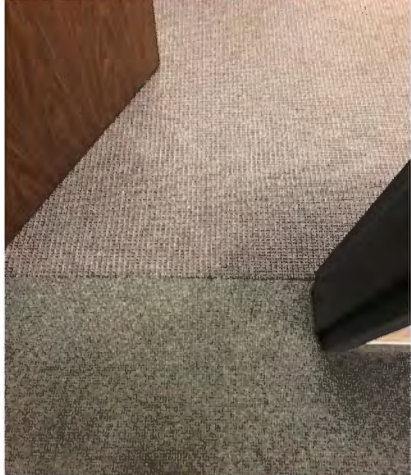
Need a floor material transition
76

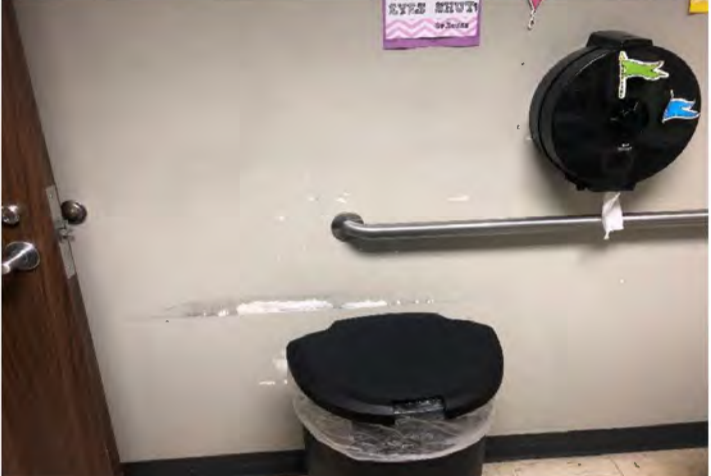
Damage to wall.
77	 	Damage to lab epoxy table tops
78

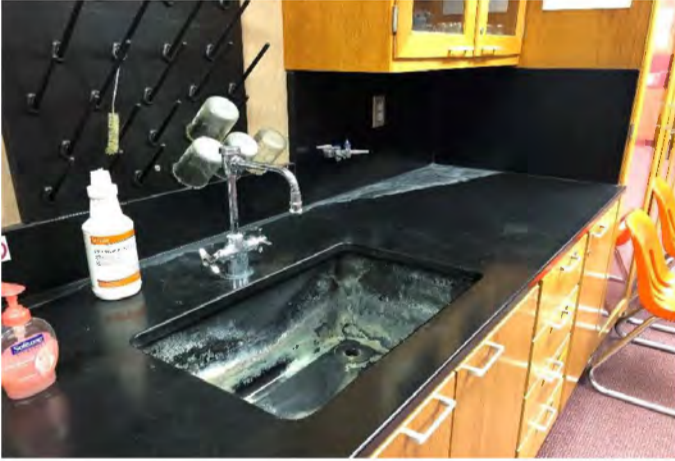
Epoxy sinks have corrosion.
79

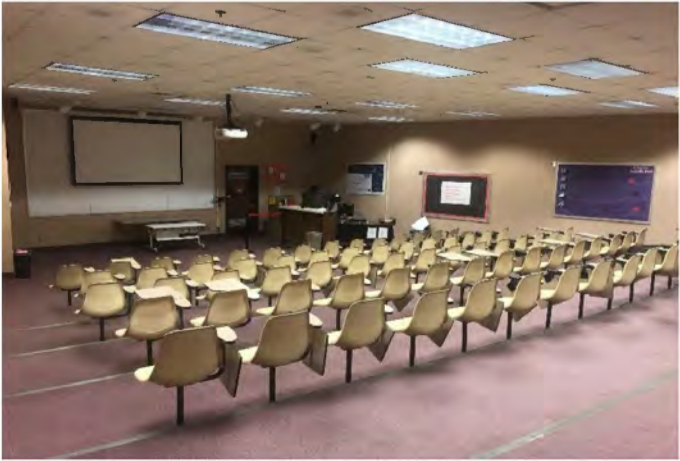
Photo #	Photo Image	Description
80

Lecture room with fixed seats is not accessible.

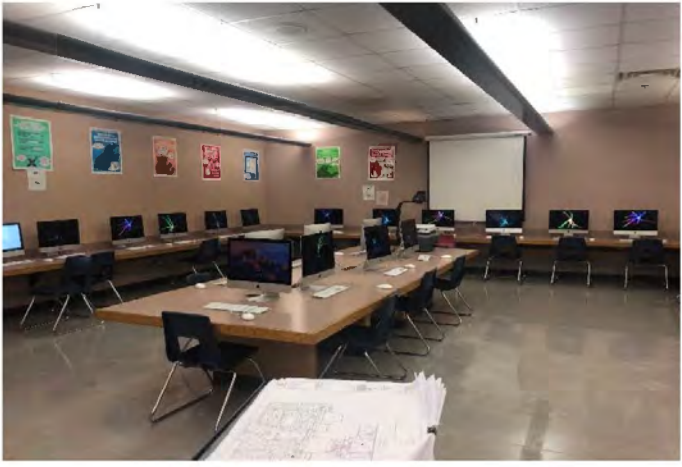
Casework is in worn condition.
81

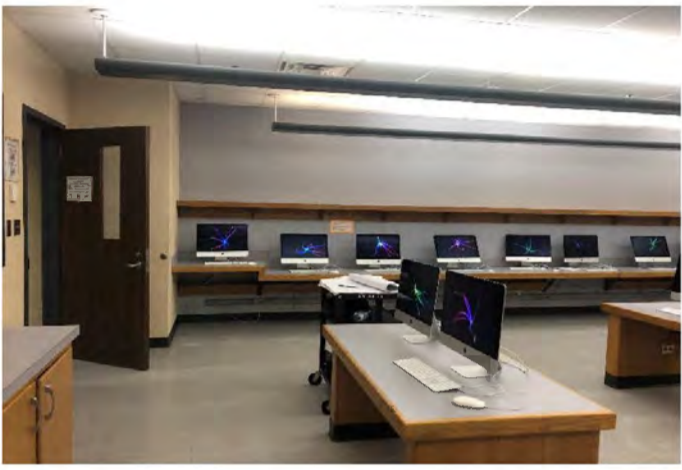
Casework is in worn condition.
82

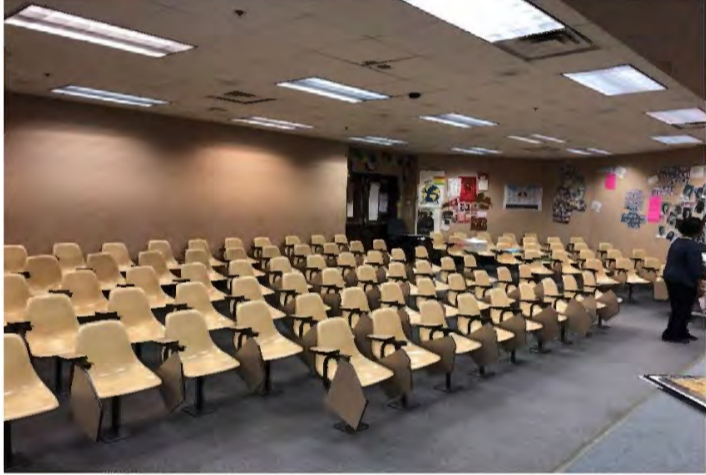
Fixed seating on non-ADA compliant slope. Several seats are broken.
83

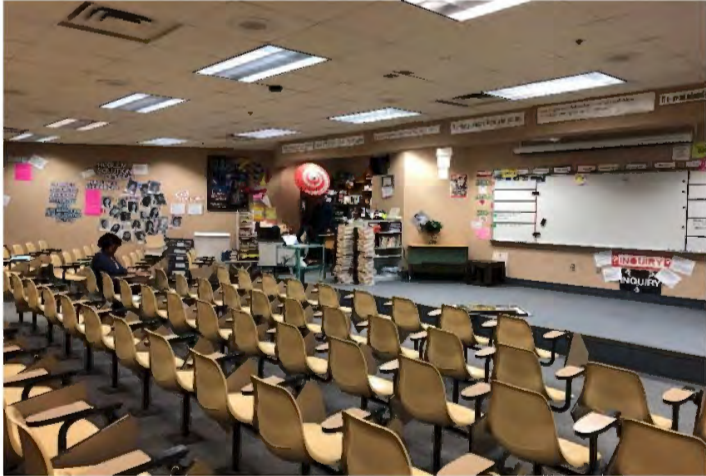
Fixed seating on non-ADA compliant slope. Several seats are broken.
84

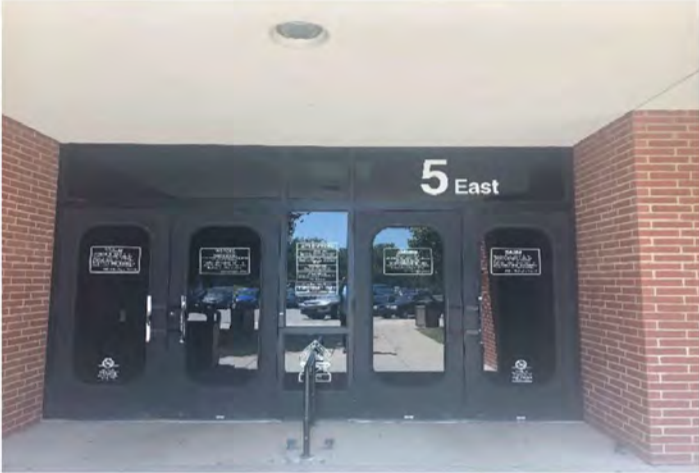
Concrete pitting. Corrosion on doors.
87

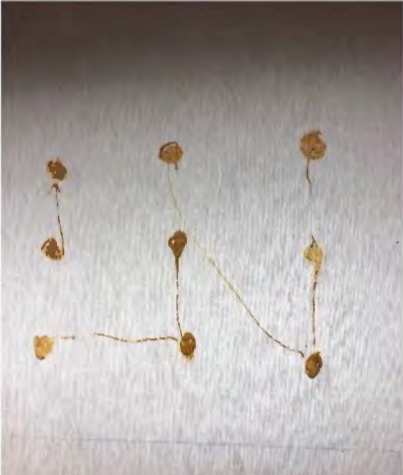
Evidence of wall mounted board removal on wall covering.
88

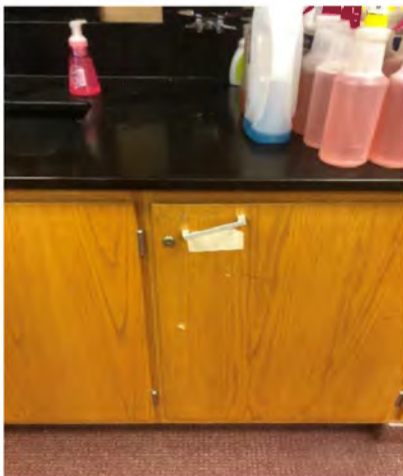
Science casework handle needs reattachment (several instances of this were found).
89

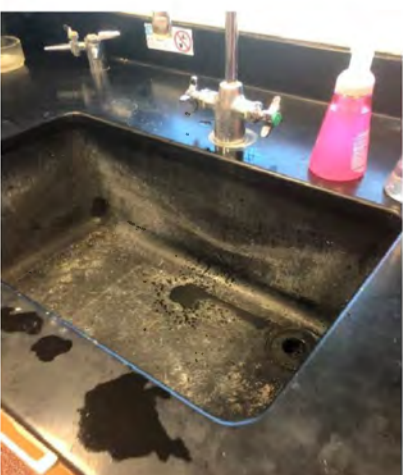
Photo #	Photo Image	Description
90

Science epoxy sinks have corrosion.

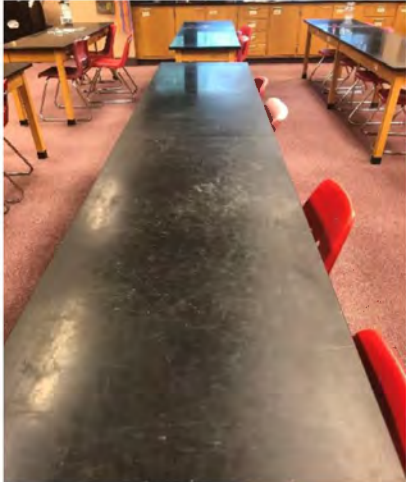
Science fixed lab tables are in poor condition.
91

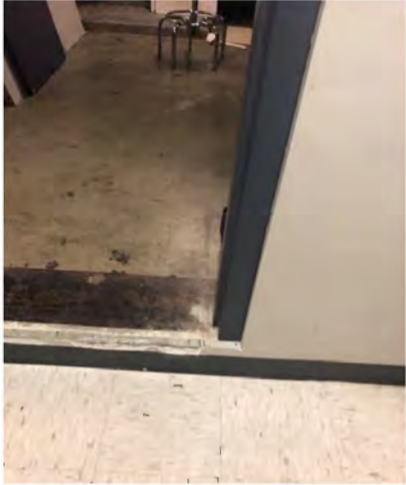
Flooring transition is needed.
92

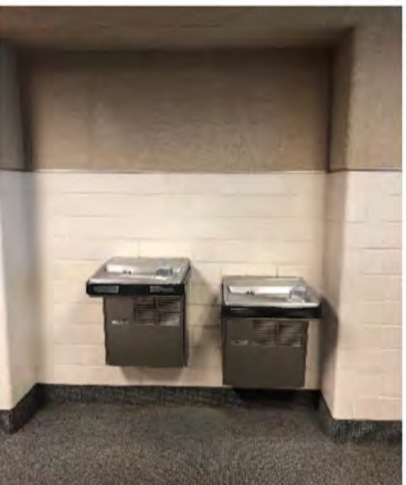
No water proof material under drinking fountains.
93

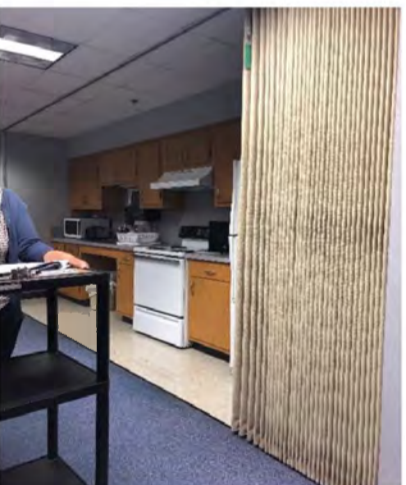
Old and dirty accordion partition.
94

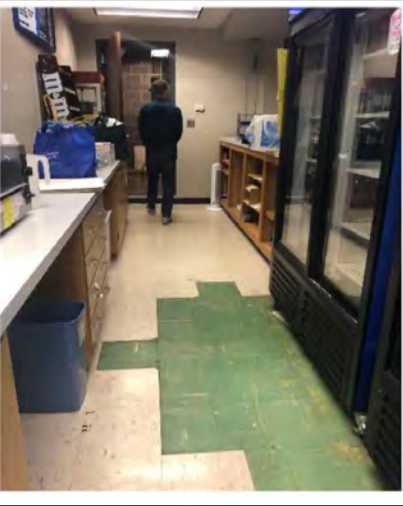
Mismatched floor tile.
96

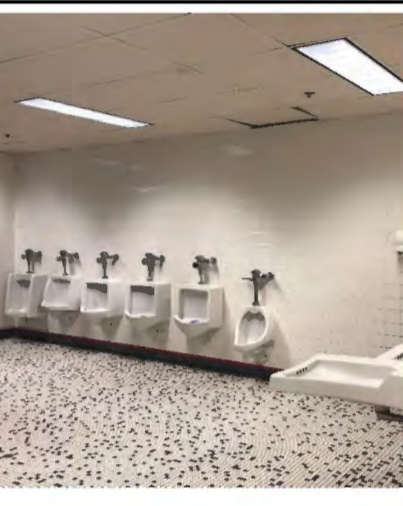
No urinal screens.
97

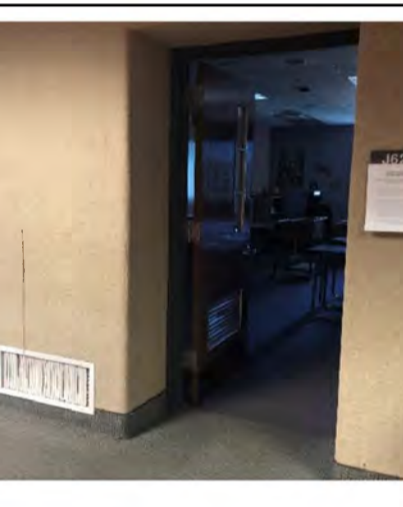
Damaged grille.
98

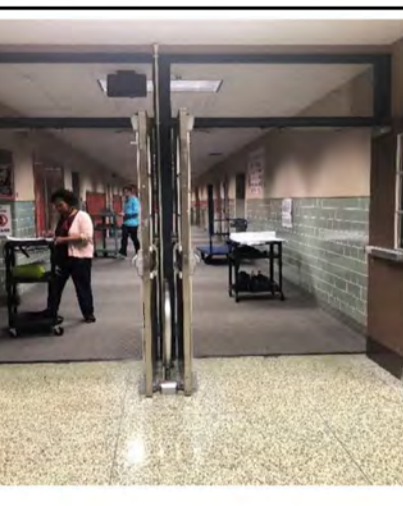
Several dissimilar finish materials coming together in one location.
99

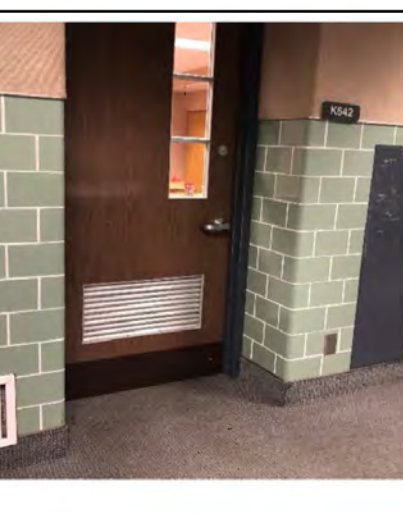
Damaged grille.

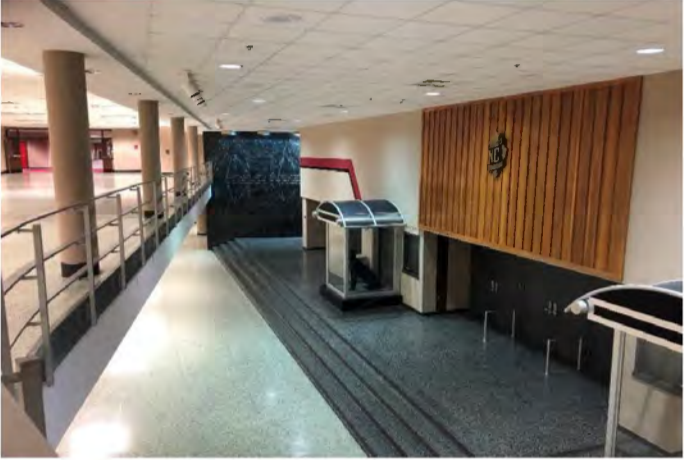
Railing does not meet current code.
102

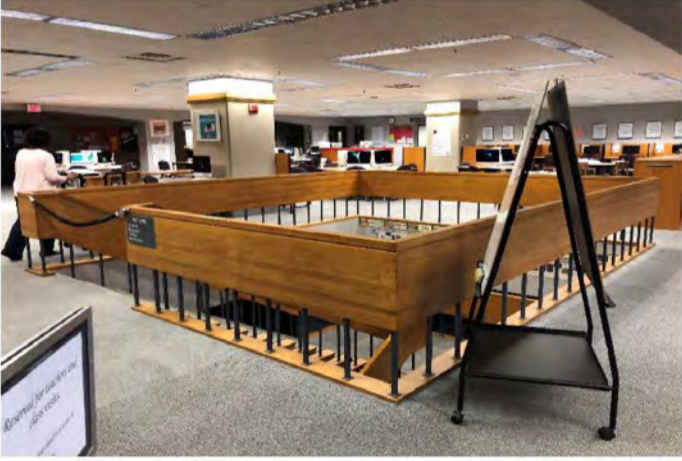
Guardrail does not meet current code.
104

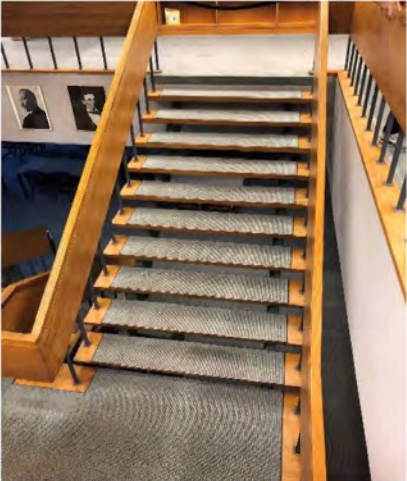
Stair does not have a hand rail.

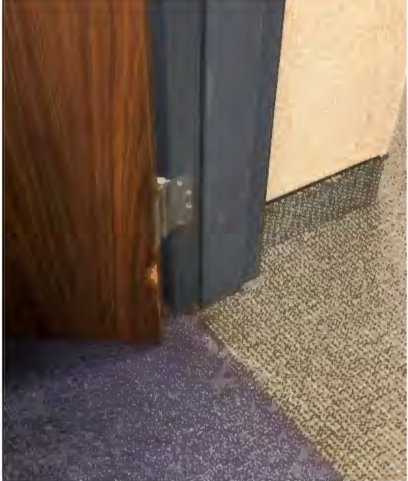
Damage to flooring. Perimeter of carpet is a different color from rest.
107

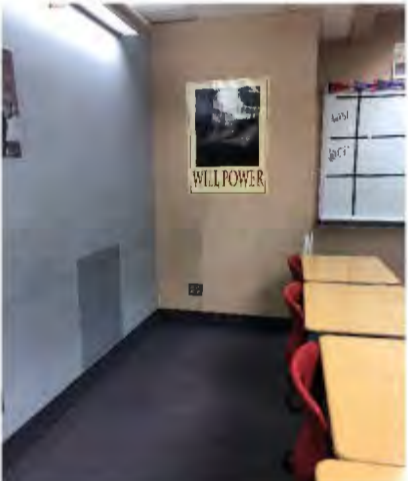
Vinyl patch does not match the rest of the wall covering.
108

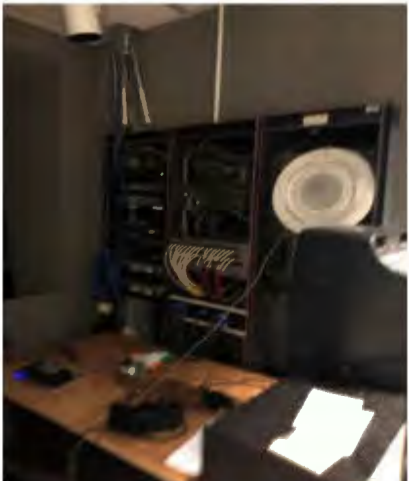
Auditorium control area is dated.

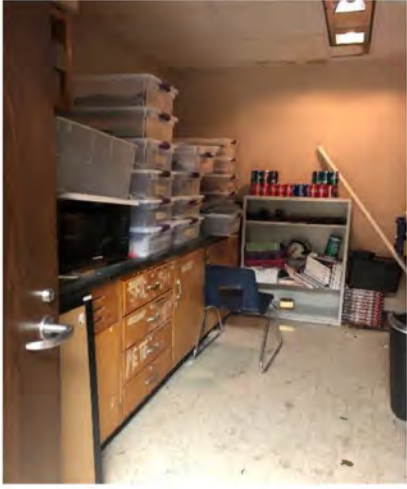
Poor storage.
111

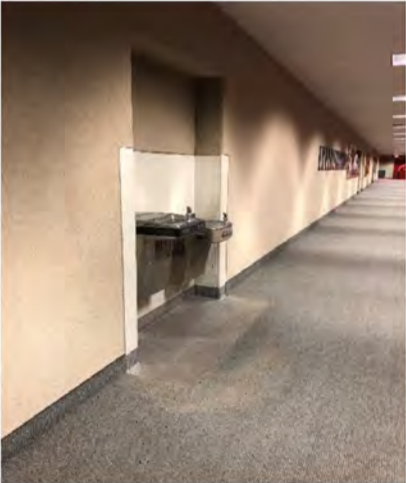
Discolored carpet. No water proof area at water fountains.
112

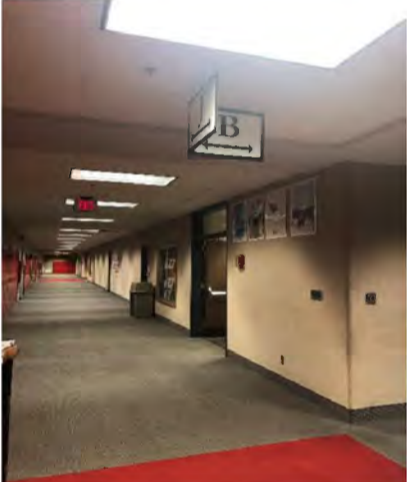
Damage to corners of vinyl wall covering.
113

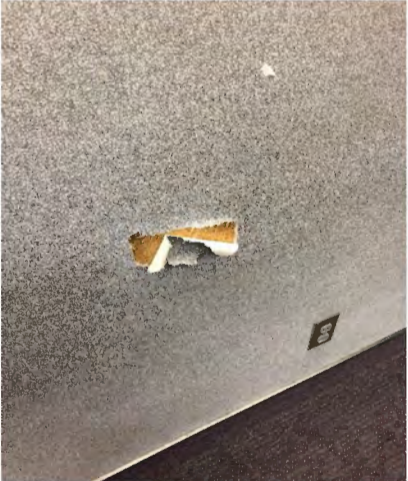
Tear in a wall covering.
114
