WASHINGTON
TOWNSHIP SCHOOLS

Secondary School Master Plan

SECONDARY SCHOOL FACILITY CONDITION ASSESSMENTS

EXISTING CONDITIONS ASSESSMENT SUMMARIES

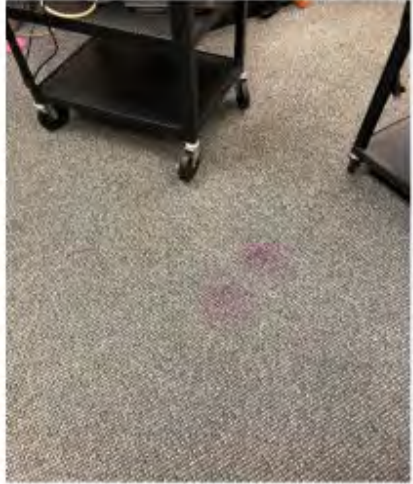
Stained carpet.
116

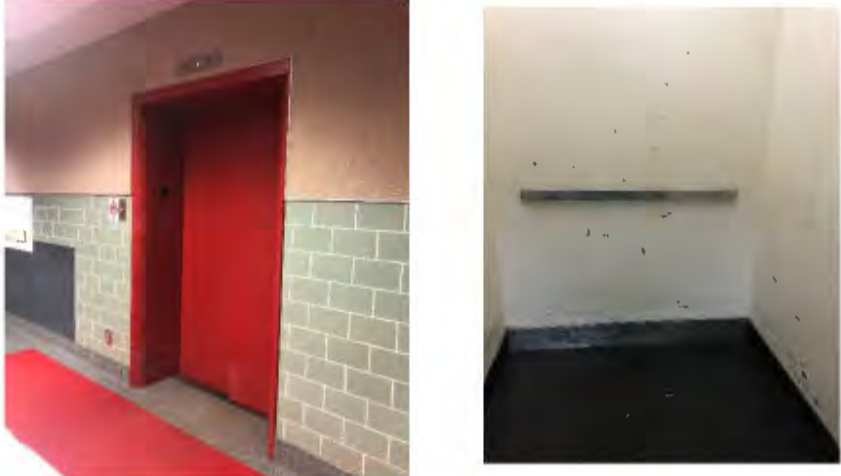
Oldest elevator has original finishes inside. Frame is rusted in cab.
117

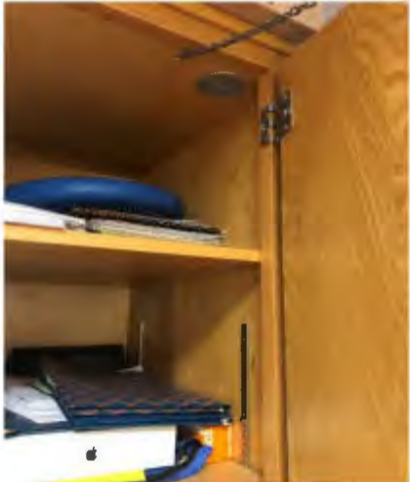
Existing teacher wardrobe cabinet is vented, top and bottom. In some cases, water is getting in and damaging contents.
118

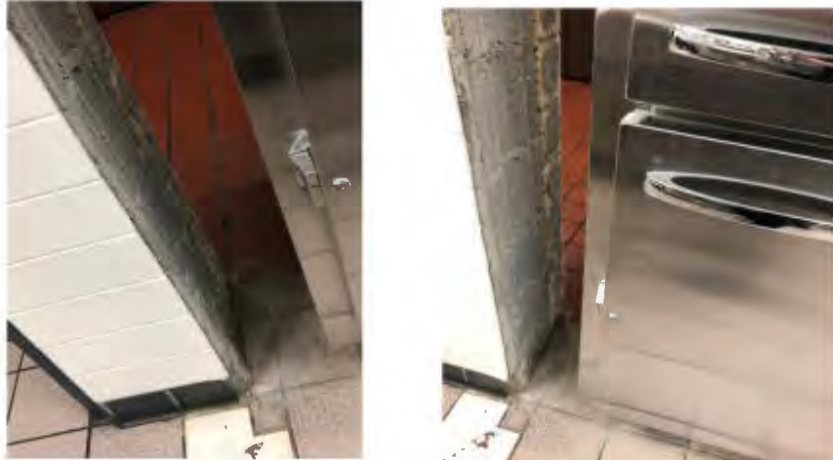
Transition piece between wall and serving line equipment is missing. Tile replacement does not match.

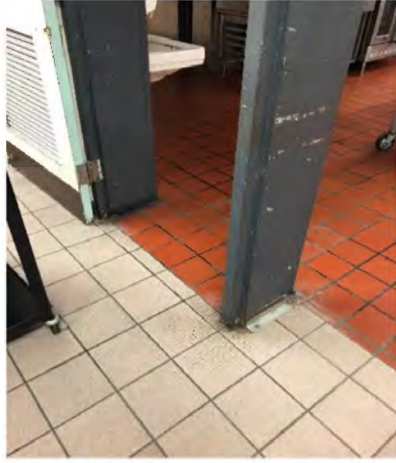
<p>Floor transitions from quarry tile to slip resistant ceramic. Both tile & grout are hard to clean.</p>
121

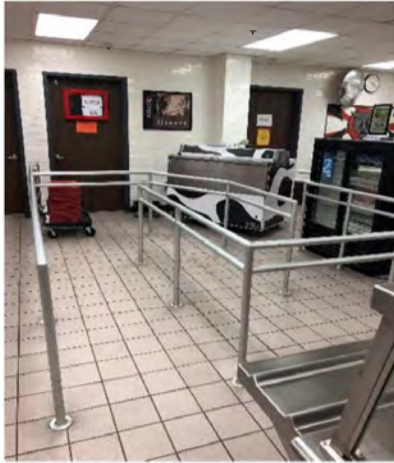
<p>Serving line que not is accessible.</p>
122

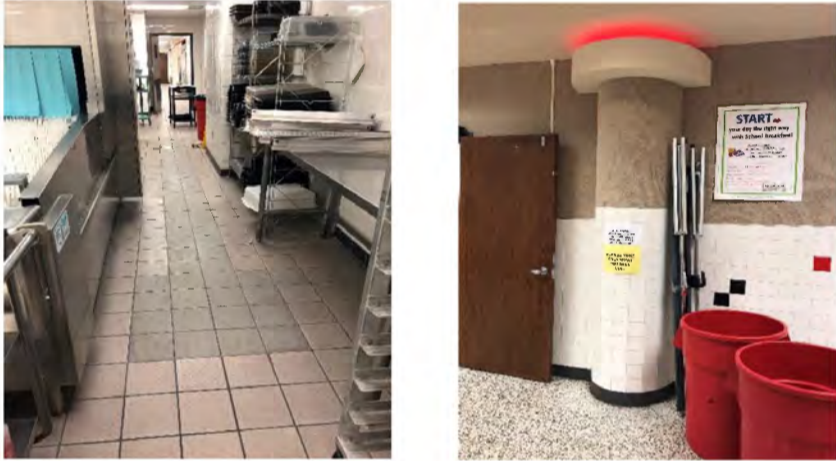
<p>Patched floor tile in the kitchen and neon accent in the Cafeteria.</p>
123

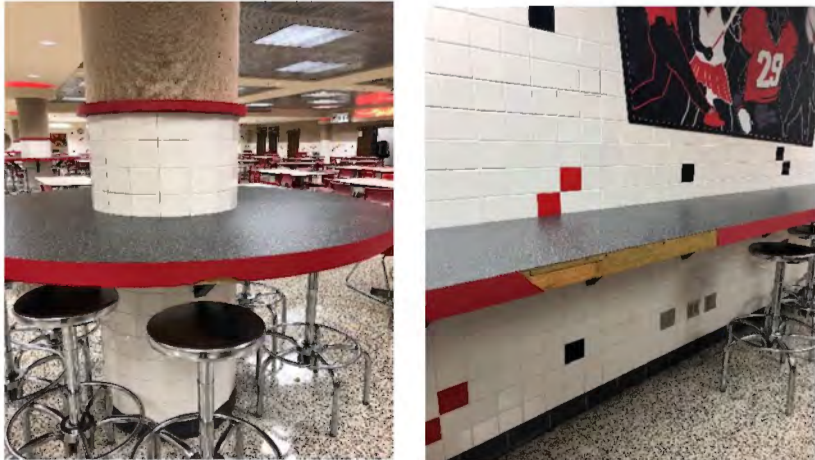
<p>Tile and counter tops are in poor condition in the Cafeteria.</p>

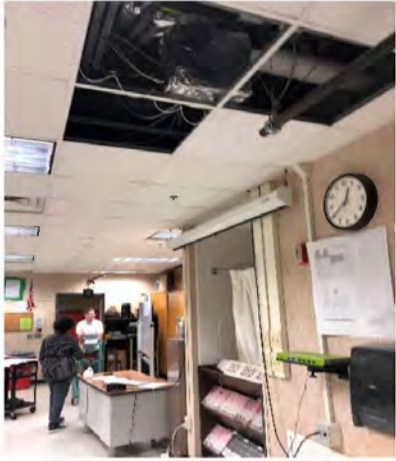
Missing ceiling tiles.
126

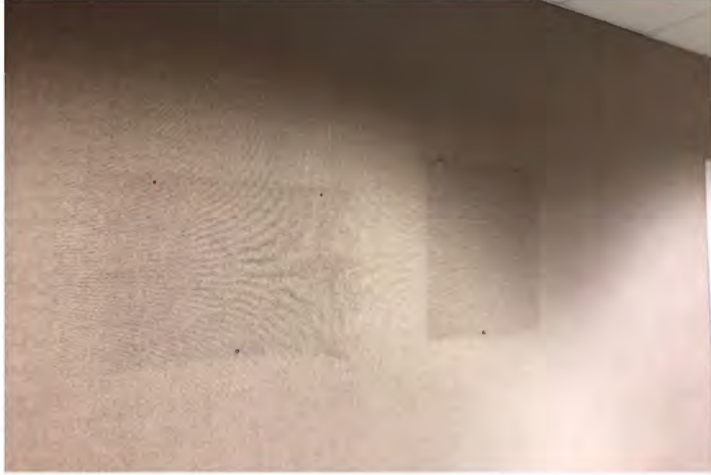
Ghosting on wall covering.
127

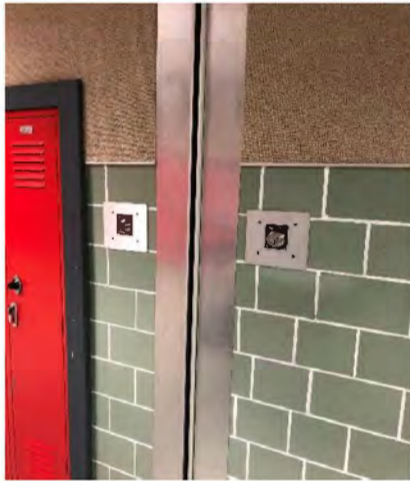
Not all security gates have a key control on both sides.
128

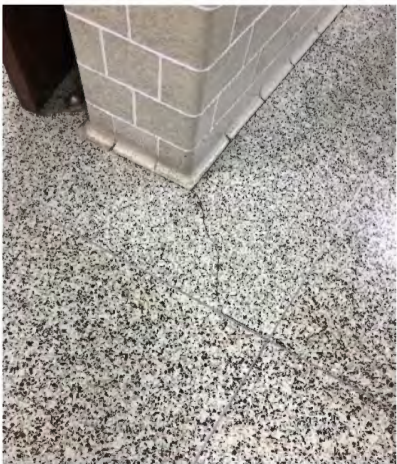
Cracked terrazzo.

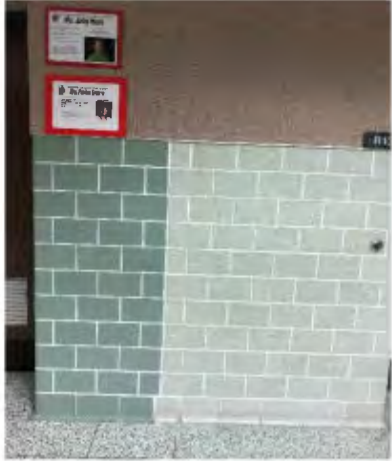
Mismatched glazed block.
131

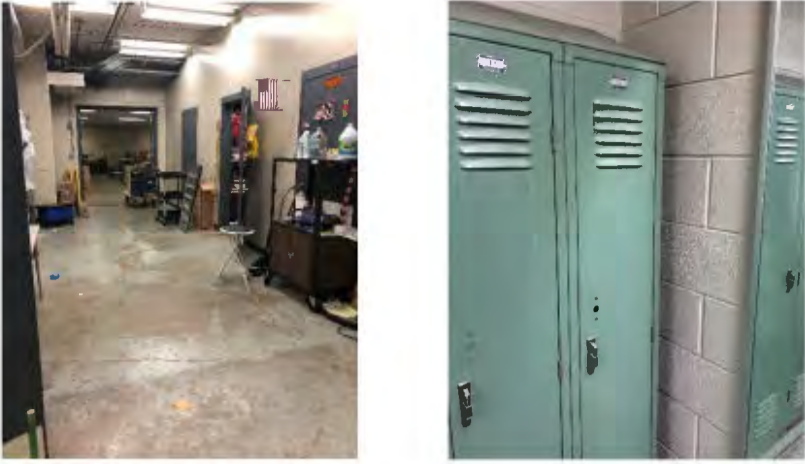
Custodial area has no floor finish and old lockers.
136

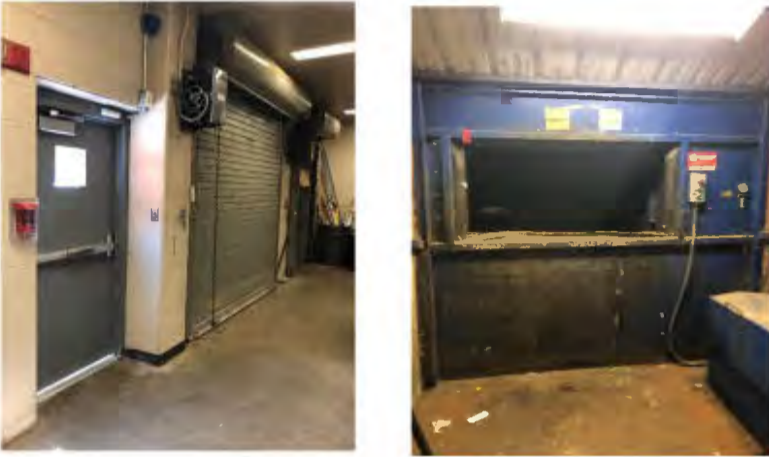
The receiving area's exterior door is not sealed. Need better exhaust for compactor.
137

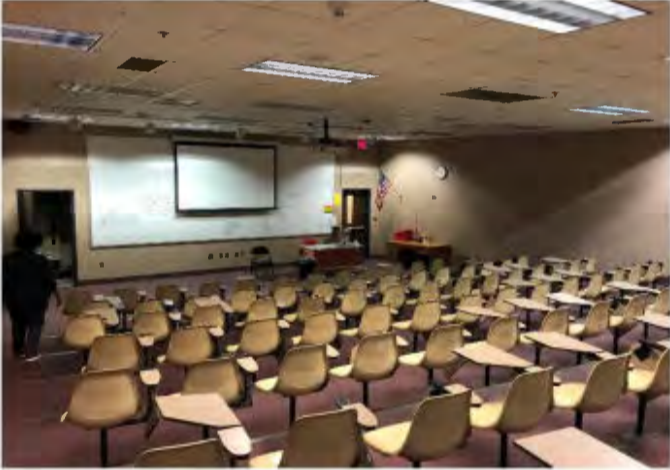
Lecture room with fixed seats is not accessible.
138

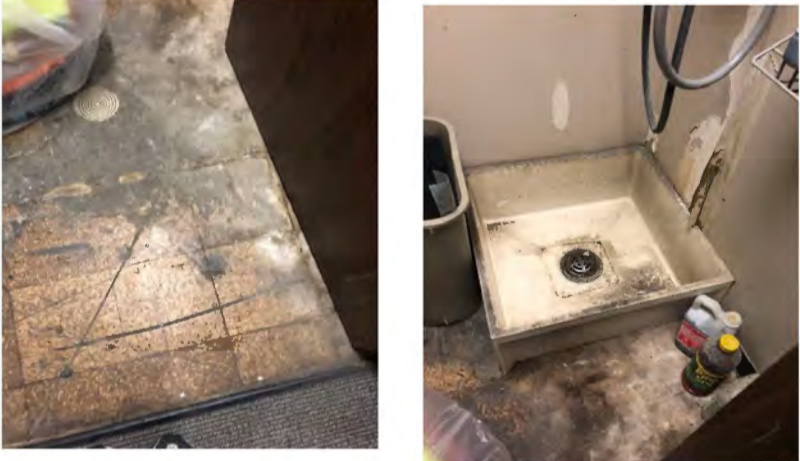
Dirty, worn floor and mop basin at Janitor's closet.
149

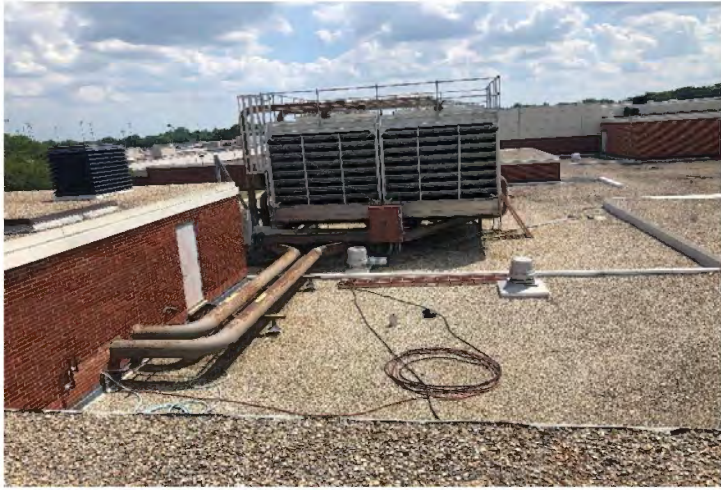
<p>Cooling tower will need to be rebuilt or replaced.</p>
6

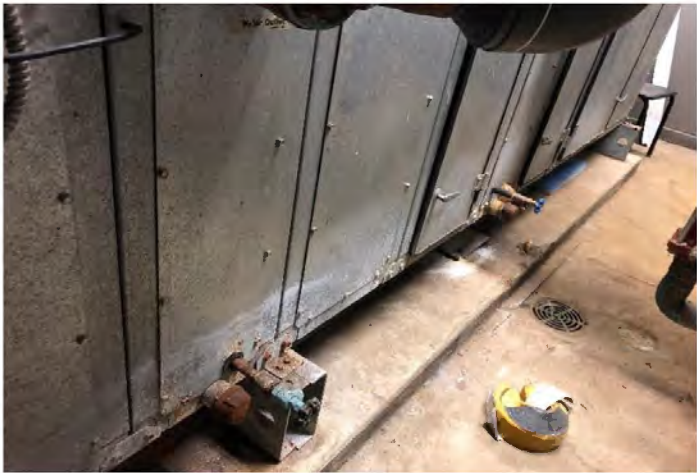
<p>Typical picture of (1) of the (48) indoor air handling units. These units were installed in 1993 and have exceeded their life expectancies of 15 to 25 years.</p>
7

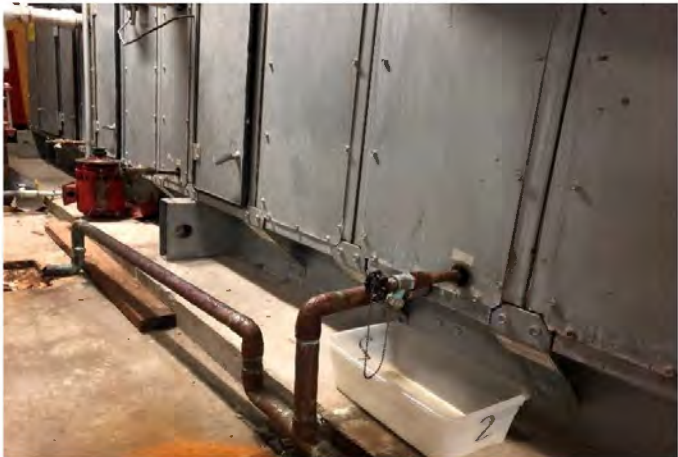
<p>Typical picture of (1) of the (48) indoor air handling units. These units were installed in 1993 and have exceeded their life expectancies of 15 to 25 years.</p>
8

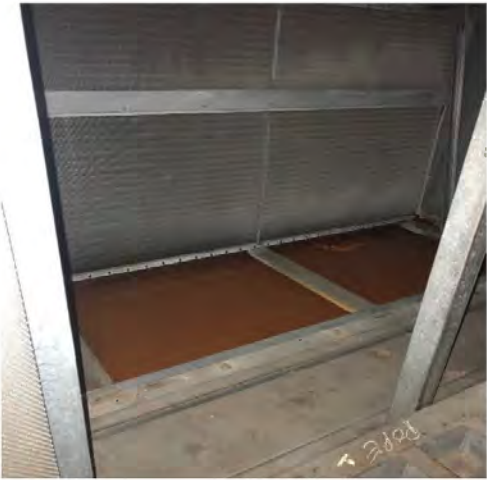
<p>Typical picture of a cooling coil drain pan that has rusted.</p>
9

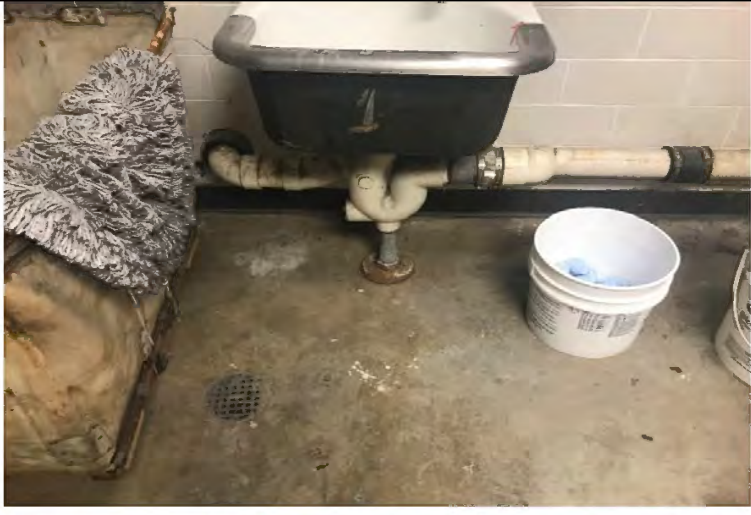
<p>Retrofit waste piping in laundry is not code compliant or properly sloped.</p>
2

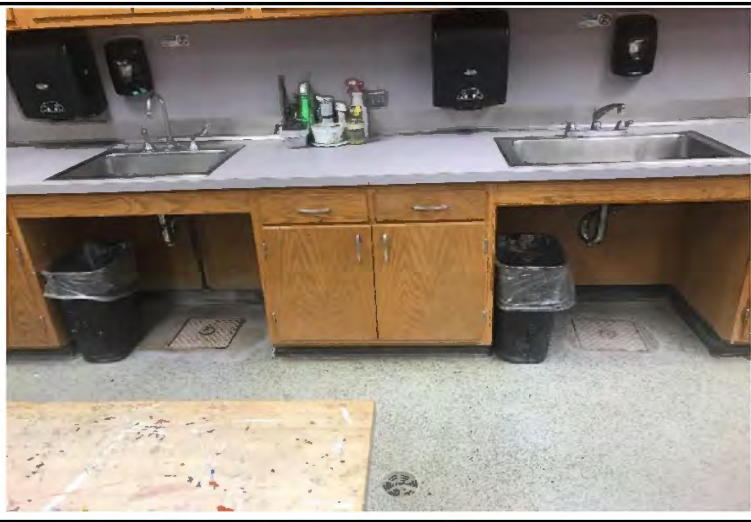
<p>Art Room sink plaster-traps are no longer operational and are allowing solids to pass into the waste system. Camera scoping of underground waste system will be used to determine scope of replacement. Single point solids interceptor will be considered for each classroom or for the entire suite.</p>
3

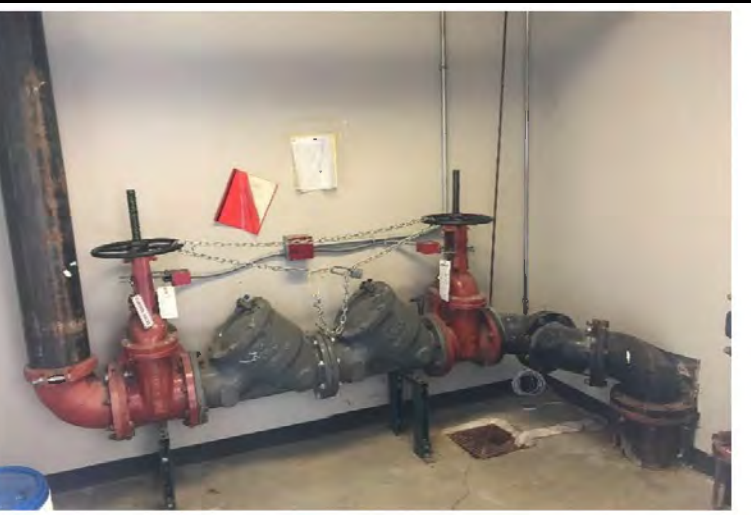
<p>The fire protection risers are in fair condition. The sprinkler system is also in fair condition.</p>

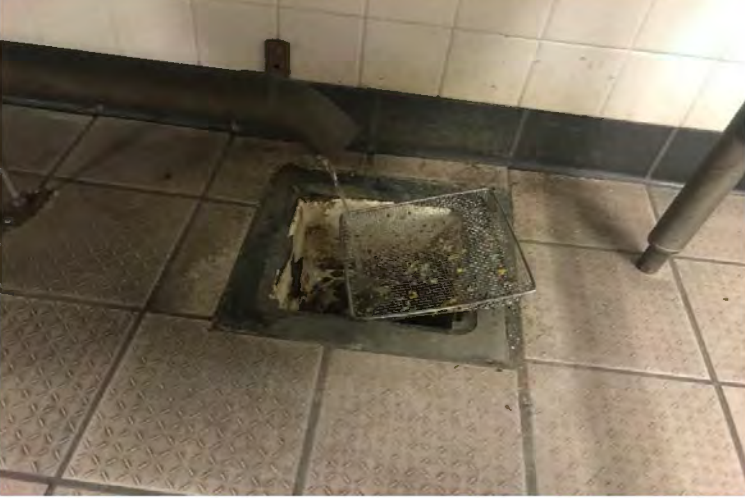
<p>Numerous grates are missing from floor sinks in the kitchen.</p>
6

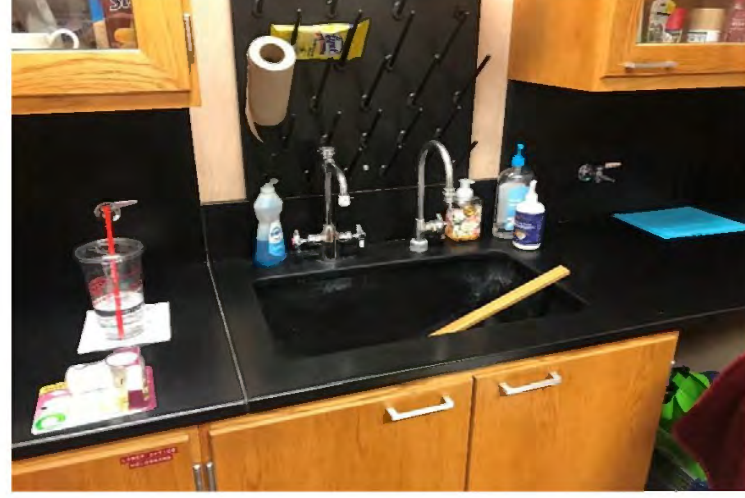
<p>Approximately 40% of the deionized water faucets within the lab classrooms are functional.</p>
7

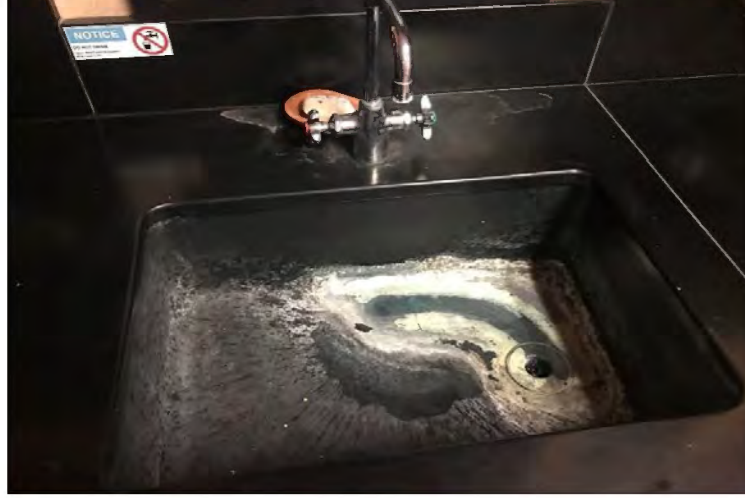
<p>Heavy corrosion on fixtures was found.</p>
8

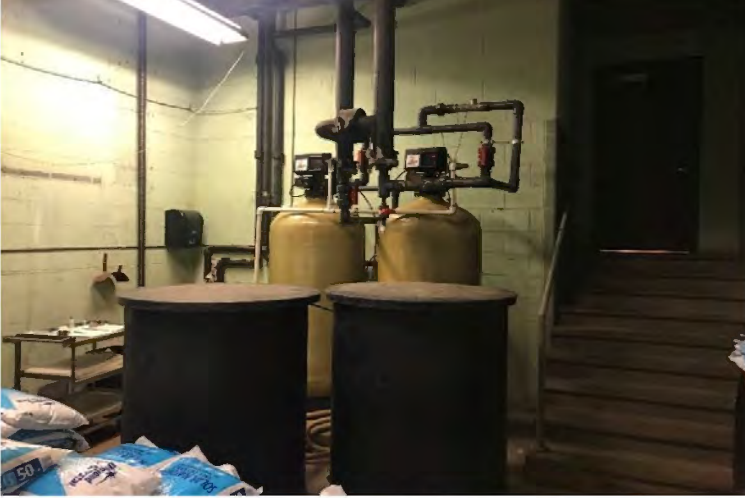
<p>The duplex softener system is in average condition. Based upon its age, the media will need to be changed out and valves rebuilt. We recommend replacing the softeners with a system sized to treat the entire building.</p>
9

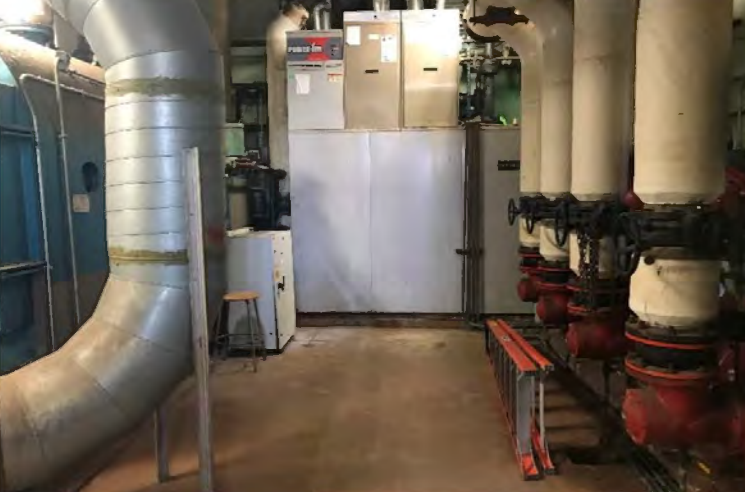
<p>The triplex gas fired water heaters and large storage tank are in poor condition. The thermostatic mixing valve and hot water circulating pumps are concealed behind the heaters with extremely poor access. The entire domestic hot water plant needs to be replaced.</p>

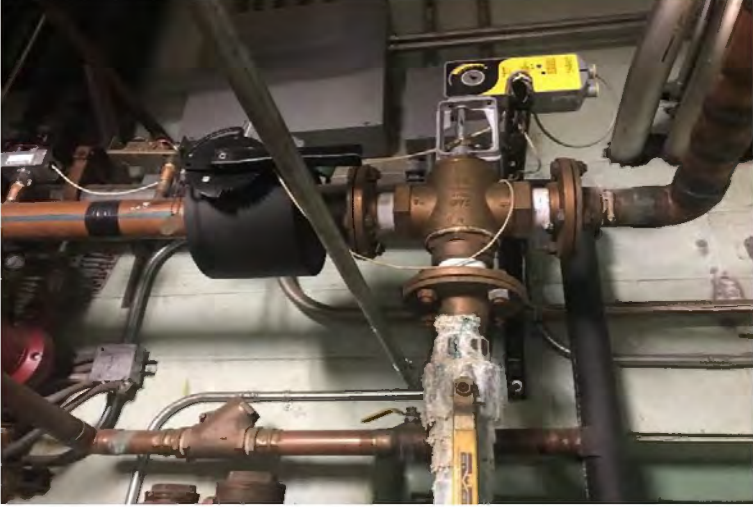
<p>Heavy corrosion due to leaks and poor water quality was found at the thermostatic mixing valve.</p>
11

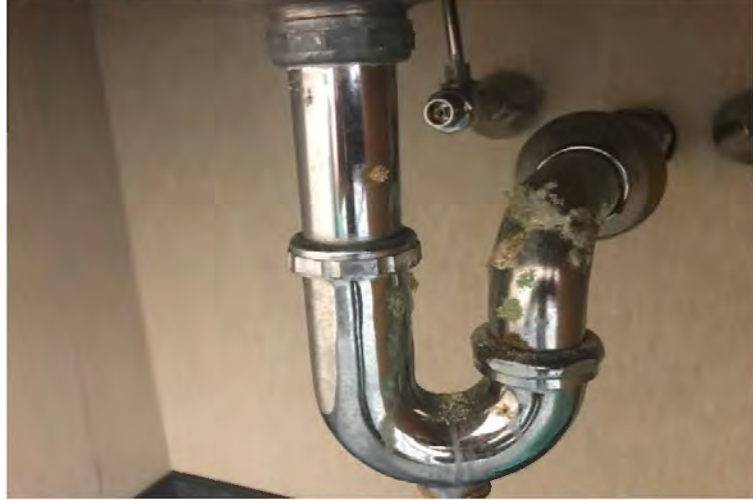
<p>Heavy pitting is occurring on numerous sink drains.</p>
12

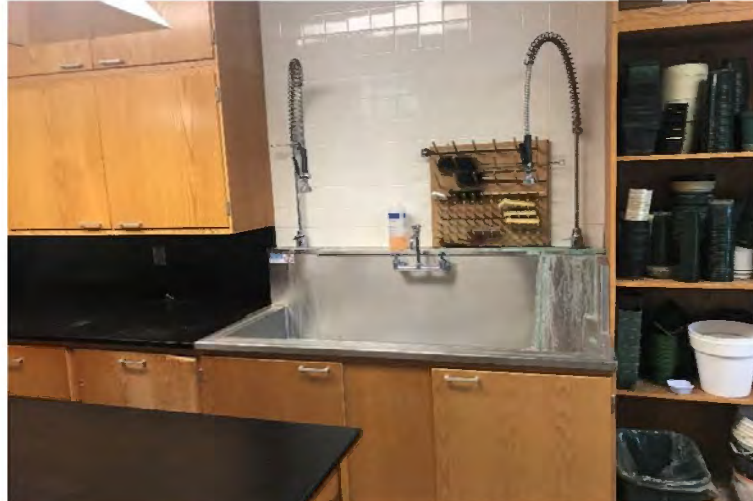
<p>More evidence of heavy water corrosion.</p>
13

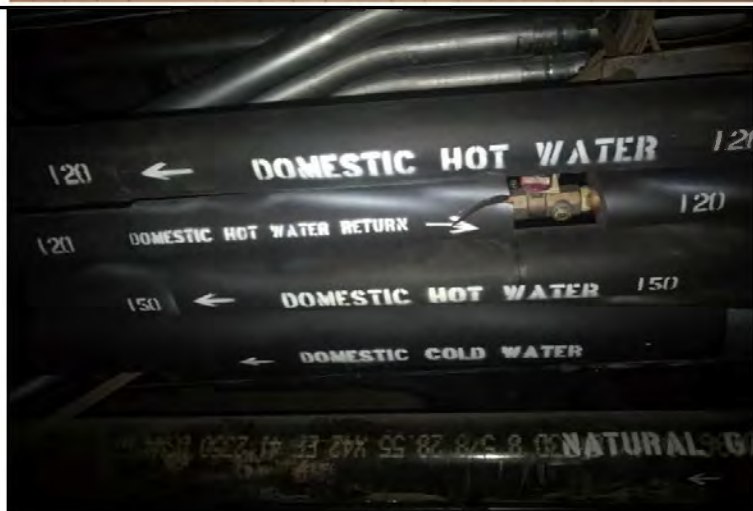
<p>Domestic piping that was installed in the tunnel in 1992 is in fair condition.</p>

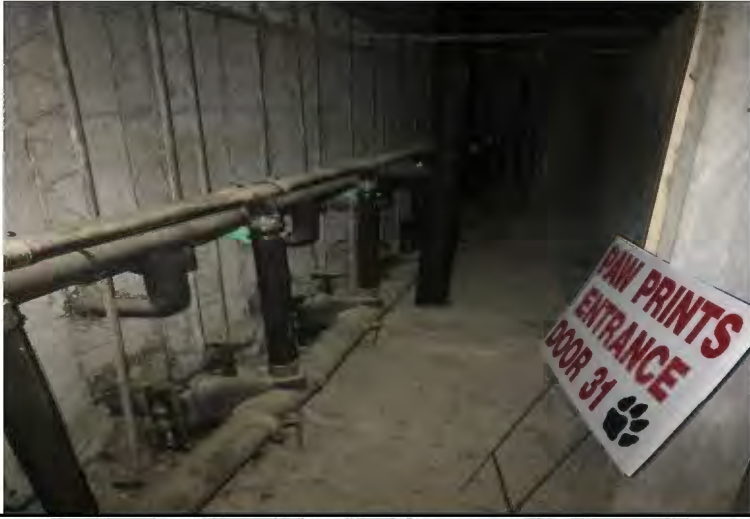
<p>Sanitary and domestic piping within most plumbing chases are in fair condition. A large percentage of this piping was installed in 1992. Camera scoping is planned to evaluate the original underground sanitary and storm piping.</p>
16

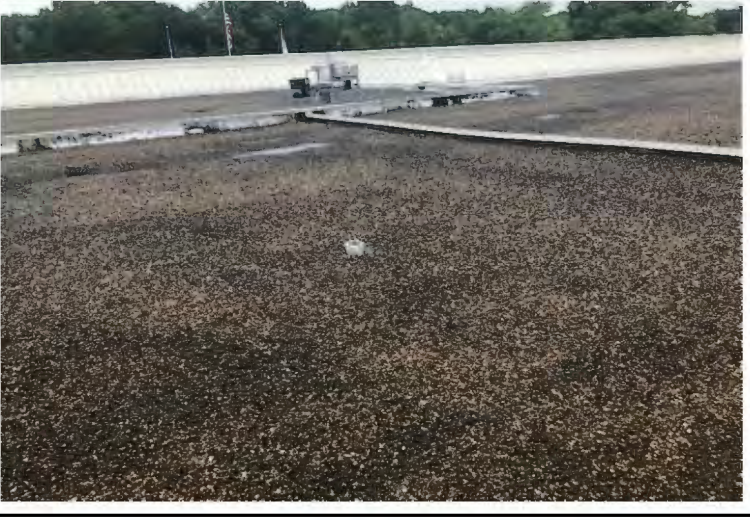
<p>Numerous sanitary vents through the roof have been cut off too short. Vents can become blocked during heavy snowfalls. All VTRs need to be extended to a minimum of 12" above finished roof.</p>
17

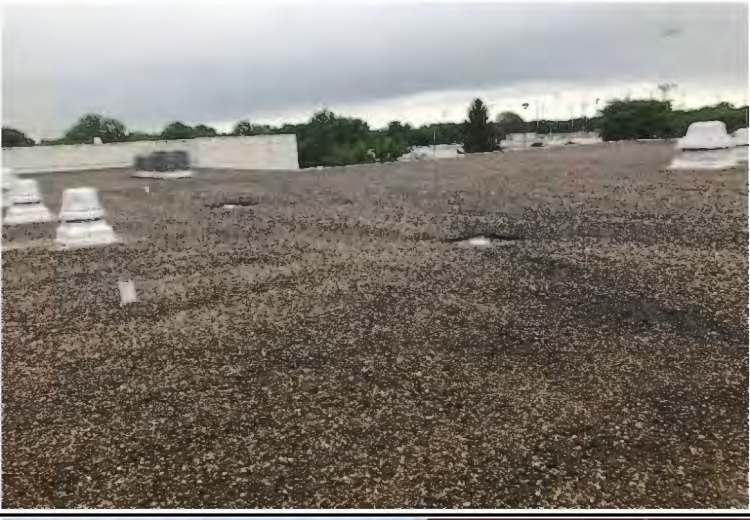
<p>Most roof areas do not have overflow roof drains as currently required by code.</p>
18

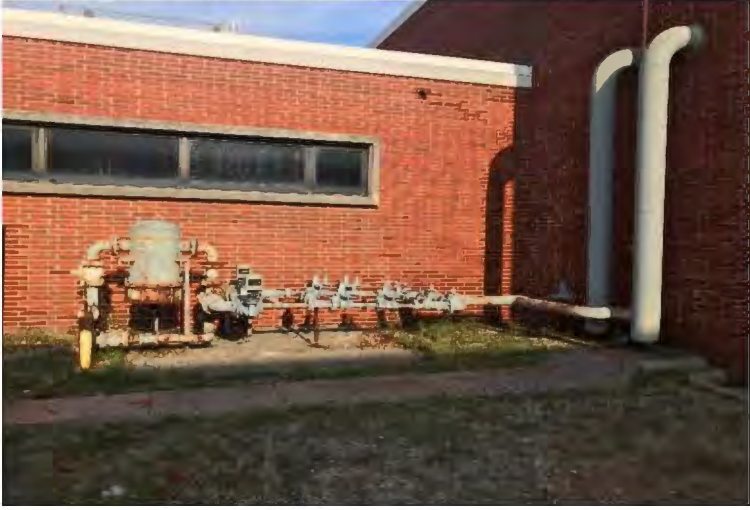
<p>The gas meter assembly is in poor condtion. At a minimum, all rust needs to be removed then painted with rust inhibitor paint.</p>

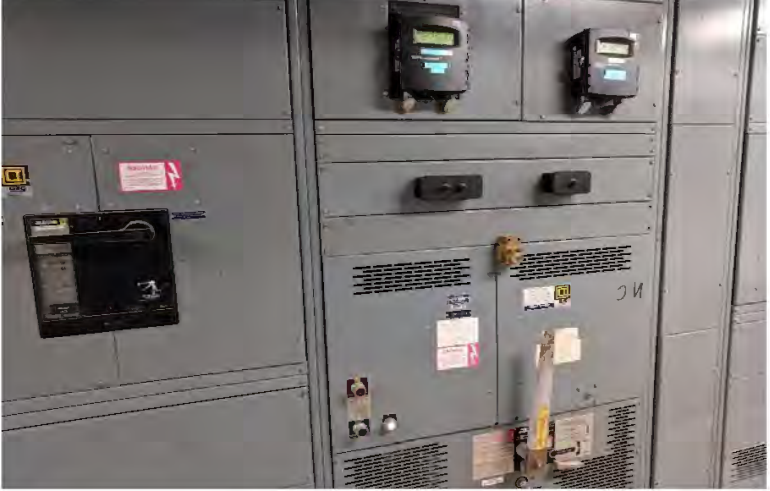
Photo #	Photo Image	Description
1

<p>The main service bolted pressure switches have been requested to be replaced with breakers by facilities. This requires all (4) main switchboards to be replaced in its entirety. Overall condition of supporting Distribution (1-400A Distribution board and 4-225A Panelboards require replacement) is satisfactory and does not require replacement. It is recommended to have an infrared scan to locate any loose or corroded connections.</p>
2

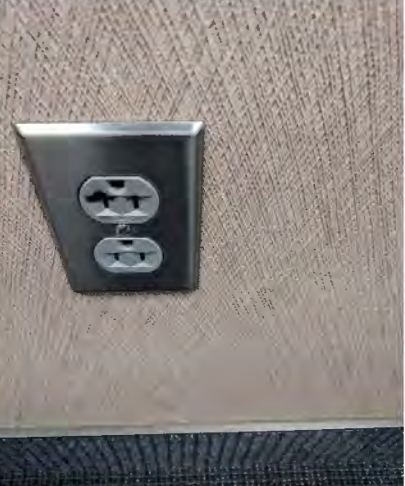
<p>Evidence of arcing.</p>

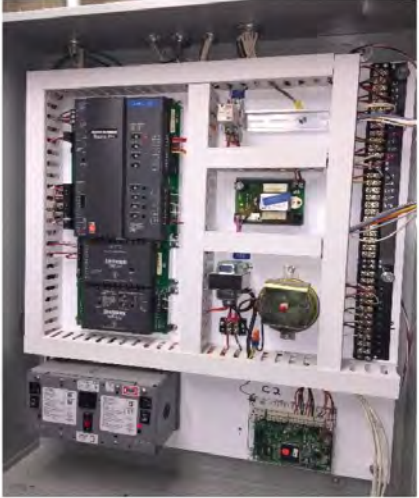
<p>Most panels are b3 controllers and should remain.</p>
6

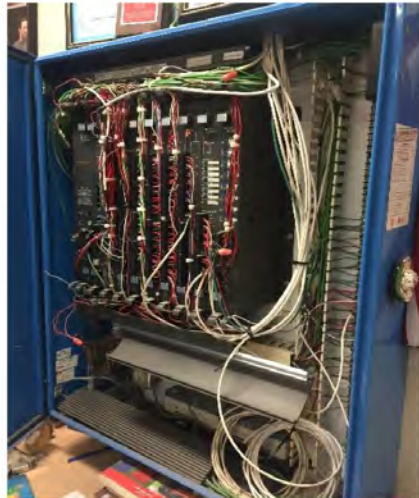
<p>Andover 9410 controller that needs to be replaced. This panel controls all of the hot and chilled water systems and is significantly older than most controllers in the high school.</p>
7

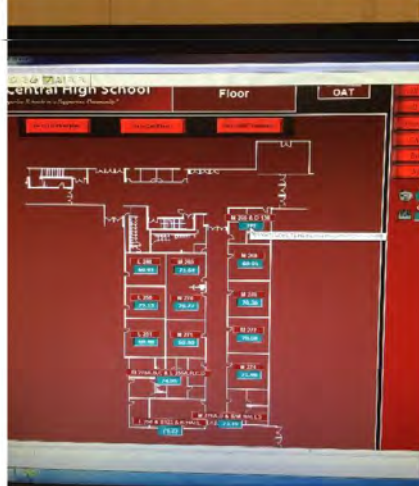
<p>Example graphic showing missing point link. Several graphics are missing OAT, ST, and other graphical links to other systems.</p>

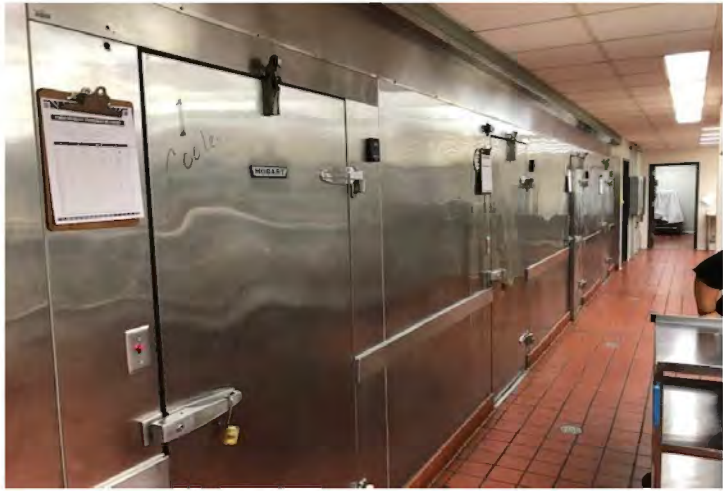
<p>The existing walk-in coolers are original to the school. Their configuration and the refrigeration systems are both out-of-date and inefficient. We recommend a complete reconfiguration and replacement of these units.</p>
2

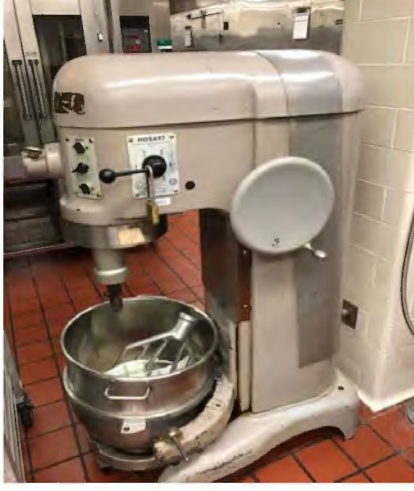
<p>A significant amount of prep equipment is outdated and oversized for today's kitchen use.</p>

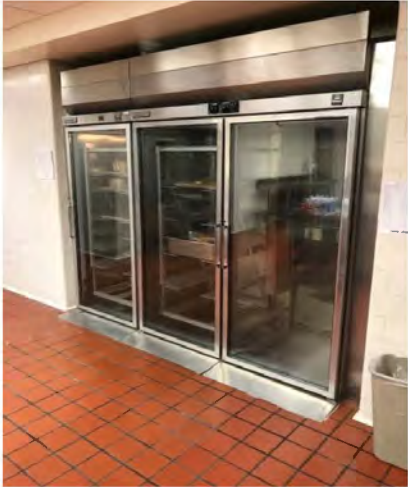
<p>These pass-thru units are inefficient and the configuration is no longer appropriate for the foodservice operation.</p>
6

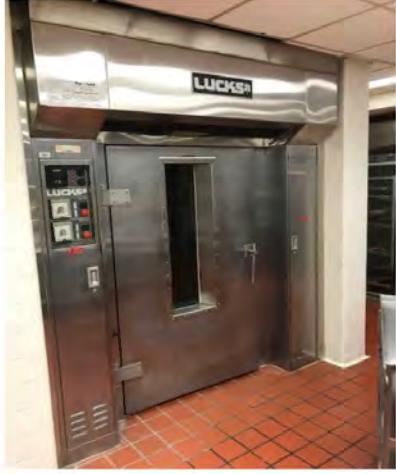
<p>This is an old bake oven that will be removed and the space will be reallocated.</p>
7

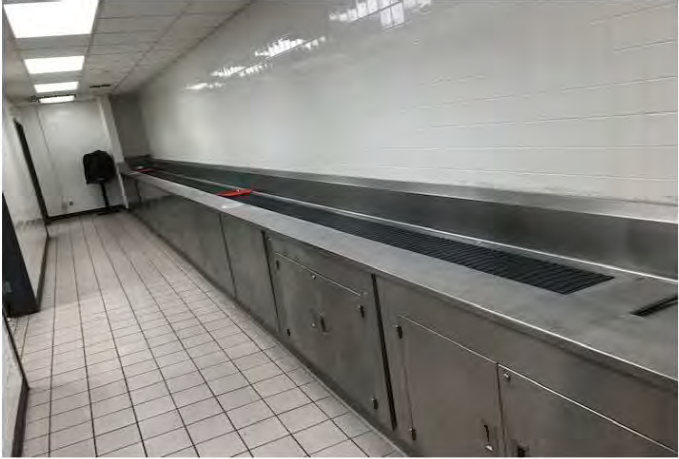
<p>The conveyor unit is underutilized and outdated. It will be removed.</p>
11

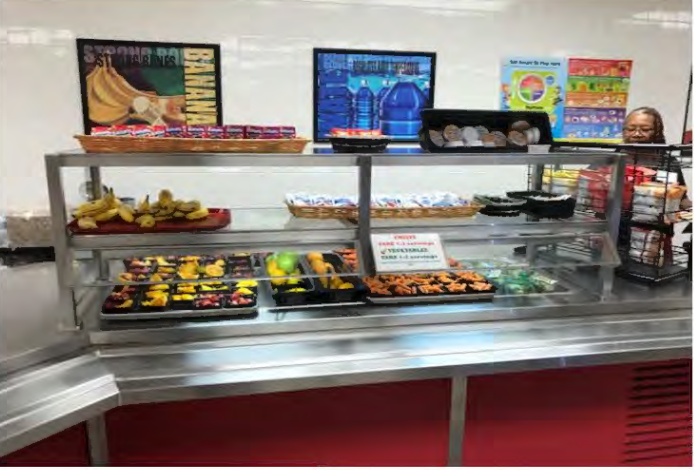
<p>While the food offerings are well done and appealing, the serving lines do not properly merchandise the food offerings and/or "entice children to eat healthier."</p>
12

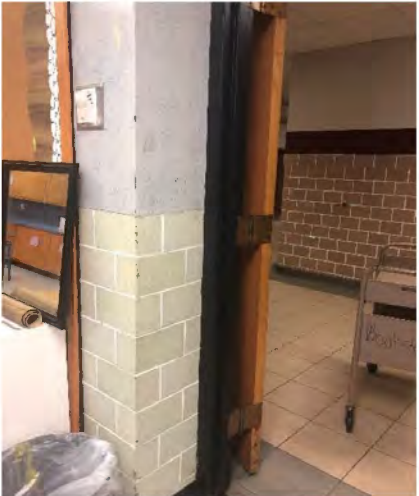
<p>Damaged corners. This is typical. Vinyl wall covering with structural glazed facing tile 1/2 height.</p>

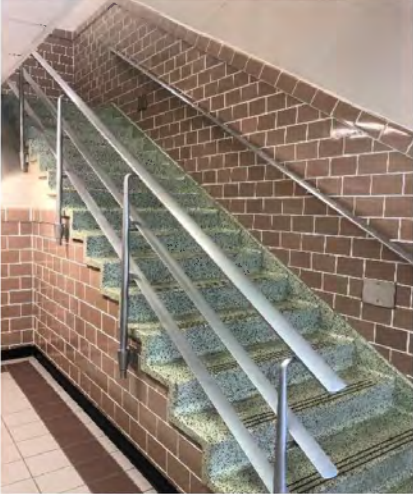
<p>Railings and guard rails do not meet current code. This is typical.</p>
7

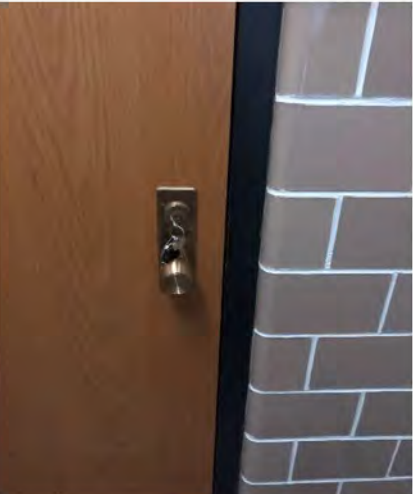
<p>Doors in a portion of the building have knobs in lieu of lever handles.</p>
8

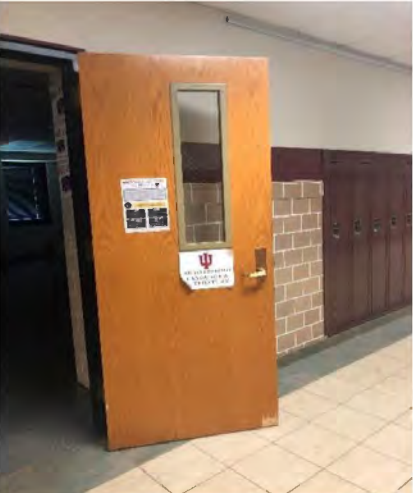
<p>Classroom doors are delaminating. No way to lock the door from inside the classroom. This is typical.</p>
9

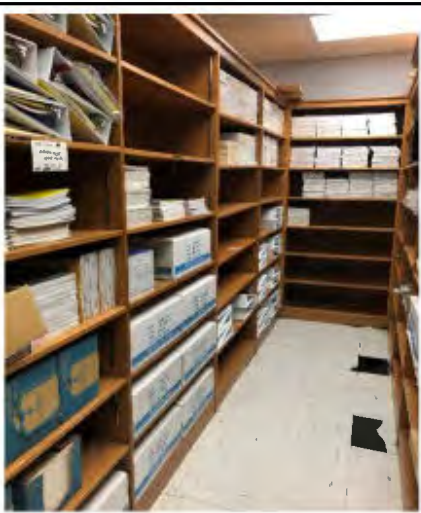
Missing floor tiles.

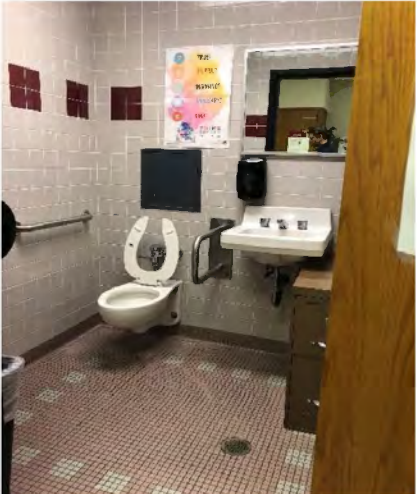
<p>Grab bars, toilet, faucet, and the mirror are not meeting current ADA. (Clinic)</p>
16

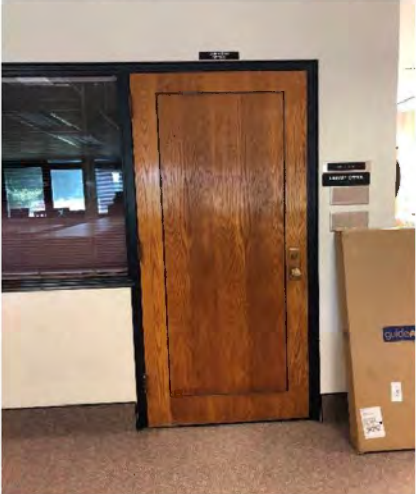
<p>Door hardware is not accessible. Door clearances are not accessible.</p>
18

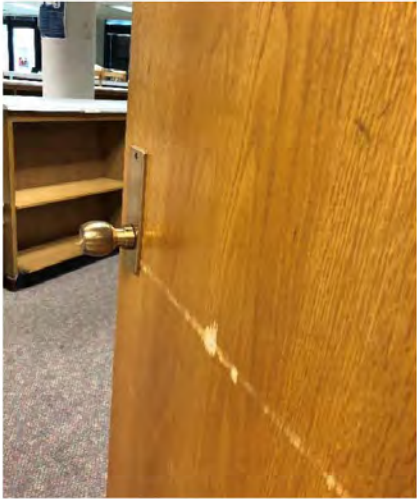
<p>There is damage to the Media Center Workroom door.</p>
19

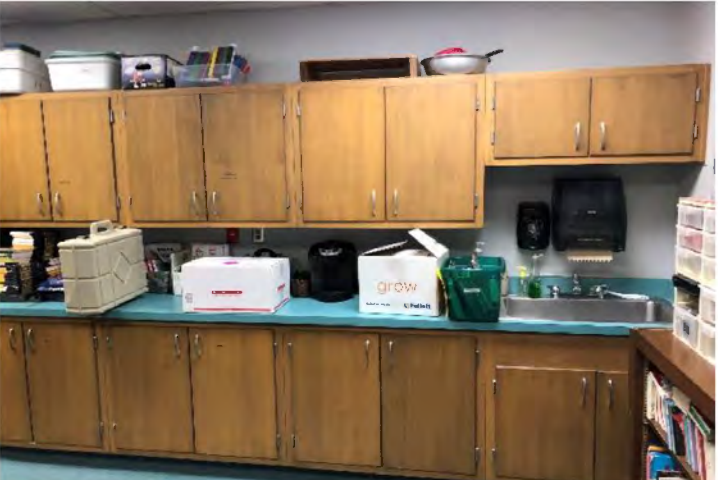
<p>The casework in the Media Center Office is worn.</p>

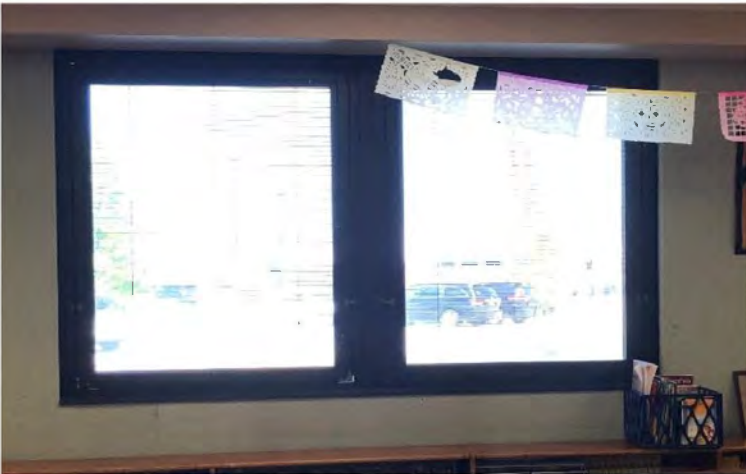
<p>Air infiltration through exterior windows. This is typical for all.</p>
22

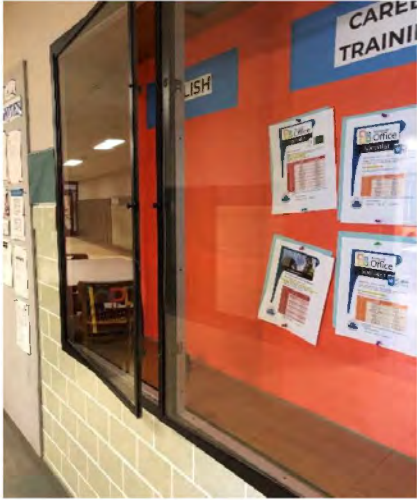
<p>Display case doors are not lockable.</p>
24

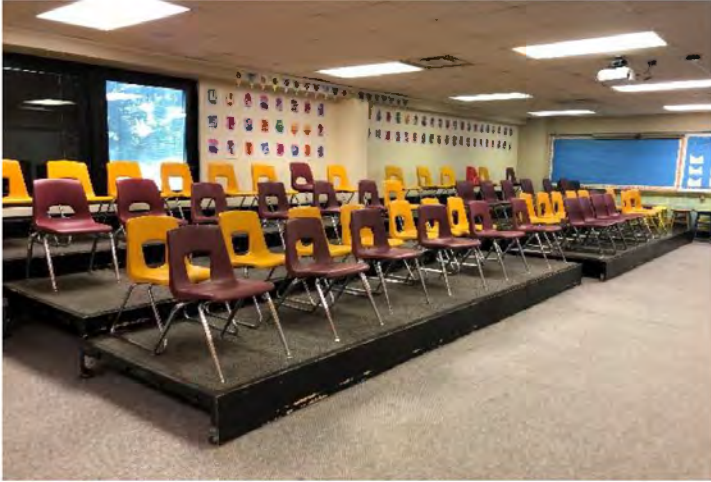
Choir risers are worn.
26

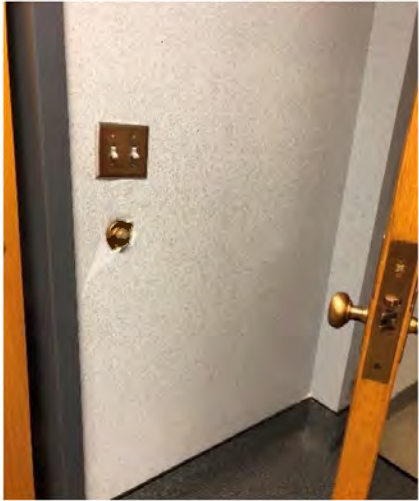
Wall damaged, and door hardware is not accessible.
28

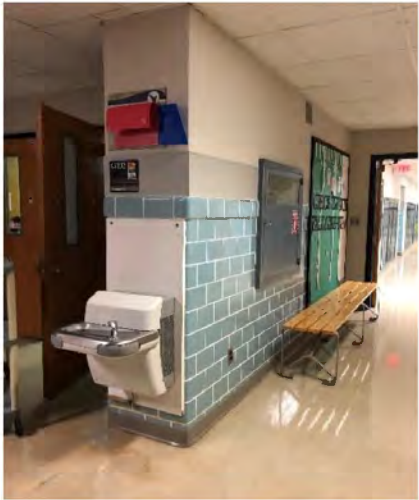
Drinking Fountain protrudes too far into the corridor.
29

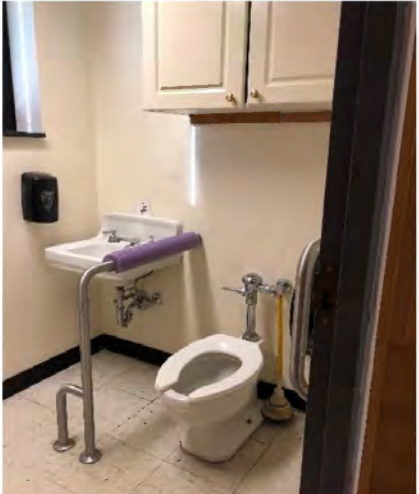
Current ADA is not met.
31

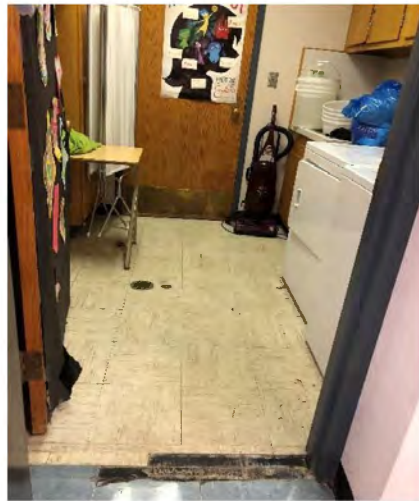
Floor is in bad shape. Missing transition and some tile. Doors have knobs instead of lever handles, so they are not accessible.
32

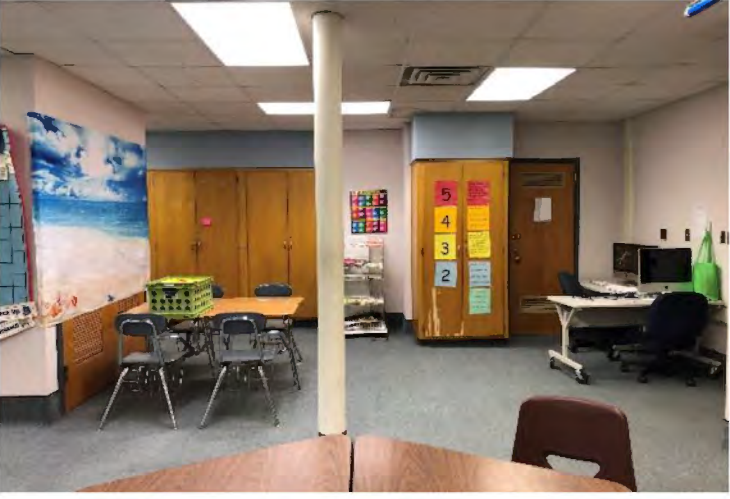
Damage to casework.
34

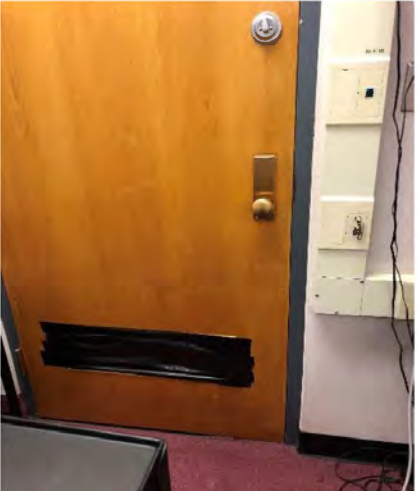
Abandoned door louver/grille.

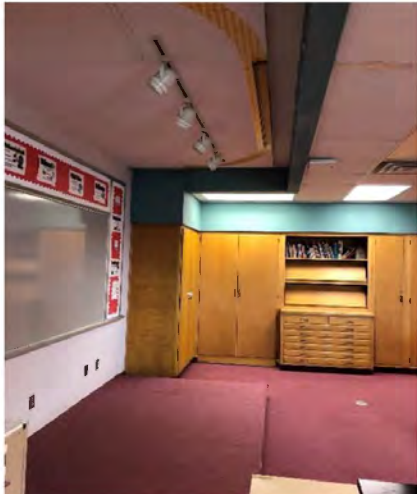
<p>The platform is not accessible. Bulkhead lights are not conducive to current classroom use. The carpet is in bad condition.</p>
36

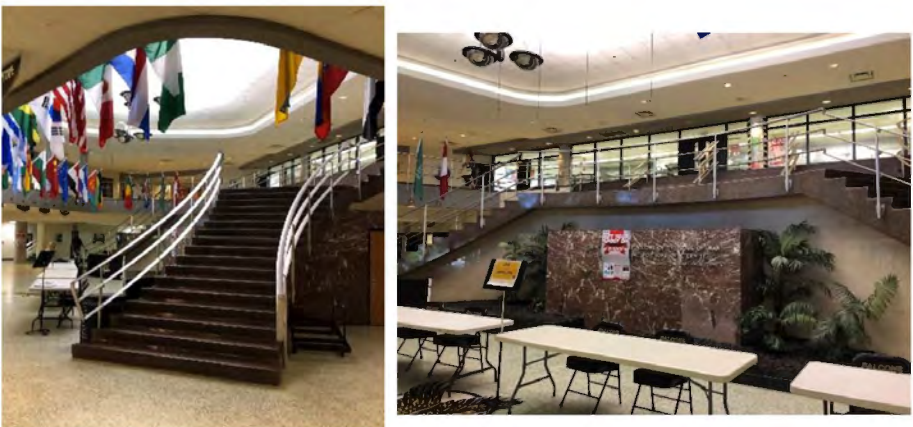
<p>Railings and guard rails do not meet current code. This is typical.</p>
39

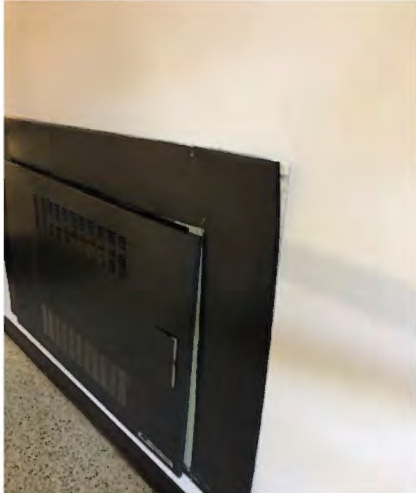
<p>Unit vent and unit vent trim are not attached. Vestibule.</p>

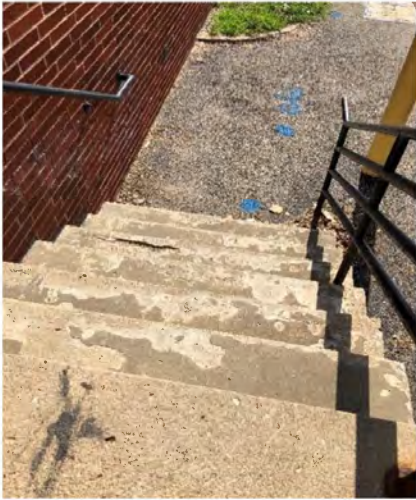
Spalled exterior concrete steps at loading dock.
42

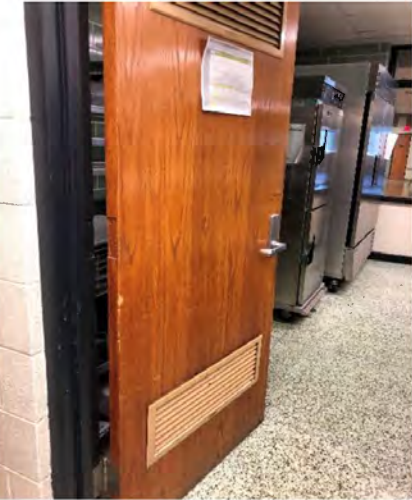
Door missing hinge. Mixture of chrome and brass looking hardware throughout the school.
44

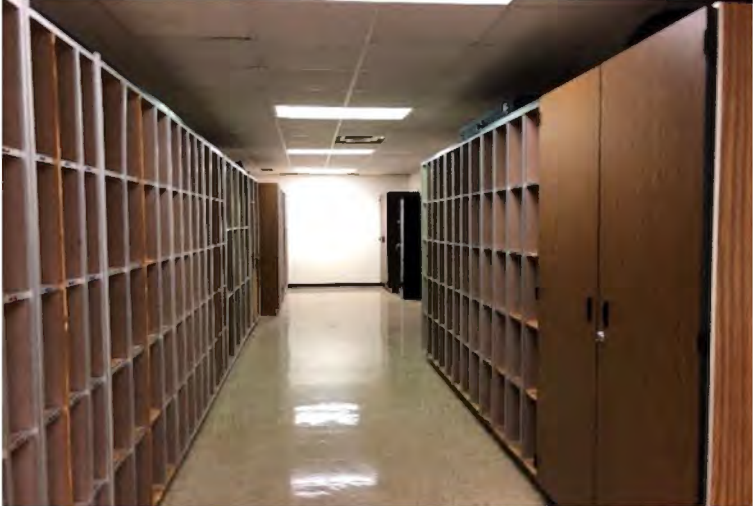
Instrument Storage casework is worn.
