WASHINGTON
TOWNSHIP SCHOOLS

Secondary School Master Plan

SECONDARY SCHOOL FACILITY CONDITION ASSESSMENTS

EXISTING CONDITIONS ASSESSMENT SUMMARIES

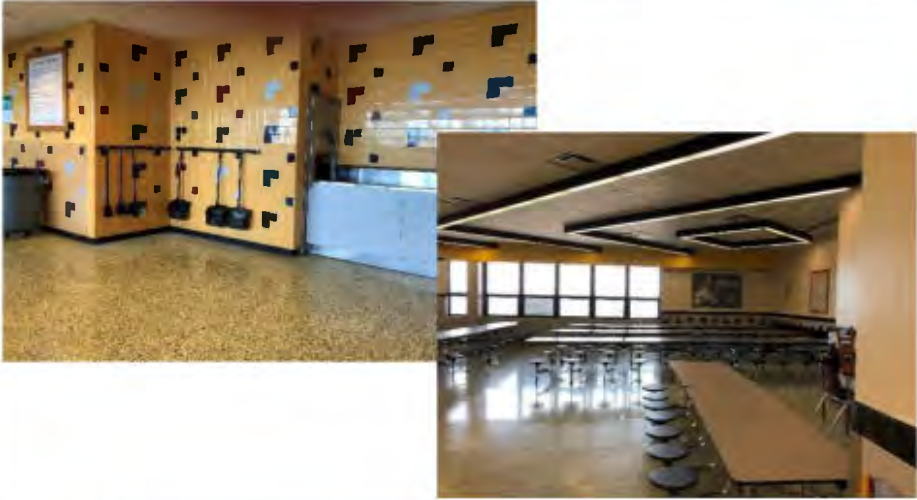
<p>Cafeteria - Dish Return tray. Room also has wall guard/protection in some locations. Ceiling mounted projection screen. Window blinds are in bad condition. Lots of unique bulkheads and linear lights. Windows are transmitting a lot of heat.</p>
47

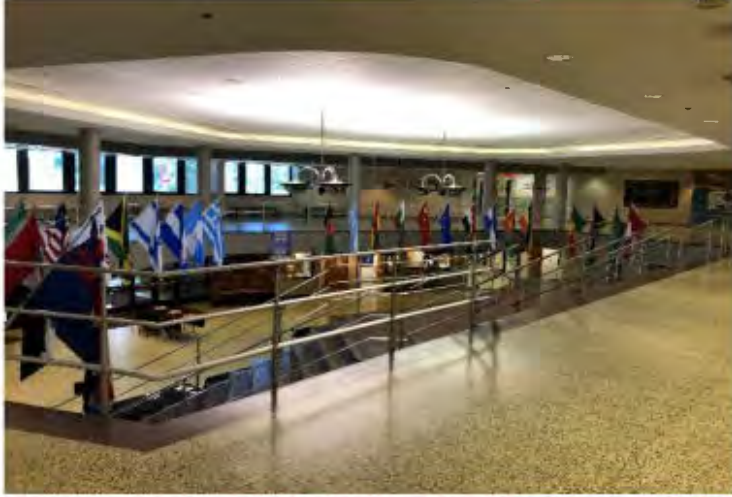
<p>Lobby guard rail does not meet current code.</p>
48

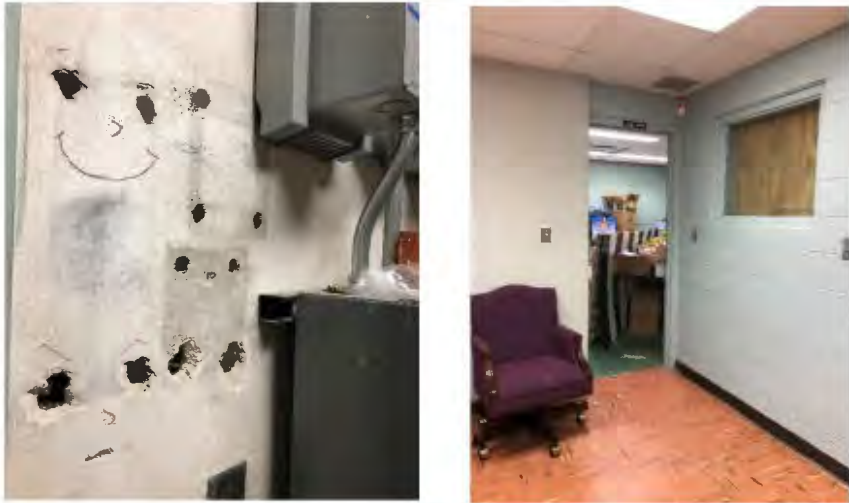
<p>Auditorium Light Booth area wall needs to be patched. 9x9 floor tile. There's an abandoned opening in the wall.</p>
49

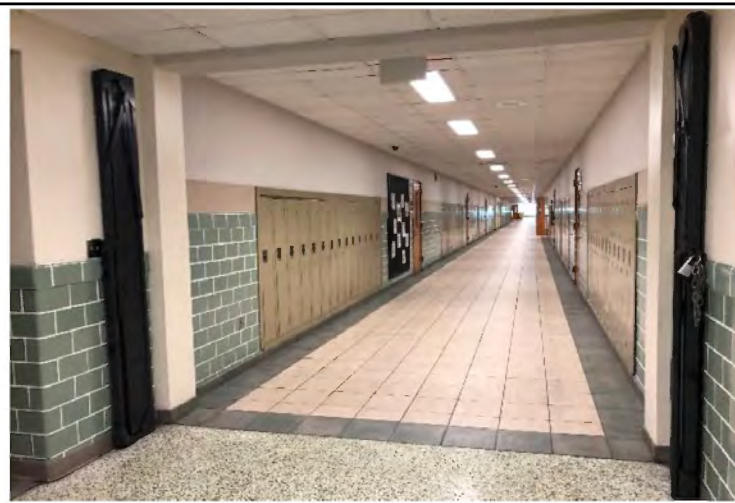
Cross corridor gate. Transition from terrazzo to ceramic tile at the 2nd floor.
52

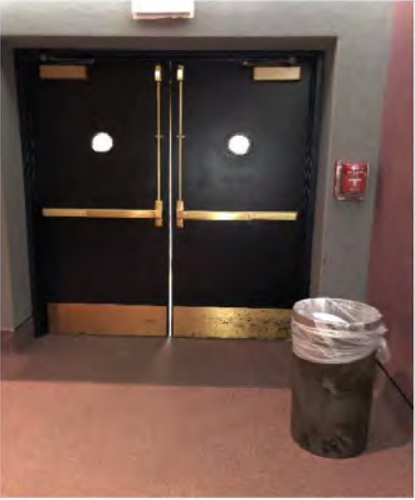
<p>Auditorium doors, lite not ADA, and worn finishes. No sound seals are on the doors.</p>
61

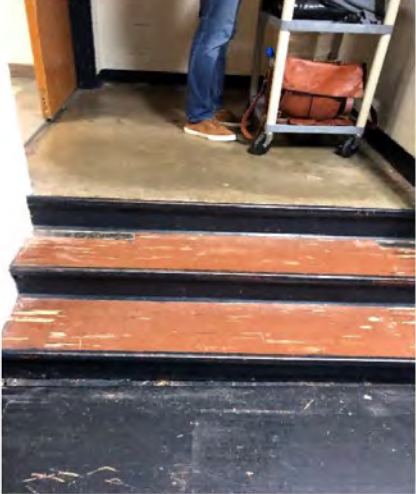
<p>Steps to the stage from the back of house are inconsistent heights. The surfaces are worn.</p>
63

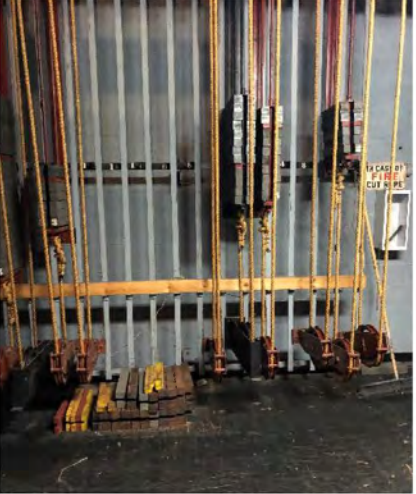
<p>The existing rigging system will need a theater consultant's inspection.</p>
64

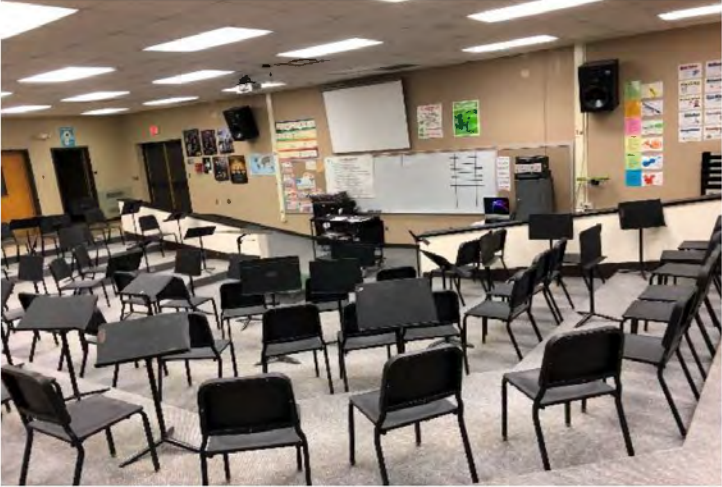
<p>Band has risers (ramps on the sides). Damage to gypsum board low walls at the ramps.</p>
66

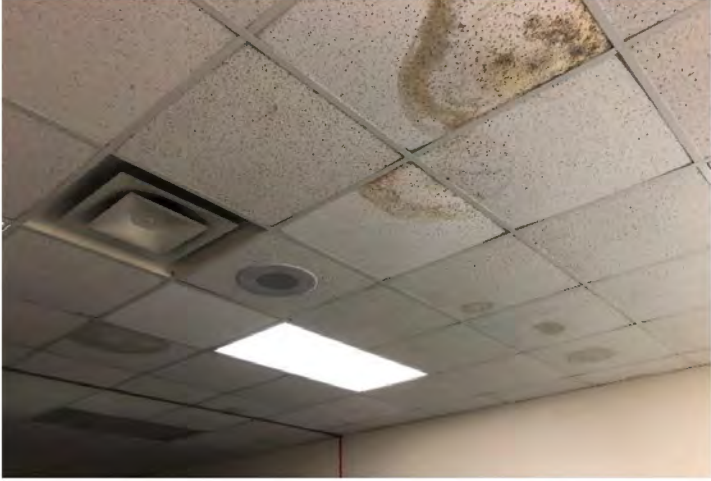
<p>Ceiling tile damage in the Percussion Room.</p>
67

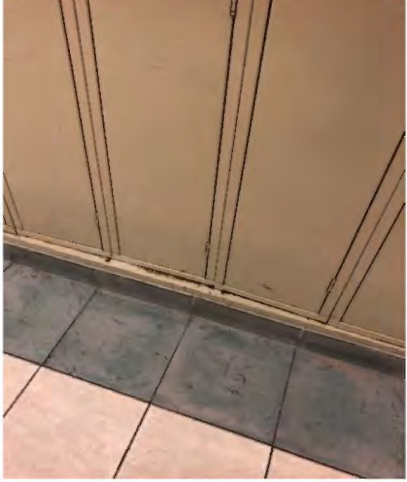
<p>Lockers have rust at the bottom. They are bowed inward in places.</p>

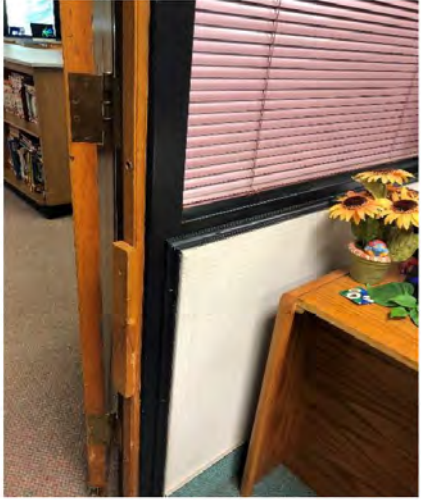
Media Center Office has furred out detail at the wall to the Media Center.
71

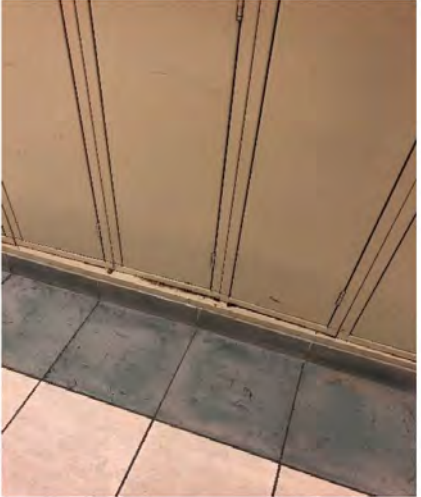
Lockers have rust at the bottom. They are bowed inward in places.
72

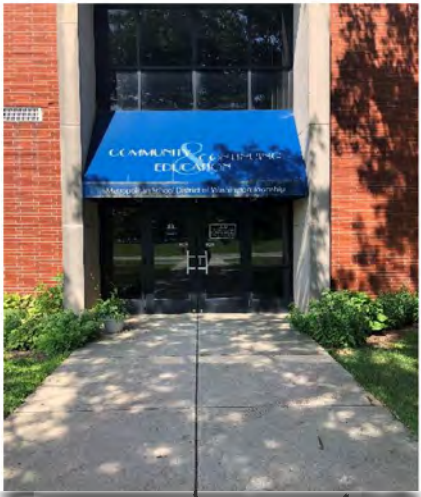
Fabric Canopy at the Community Education Center is distressed.

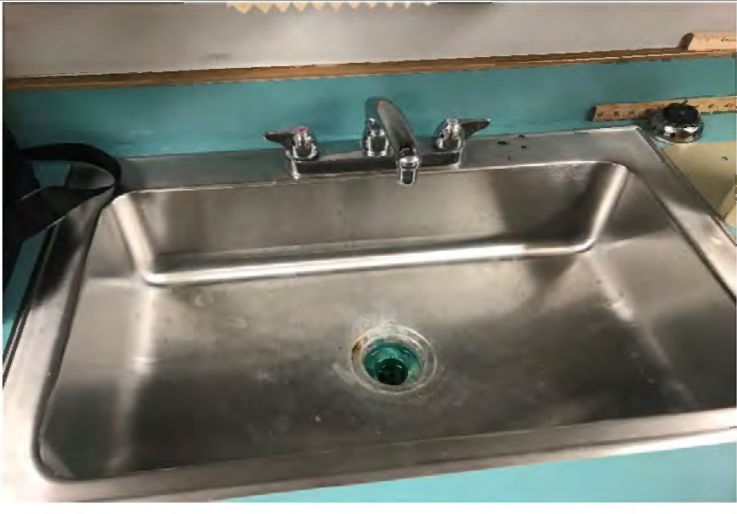
<p>Calcium buildup is common on fixtures due to hard water conditions.</p>
2

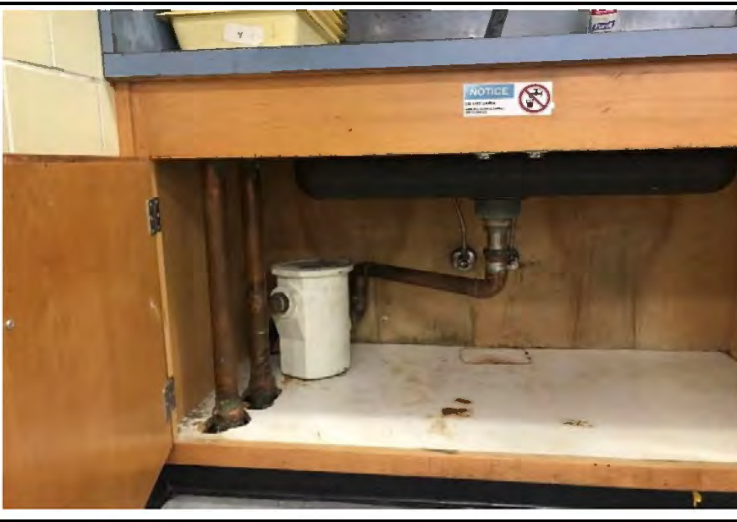
<p>Art Room sink piping is in rough condition and does not include unions to facilitate removal of solids interceptor as required for maintenance.</p>
3

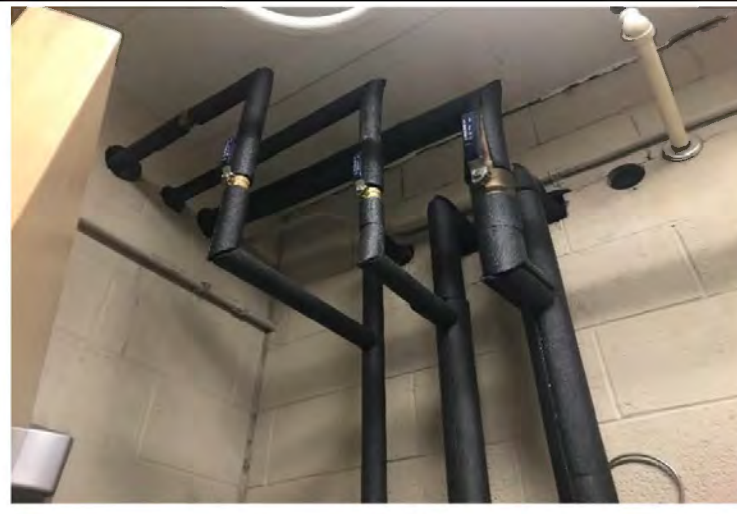
<p>Domestic piping is in reasonable condition, but the pipe insulation is showing signs of aging as it gets hard and joints separate. Once elastomeric foam insulation hardens, it loses its insulative value.</p>

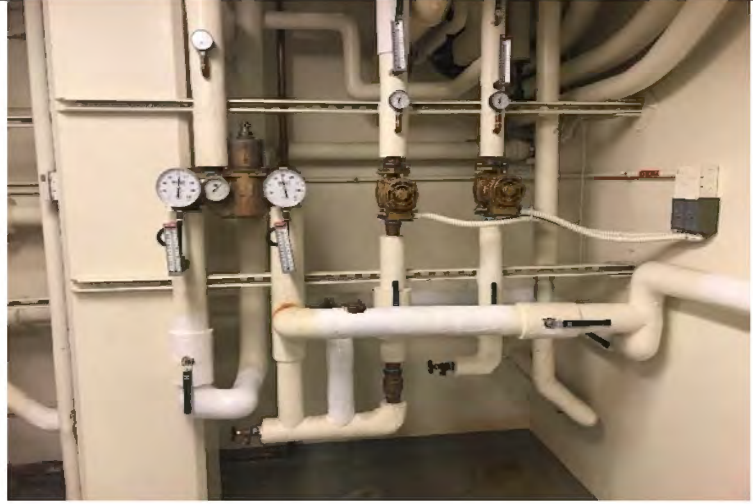
<p>Hot water return system and pumps appear to be in reasonable operating condition, however the system is not balanced. Excessive run times were observed in wing A and elsewhere in the system. Three hot water faucets were turned on at the farthest fixtures in wing A for over 20 minutes without achieving even warm water.</p>
6

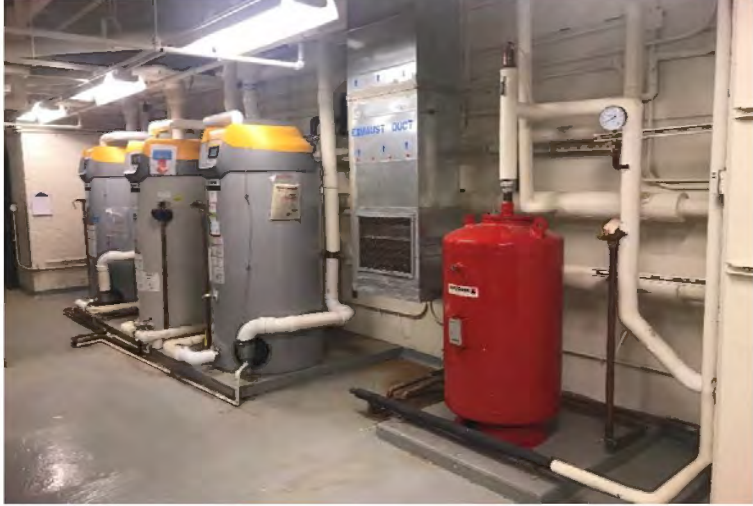
<p>The three A.O. Smith Cyclone gas fired water heaters appear to be in reasonable operating condition. High maintenance issues have been reported with this style of heater by numerous clients.</p>
7

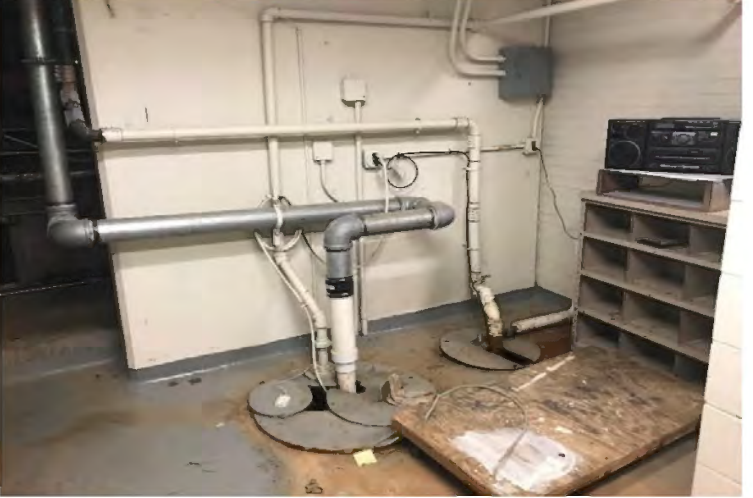
<p>Sump pumps have been installed without control panels. Control panels with remote monitoring is recommended. If and when these pumps fail, no one will know until the room is flooded.</p>
8

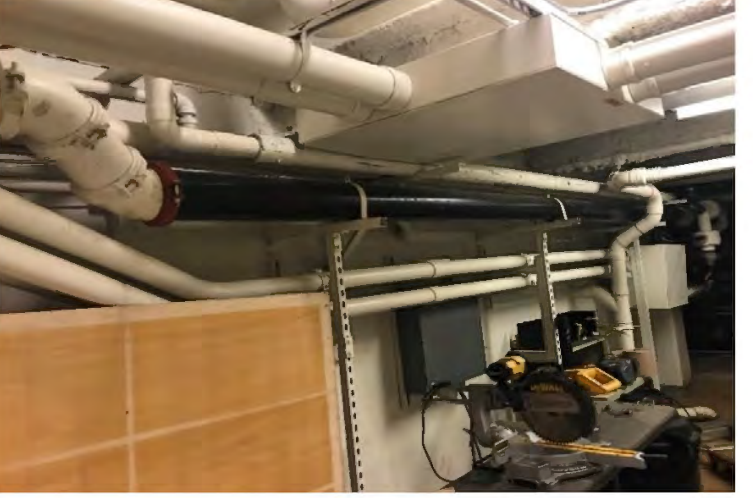
<p>Numerous fire protection pipe sections have been replaced due to failures. The building is partially sprinklered and will continue to have pin holes leaks and failures as the system ages.</p>

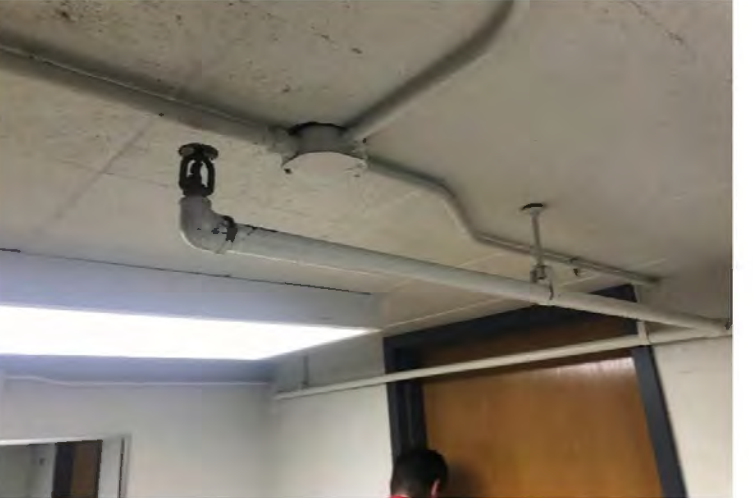
<p>Abandoned sprinklers found in the Auditorium Green Rooms are a code violation. If the sprinkler system is not functioning the heads and piping are required to be removed.</p>

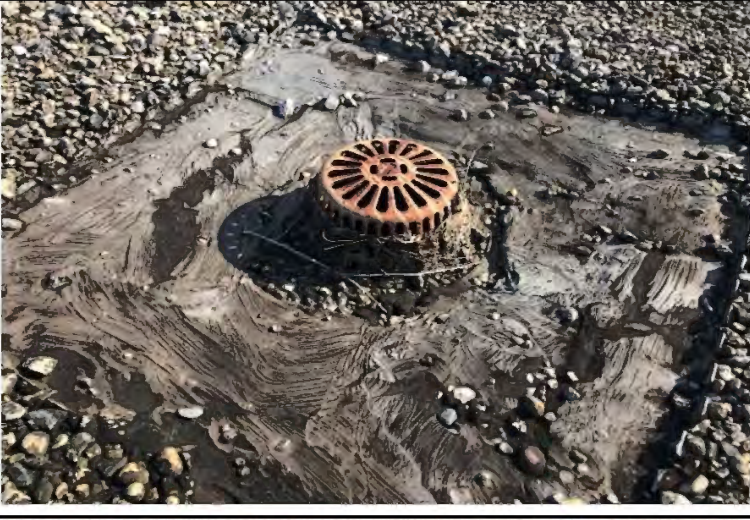
<p>The overall storm drainage system appears to be in reasonable condition, however the roof drain domes need to be cleaned on a regular basis.</p>
11

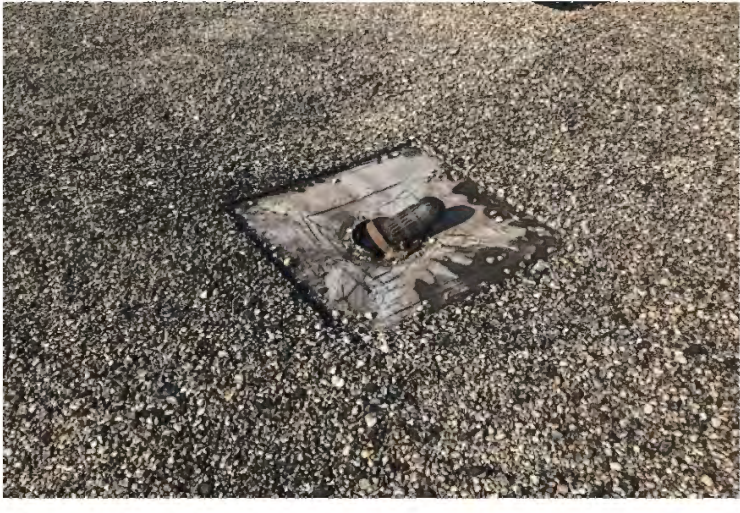
<p>Given the close proximity to the tennis courts, it is important to keep all roof drain domes in place and secured.</p>

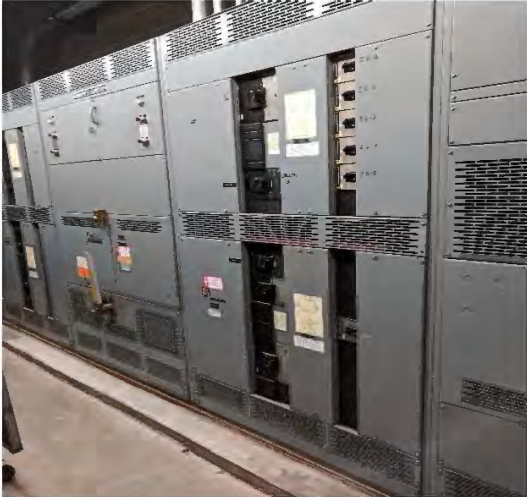
<p>The main service bolted pressure switches have been requested to be replaced with breakers by facilities. This requires the main switchboard to be replaced in its entirety. The overall condition of supporting Distribution (3 225A Panelboards require replacement) is satisfactory and does not require replacement. There are issues with short circuits at receptacles tripping the main breakers. A complete system coordination study is required to assess the problem. New breakers will be required for coordination.</p>
2

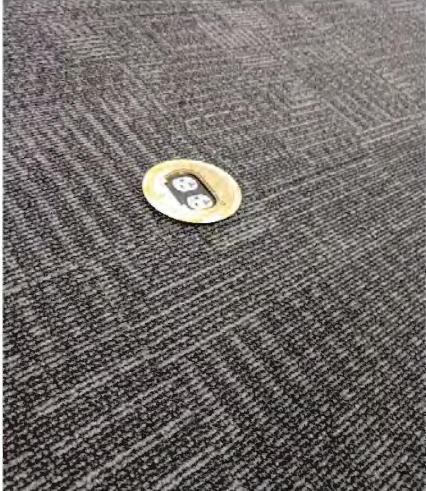
<p>Floor boxes with missing covers in LGI, Unit F.</p>
3

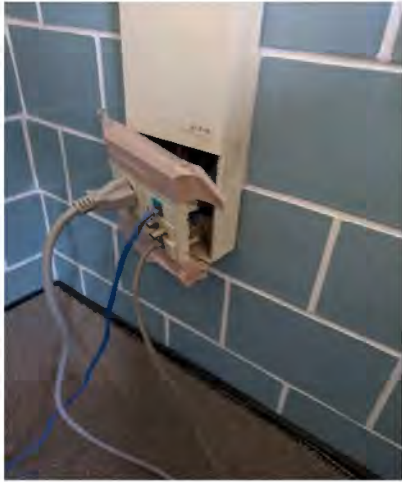
<p>Damaged raceway.</p>
4

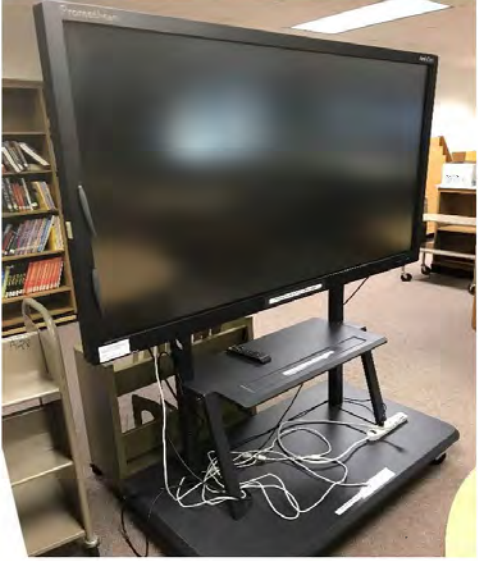
<p>Mobile monitor cart location. Mobile monitor carts are found randomly throughout the building. About 5 locations are present in the building.</p>

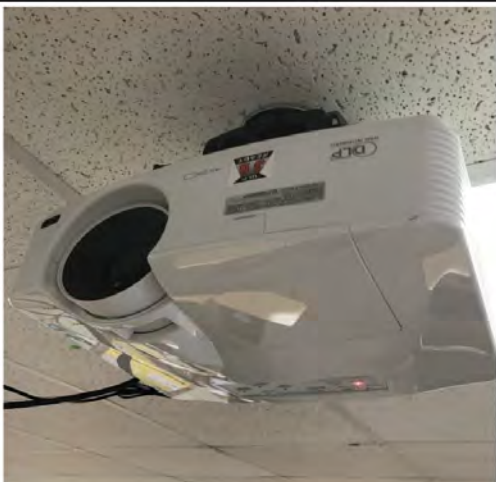
<p>Typical ceiling mounted projector location. Projector found in most classrooms throughout the building.</p>
19

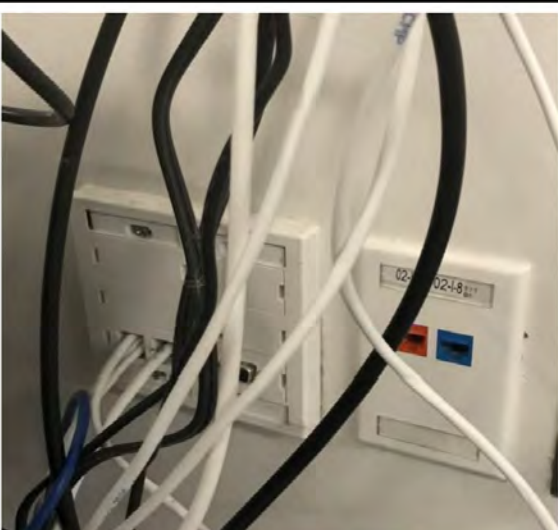
<p>New data and AV input locations. Instances are common throughout the "True North" section of the building (Units F&G).</p>
20

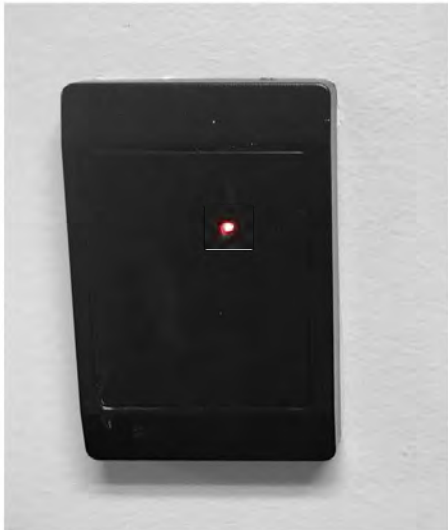
<p>Card reader location. About 5 instances occur in the building.</p>

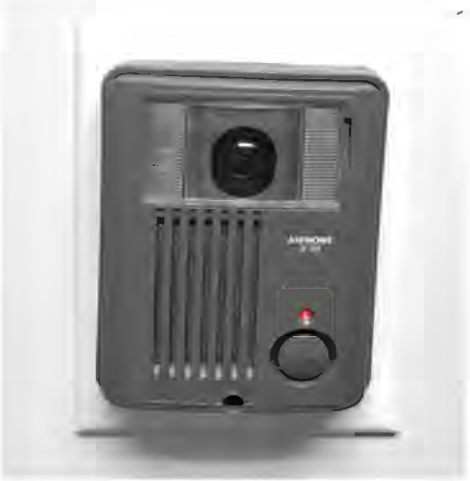
<p>Video intercom station location. Only instance is found outside of the reception office in the "True North" section in the building.</p>
22

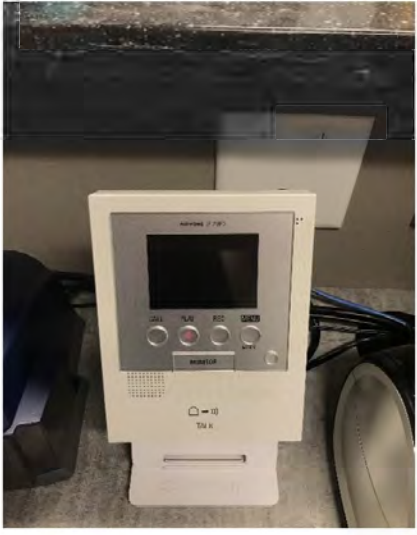
<p>Video master station location. Only instance is found on the desk inside the reception area office in the "True North" section in the building.</p>
23

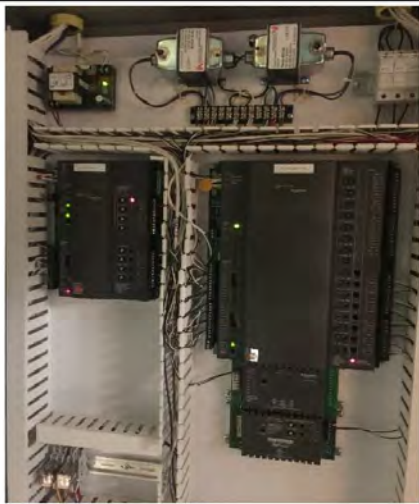
<p>Typical control panel with b3 controller that should remain. In general all controllers are b3 style and should remain.</p>
2

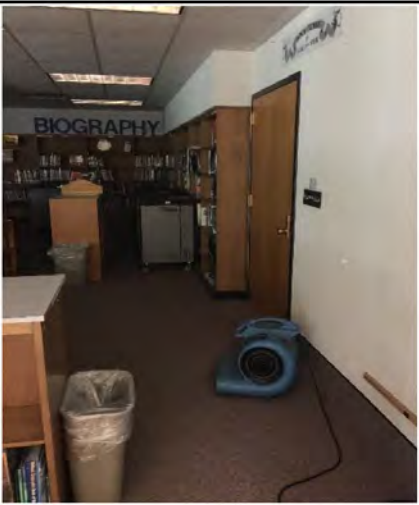
<p>Media Center extra fans due to hot area in Biography section.</p>
3

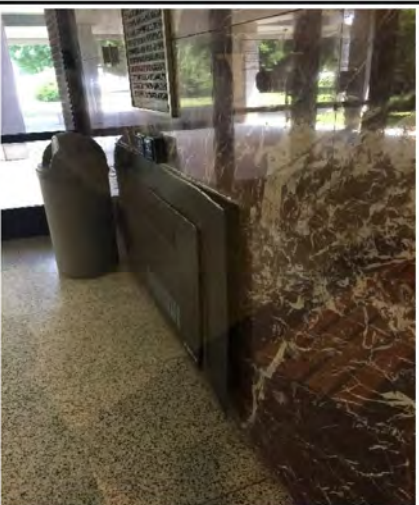
<p>Main entrance cabinet unit heater corner is bent outward.</p>
4

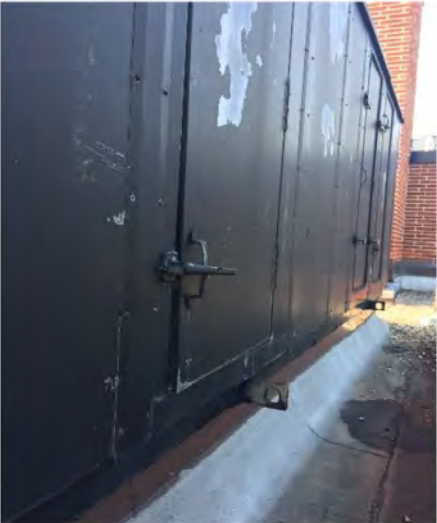
<p>Rooftop unit with door bent outward.</p>

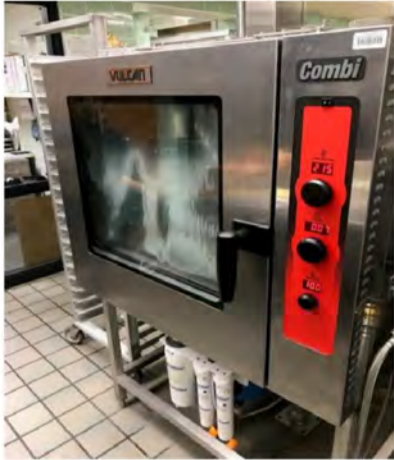
<p>Select pieces of cooking equipment will be reused.</p>
2

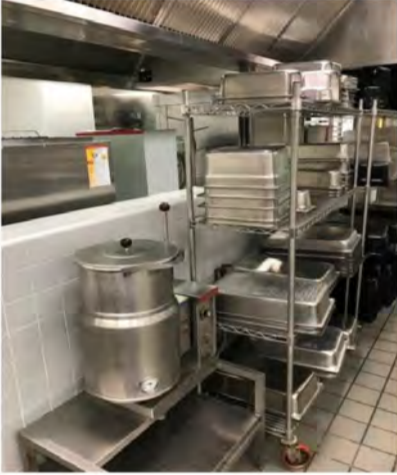
<p>The overall exhaust requirements will be less than the existing kitchen. Pan storage does not need to take up "hood space."</p>
3

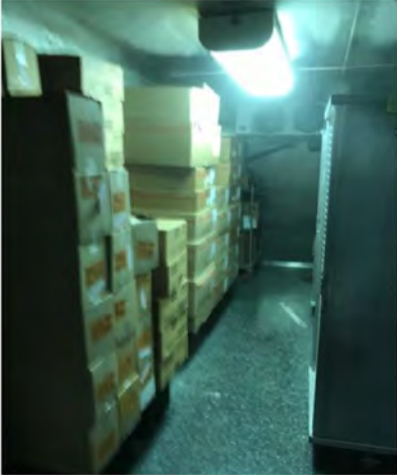
<p>The existing refrigerated storage spaces will be replaced.</p>
4

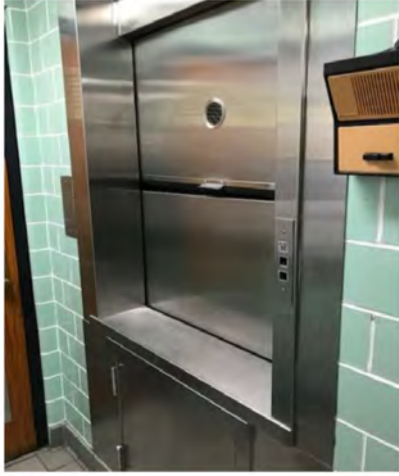
<p>The current two floor set-up requires the use of a dumb-waiter to transfer food from the kitchen to the serving level.</p>

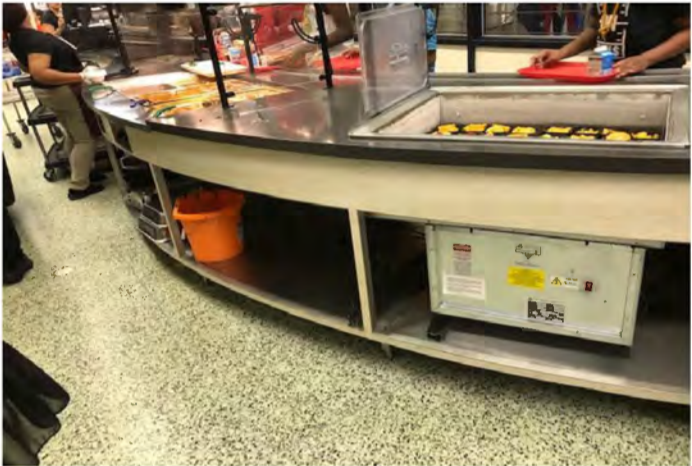
<p>Service side of serving line.</p>
7

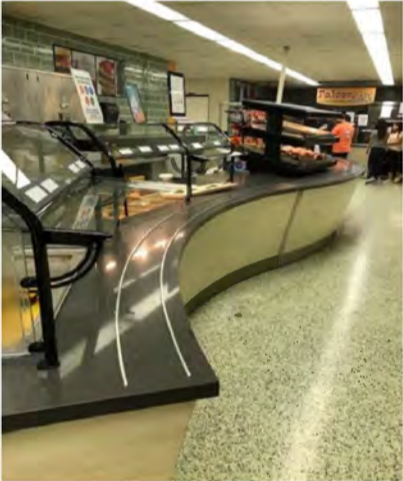
<p>The current serving lines have been in service since the 2015-16 school year. Depending on the timing of the renovation for Northview MS, the condition of the pieces, and the shape and size of the new serving area, the current serving lines may or may not be used in the renovated serving area.</p>
8

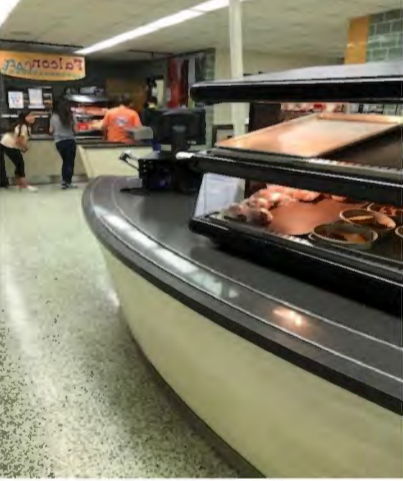
<p>Selected pieces, including the sandwich slide pictured here, will be reusable in the new servery.</p>
9

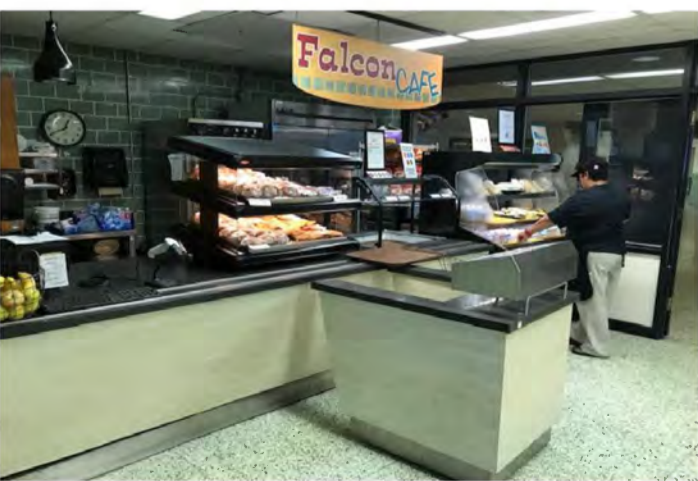
<p>Based on the straight line configuration of the Falcon Café, we believe that most of the pieces here will be reusable.</p>

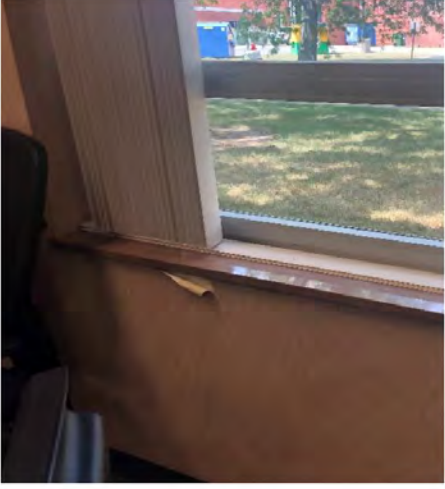
<p>Vinyl wallcovering is separating from the wall. This is typical. Windows are single glazed, non-insulated. Vented windows are hoppers.</p>
2

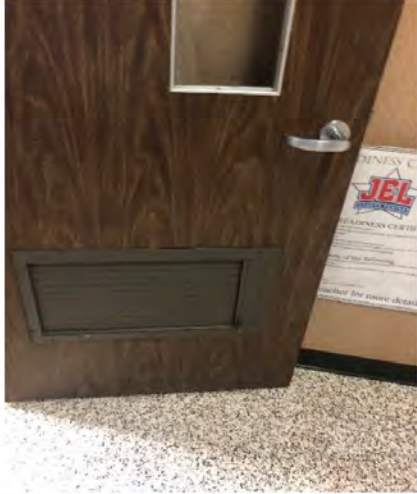
<p>Laminate finish doors are in fair condition. They have louvers, wire glass in lites.</p>
4

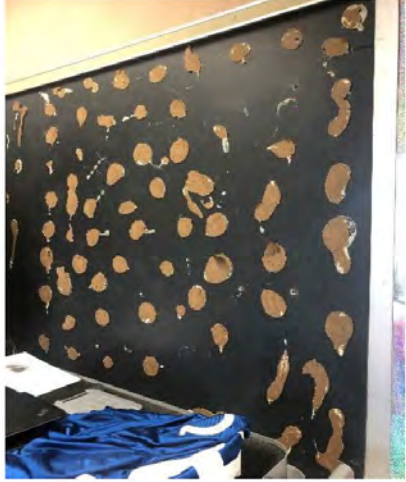
<p>Abandoned display board.</p>

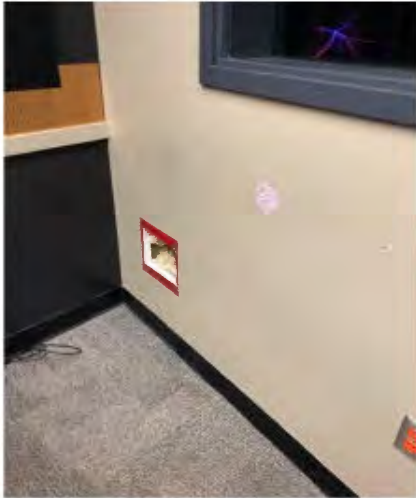
Hole(s) in wall.
6

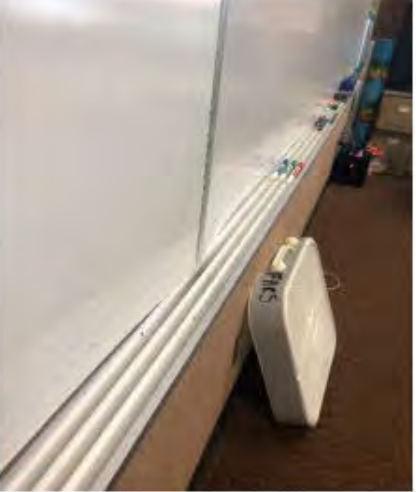
Warped marker board.
7

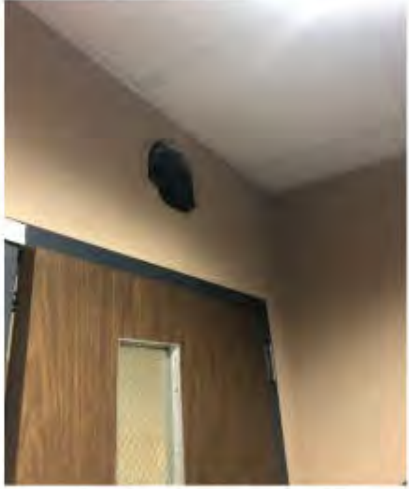
Abandoned holes in walls, it's assumed a clock system was removed and the holes were not patched. This is typical.
8

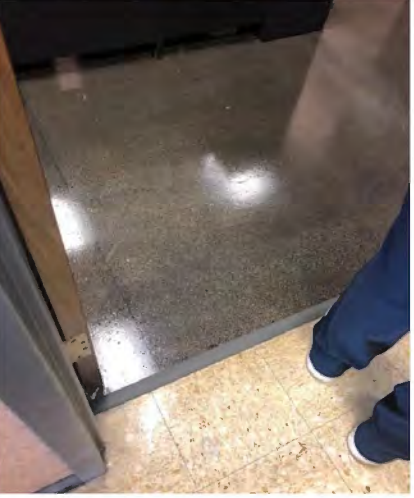
<p>Hollow metal door frame is rusted. Carpet was replaced with resinous floor. The adjacent office has new carpet. Occupants described water infiltration of the room and corridor when it rains.</p>
12

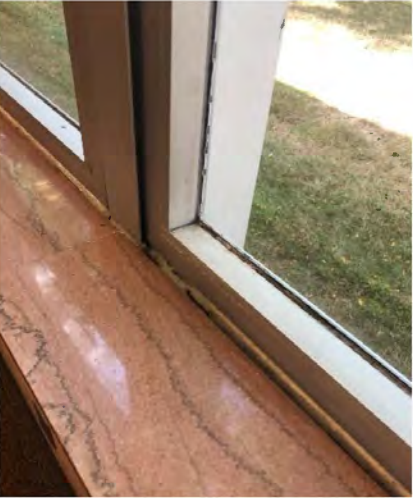
<p>Open joint, there's no caulk between the window sill and window frame.</p>
14

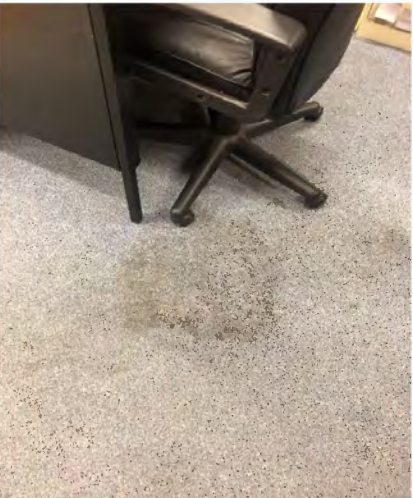
<p>Damaged carpet.</p>

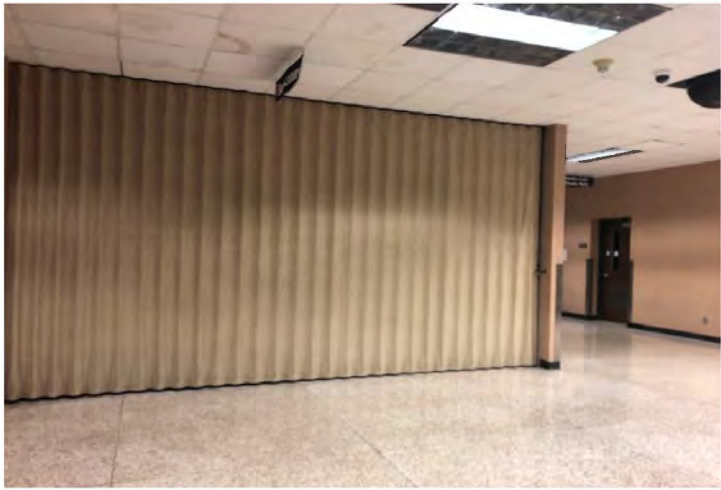
<p>Accordion partition is dirty and damaged. Ceiling tiles are stained.</p>
16

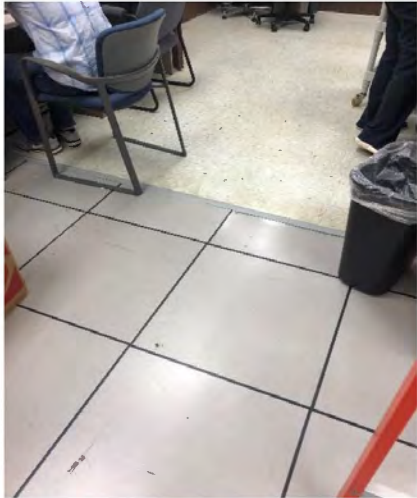
<p>Access floors with recessed slab in the Technology & Data Center.</p>
17

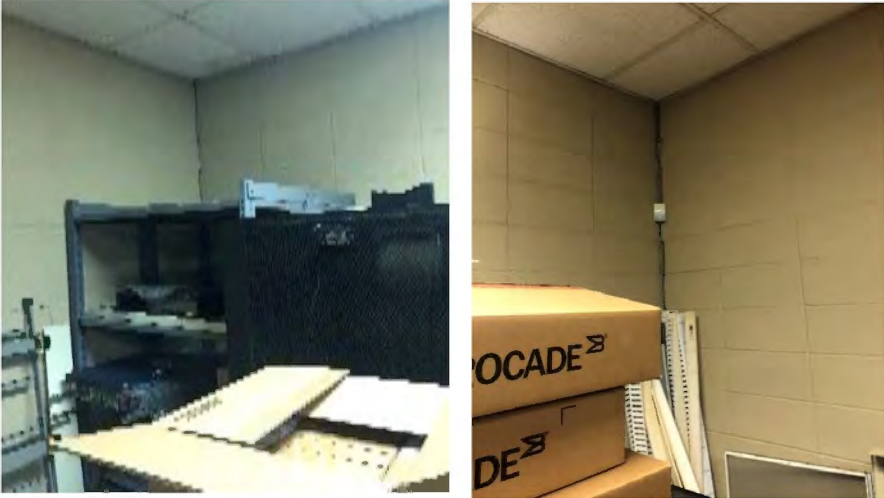
<p>There are some corners where walls meet that is not a smooth transition and has no caulk.</p>
19

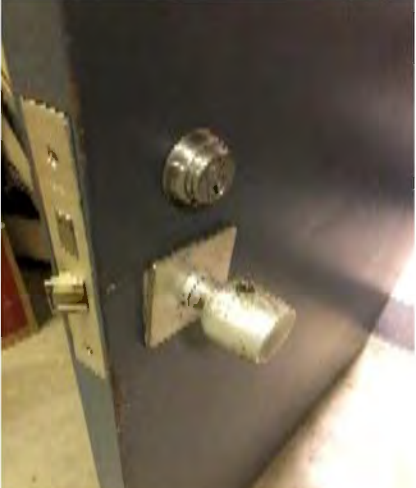
<p>Knobs do not meet ADA.</p>

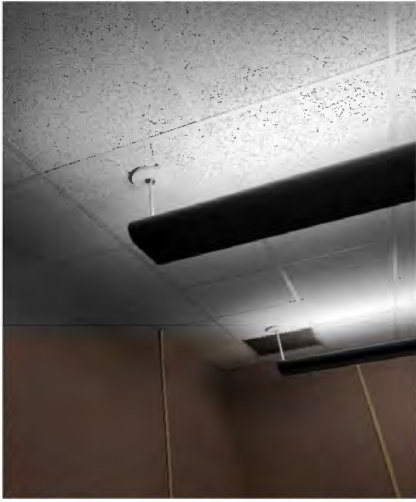
Cuts at ceiling panel where pendant lights were installed.
21

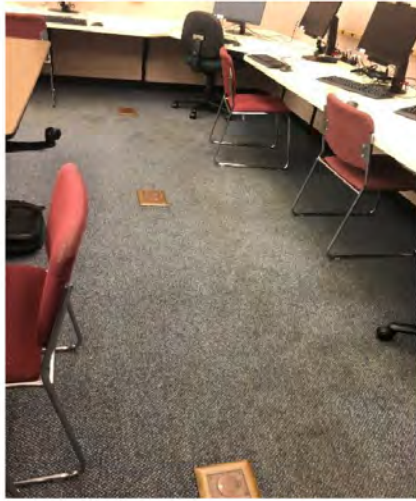
Stained carpet.
22

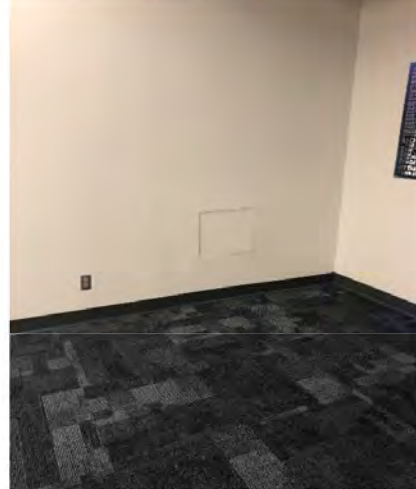
Saw cut in the wall that needs to be patched.
23

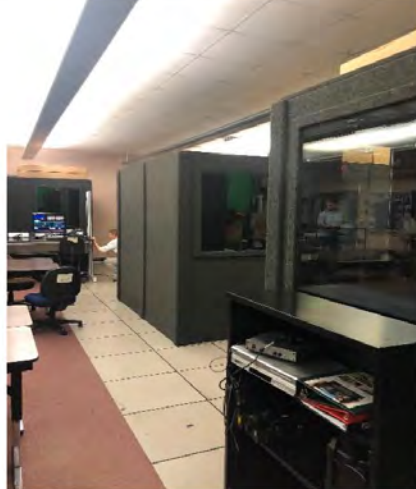
Sound booths are in a room over the access flooring.
24

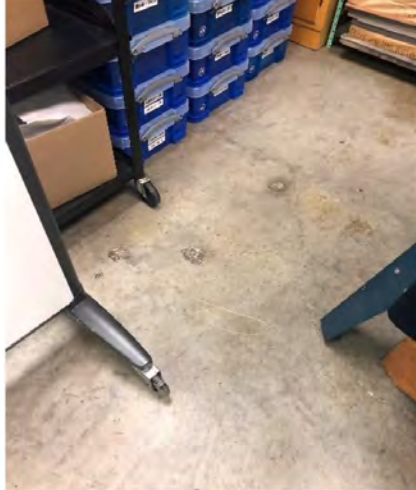
Damaged concrete slab.

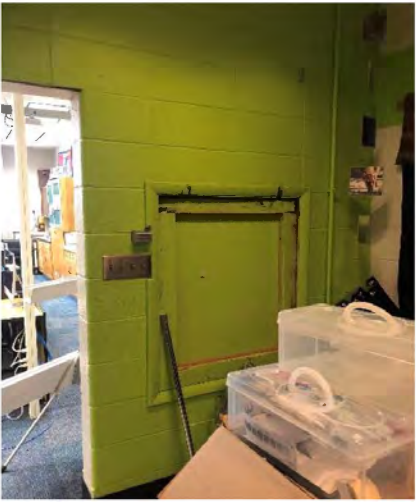
Opening in the wall was infilled with wood in lieu of CMU.
26

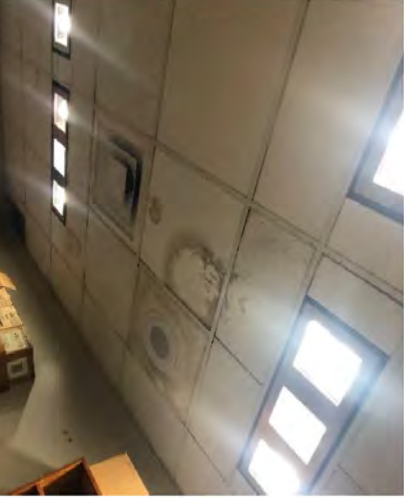
Damaged ceiling tiles.
27

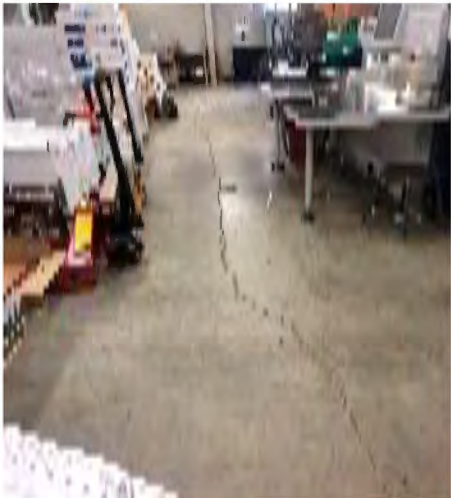
Cracked concrete.
28

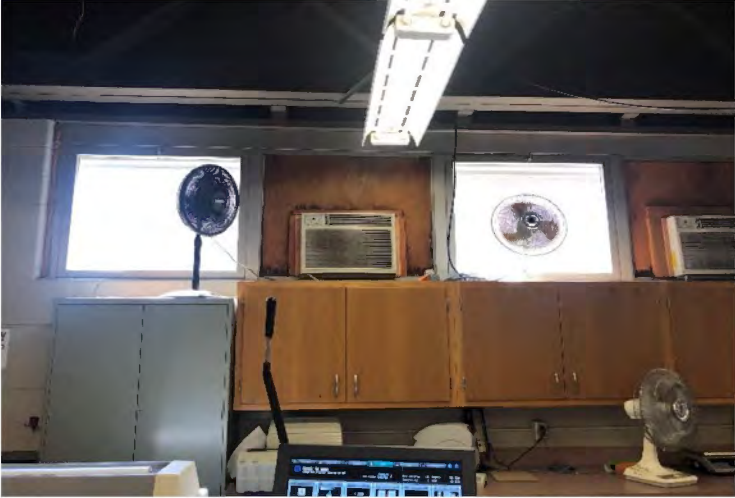
Window infills of plywood show water damage and are not sealed tight.
29

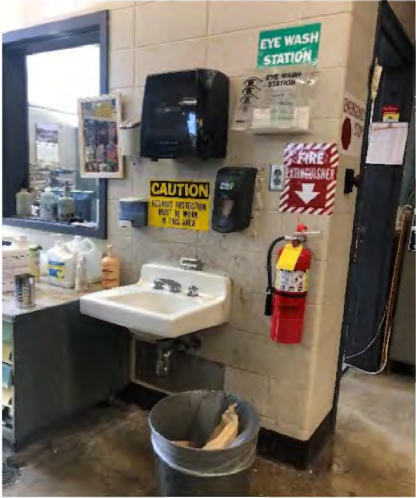
Paint is peeling from the wall. The wall is dirty. A power outlet is near the sink.

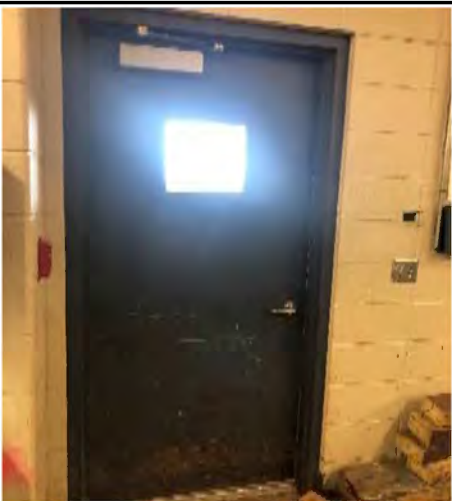
The exterior hollow metal door is damaged and not sealed well to the exterior.
33

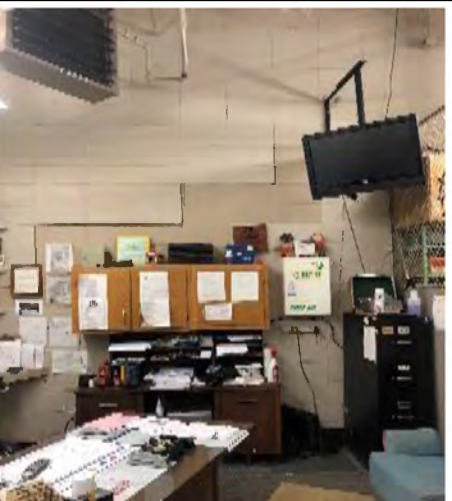
Cracking in CMU (accent paint follows the crack).
34

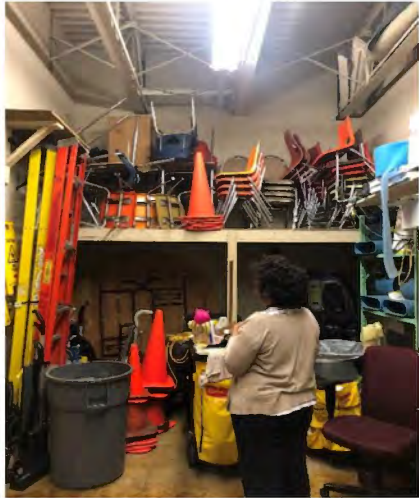
Wood framed mezzanine.
36

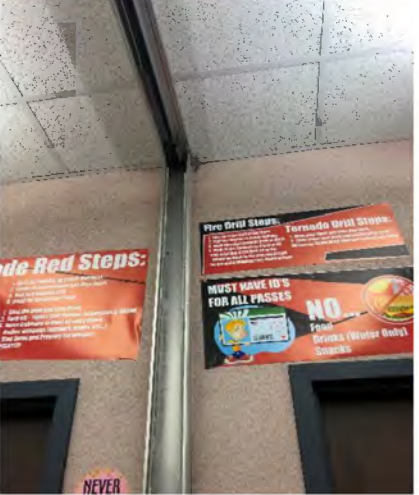
Abandoned partition track and jamb.
37

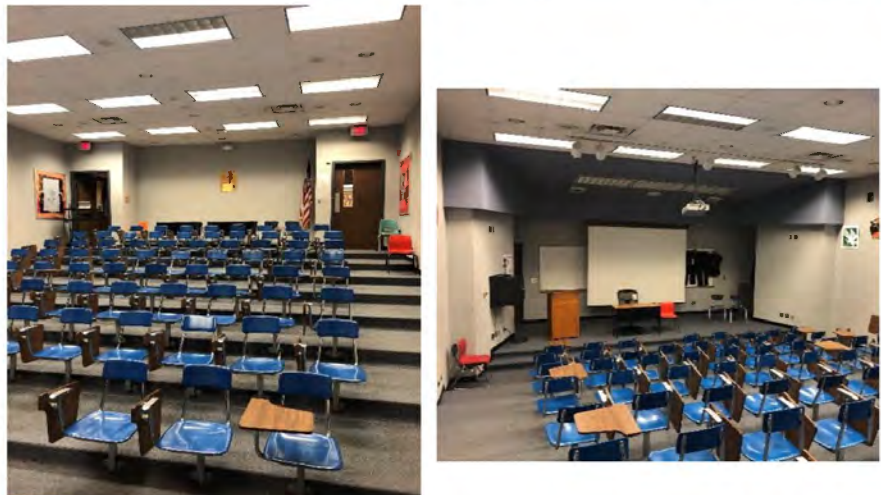
No accessible seating or teaching station. Built in lights & projector screen is in the bulkhead.

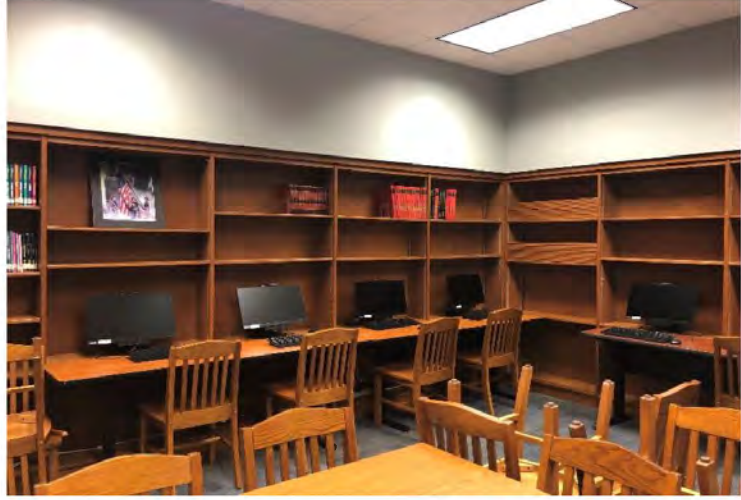
Shelving is used as desks.
42

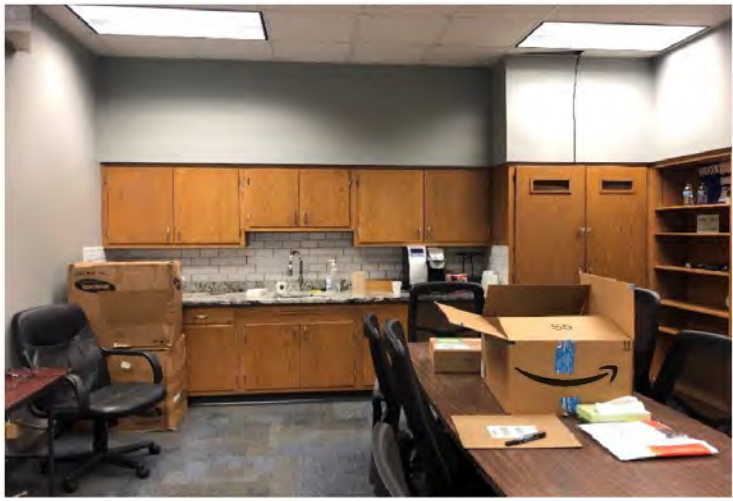
Mixture of cabinet and counter top styles throughout the building.
43

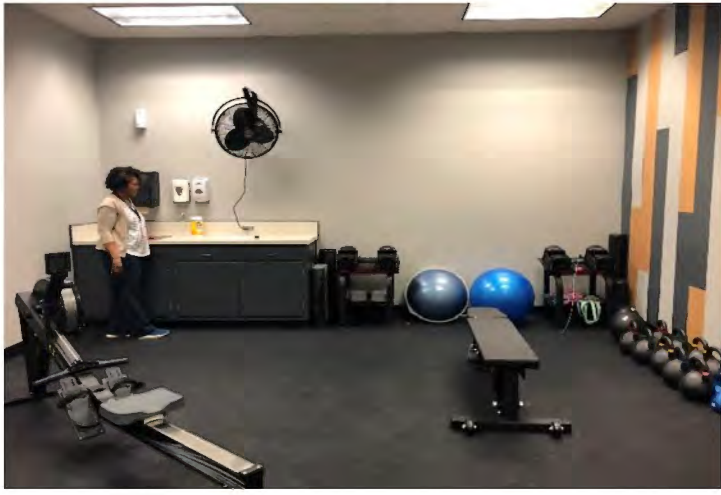
Wall finish is delaminating from the wall surface.
44

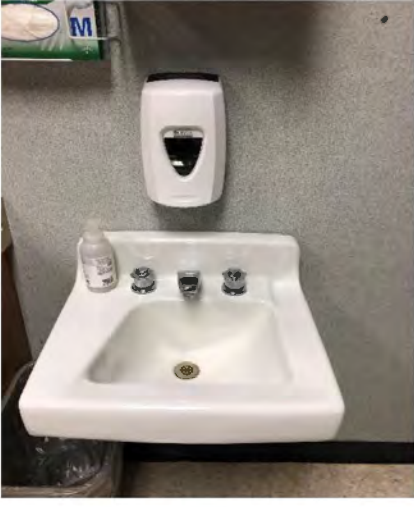
Faucet handles do not meet accessibility guidelines.
46

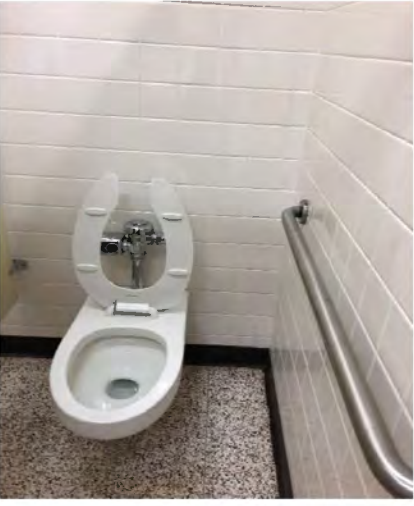
No 5ft accessible stall with grab bars.
47

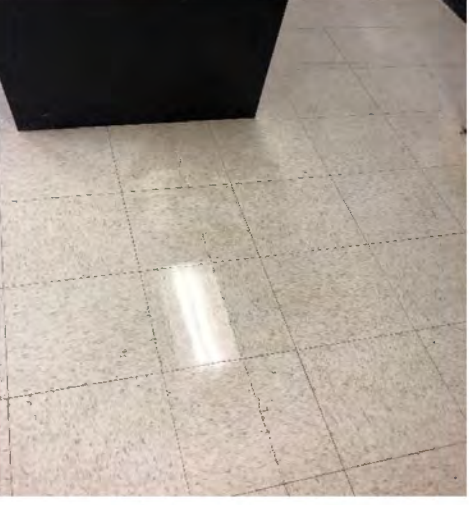
Crack in VCT floor tile.
49
