WASHINGTON
TOWNSHIP SCHOOLS

Secondary School Master Plan

SECONDARY SCHOOL FACILITY CONDITION ASSESSMENTS

EXISTING CONDITIONS ASSESSMENT SUMMARIES

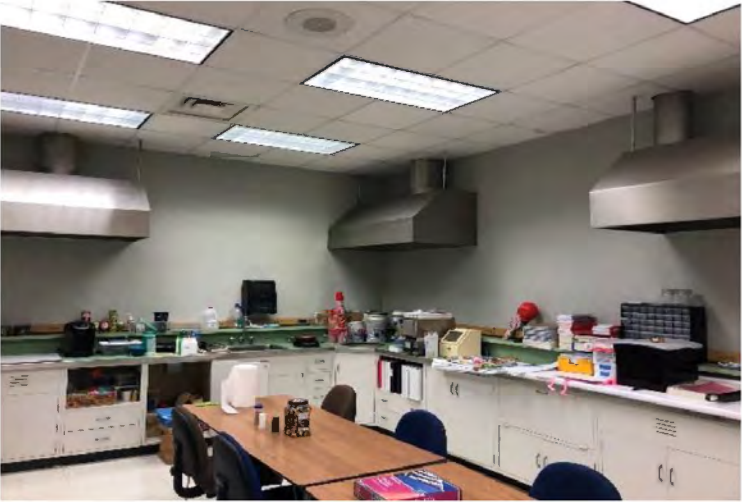
Fume hoods.
51

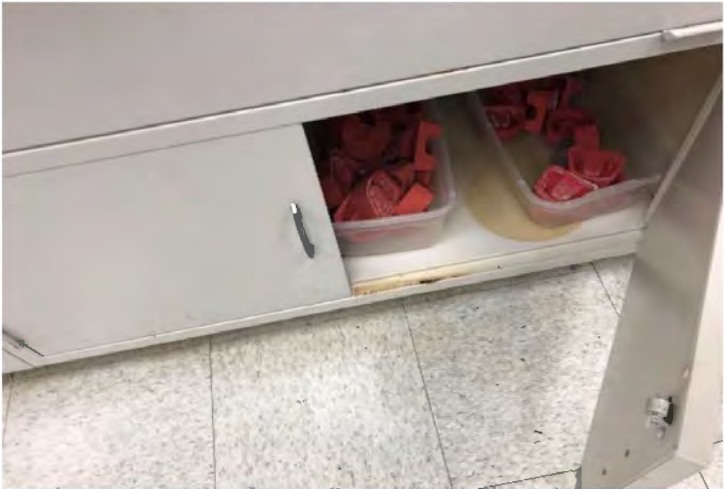
Rust in metal cabinets.
52

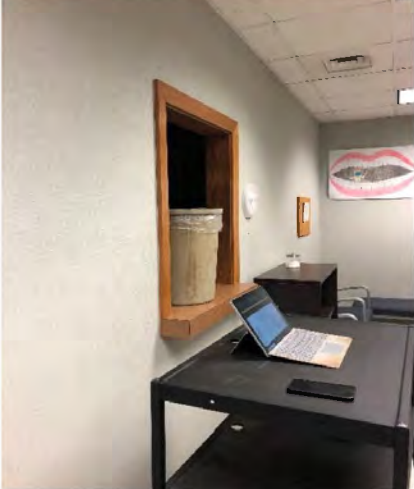
Transaction window is not at an accessible height.
53

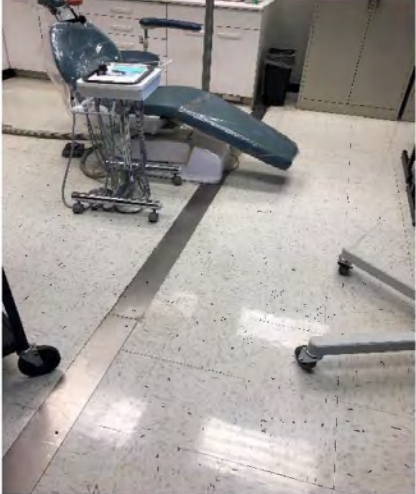
Expansion joint or access point cut into the floor.
54

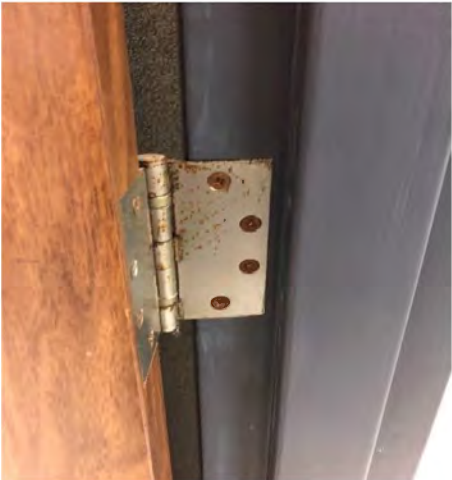
Rust on door hinges.

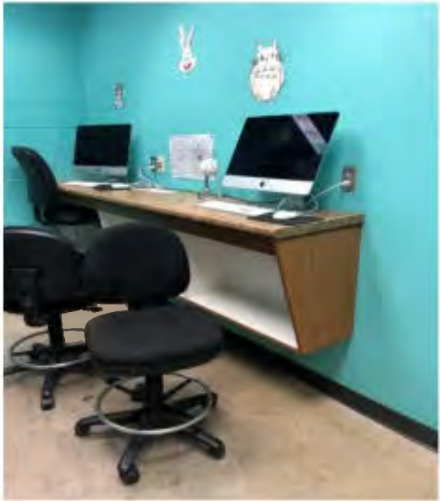
Work stations are not at an accessible height.
58

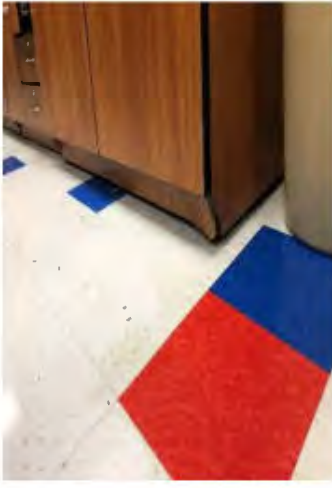
Damaged casework toe kick.
59

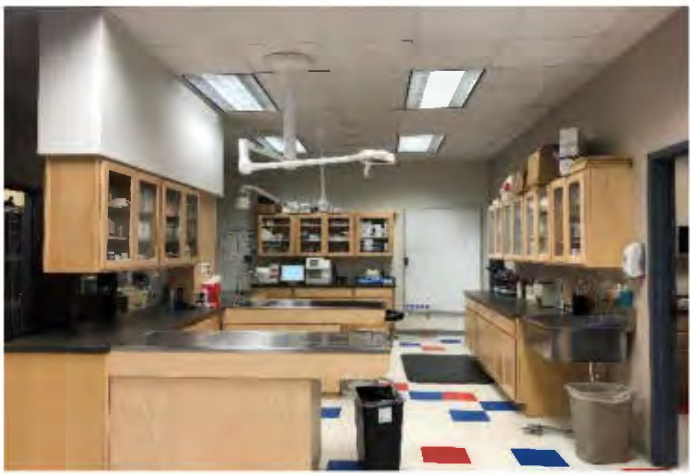
Casework is dissimilar to other casework in the building. Mixed ceiling tile types. There are no door pulls on the cabinet doors.

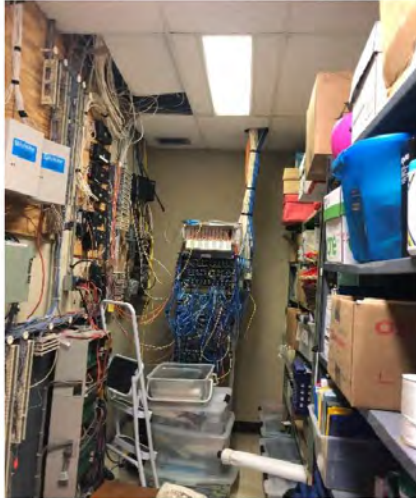
<p>Technology Room is used for storage.</p>
63

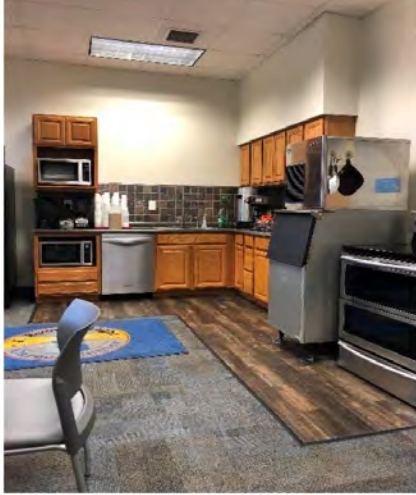
<p>Casework is dissimilar to other casework in the building. There are no pulls on the drawers or doors.</p>

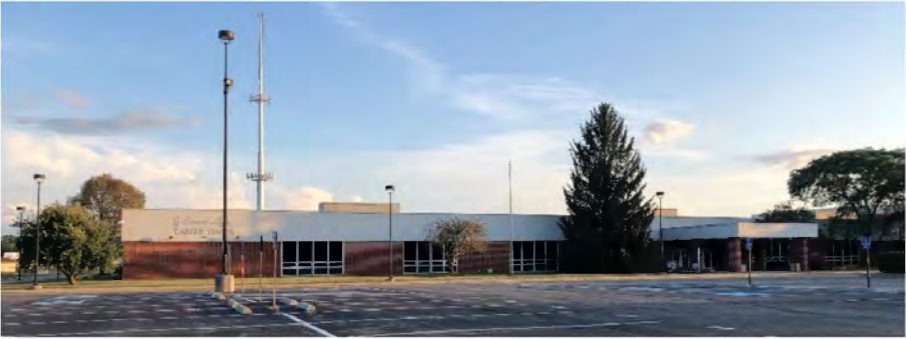
<p>Exterior metal panels are warped, fascia has oil canning. Aluminum windows are too close to grade. The caulk joints between precast panels are failing.</p>
66

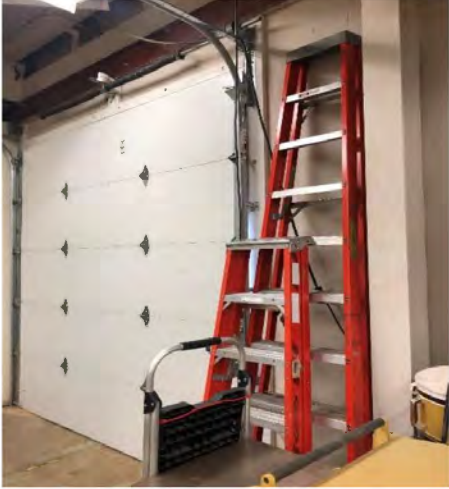
<p>No weather seals at the exterior door.</p>
67

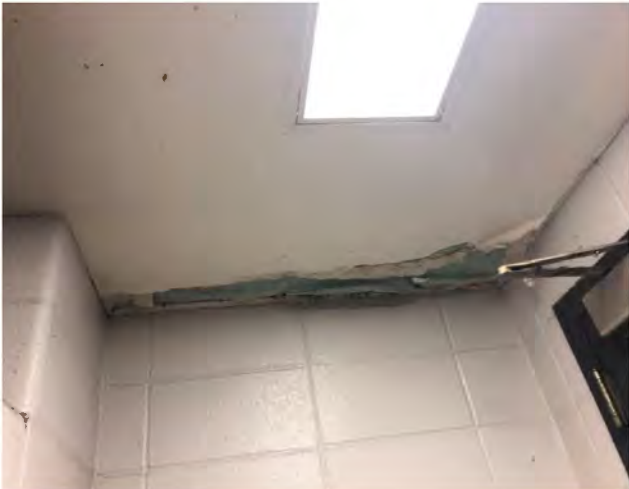
<p>Ceiling damage.</p>

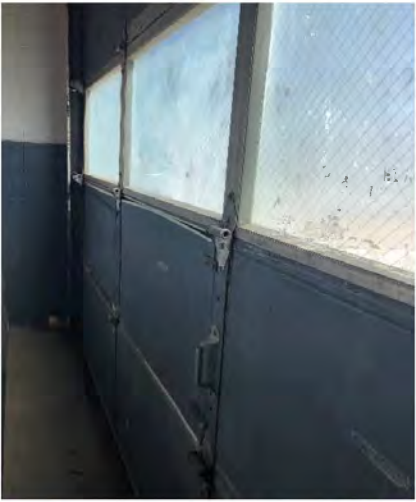
Non-insulated garage door.
71

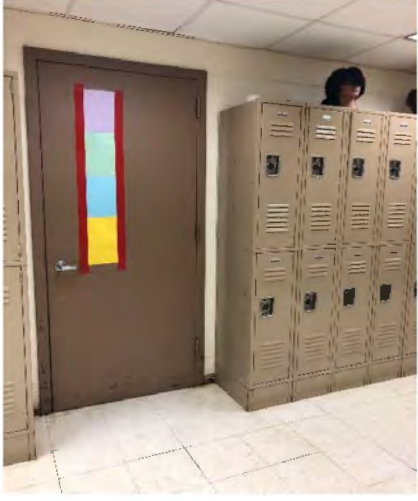
Missing wall base. Door finish is damaged.
74

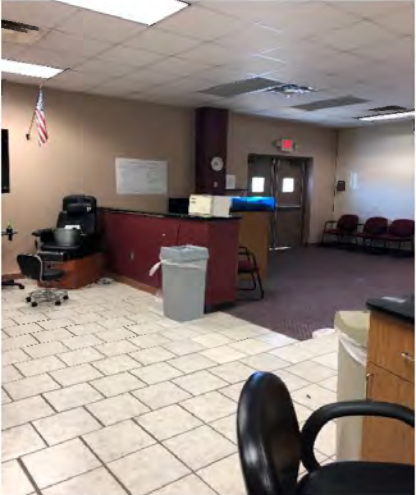
The door is not sealed to the exterior. There is a shift in the tile pattern. The reception desk is not accessible.

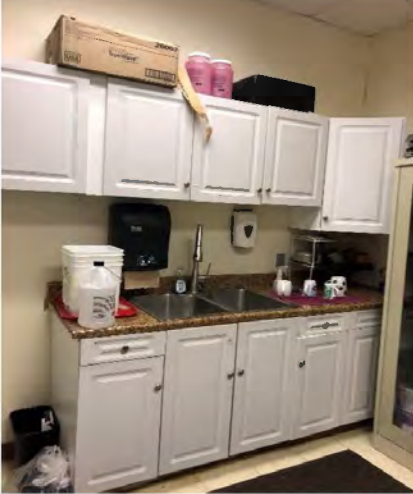
Cabinet door and drawer pulls are not accessible.
76

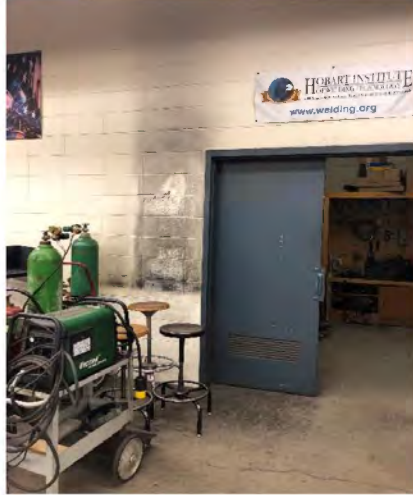
Wall damage.
77

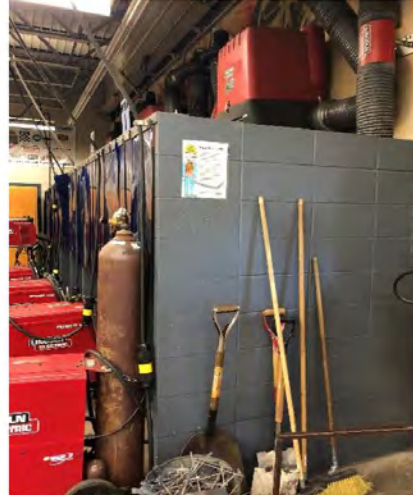
Built-in welding booths. Floor trenches.
78

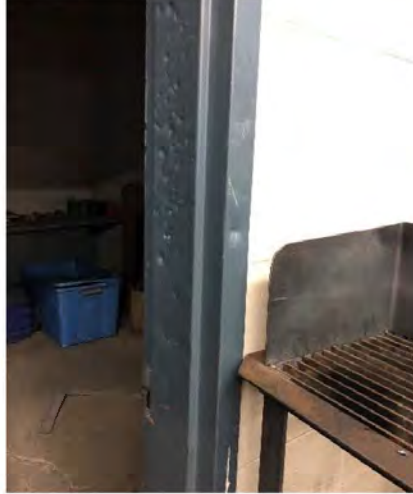
Damaged door frame.
79

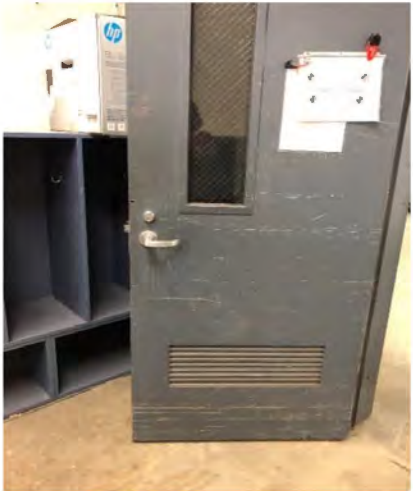
Damaged door.

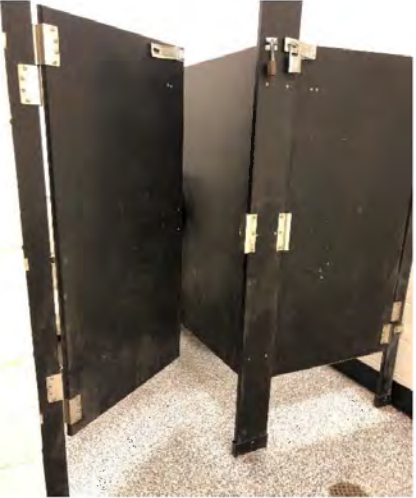
Damaged toilet partitions.
81

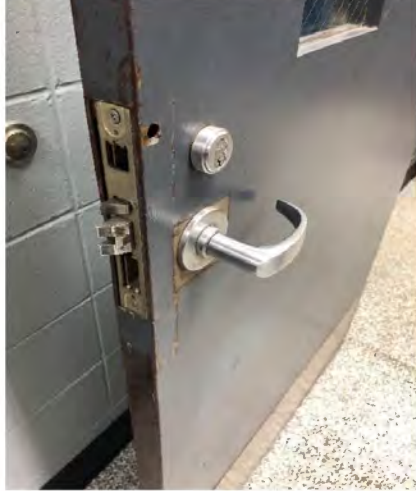
Damaged door.
82

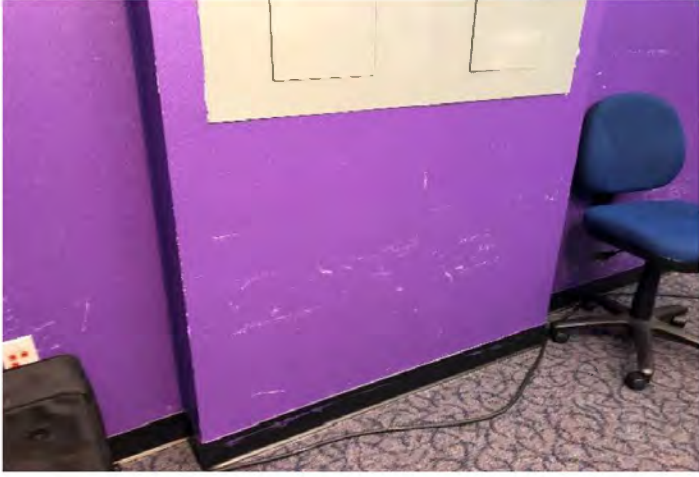
There is damage to the paint finish. Paint is on the wall base.
83

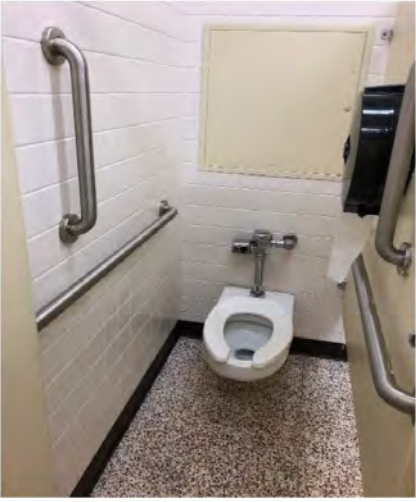
<p>Not a 5ft accessible stall. Wall tiles are missing.</p>
86

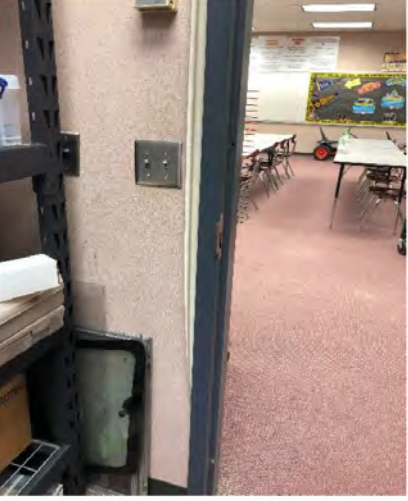
<p>Vinyl wall covering is pulling away from the wall. Some vinyl wall covering has been painted.</p>
87

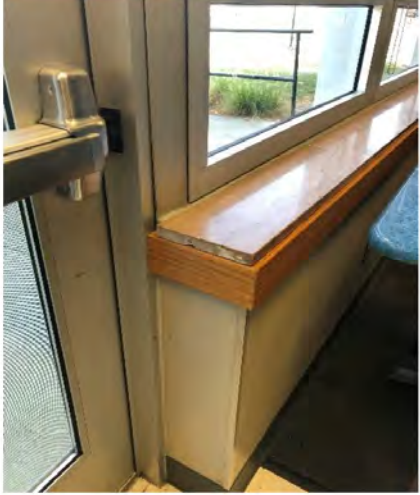
<p>Unfinished end at a window stool.</p>
88

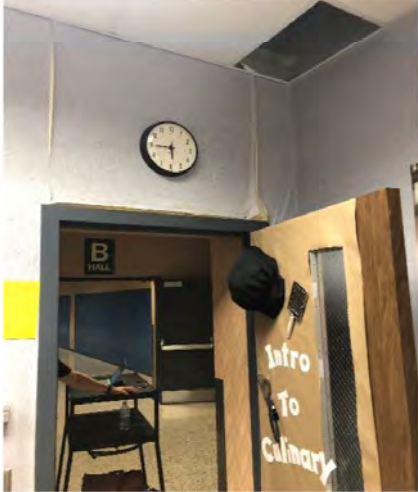
<p>Vinyl wall covering is pulling away from the wall. Ceiling tile is missing.</p>

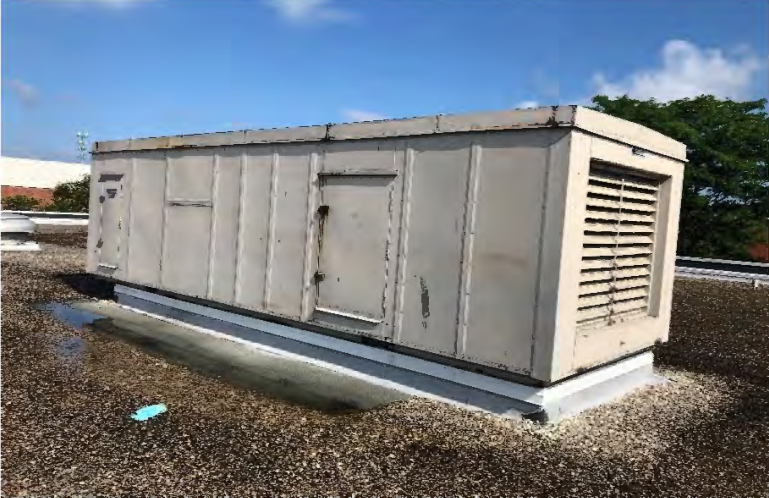
<p>Typical 40 year old Rooftop Unit. Actual unit is RTU-A3.</p>
2	 	<p>Typical 40 year old Rooftop Unit. Actual unit is RTU-B4.</p>
3

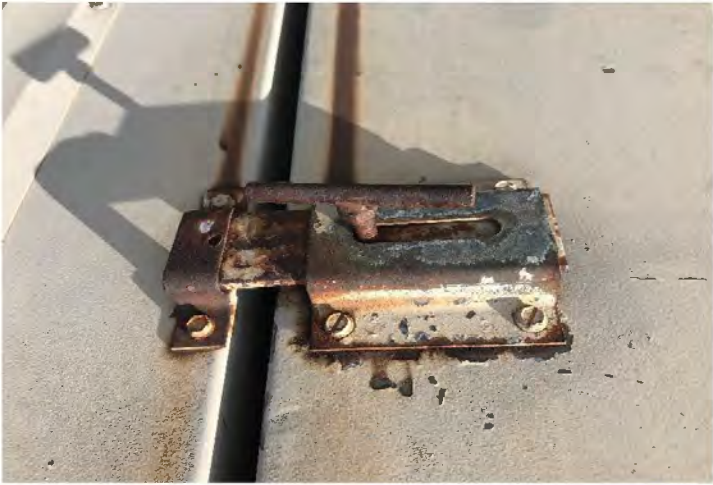
<p>Typical door latches to access must units have rusted and very difficult to access the units for service.</p>
4

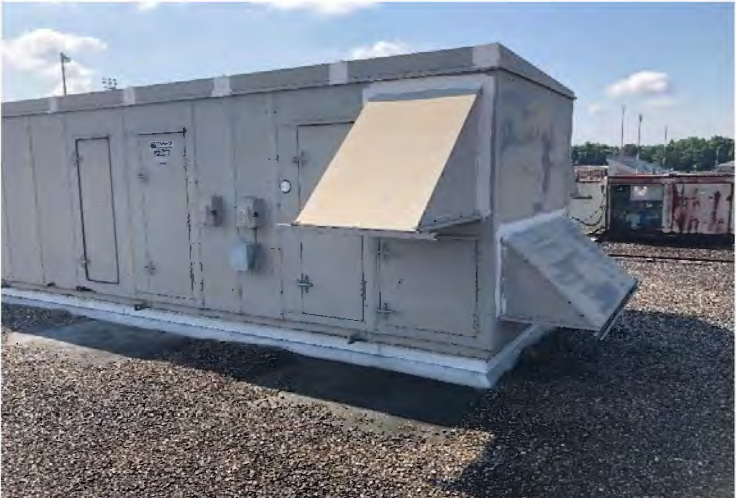
<p>Some of the rooftop units have had to be reroofed and caulked to prevent leaks into the unit and building.</p>

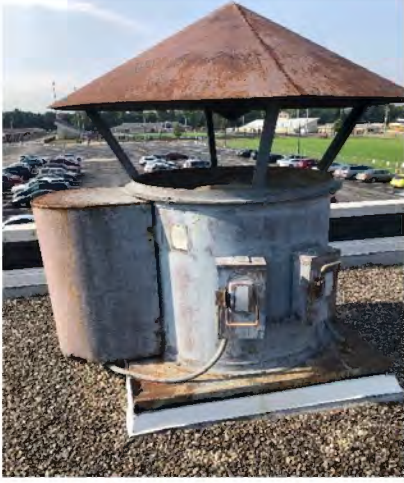
All rooftop exhaust fans need replaced. Typical picture of a fan.
6

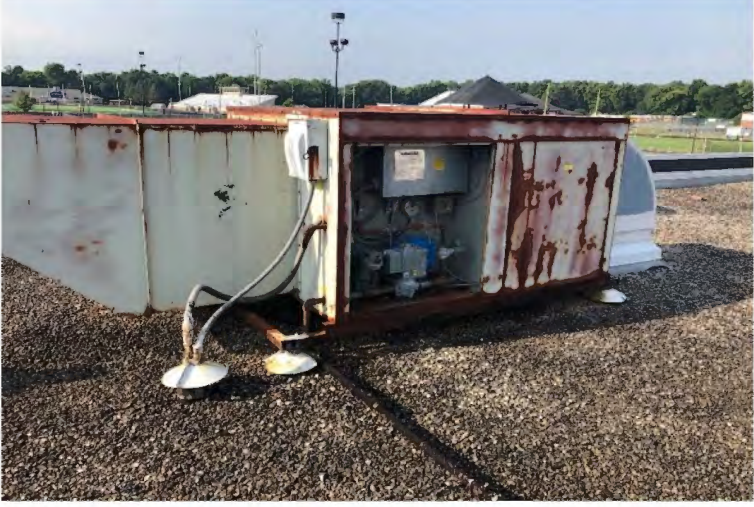
Typical rooftop unit. This one is missing a panel allowing weather conditions inside it.
7

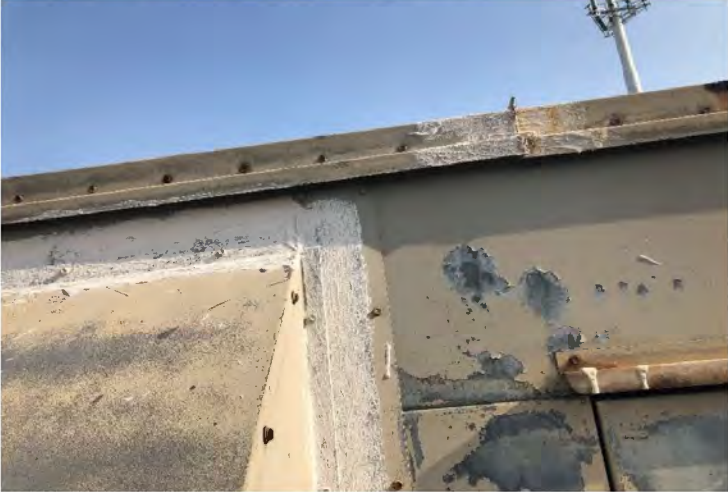
Typical caulking done on units to prevent leaking.

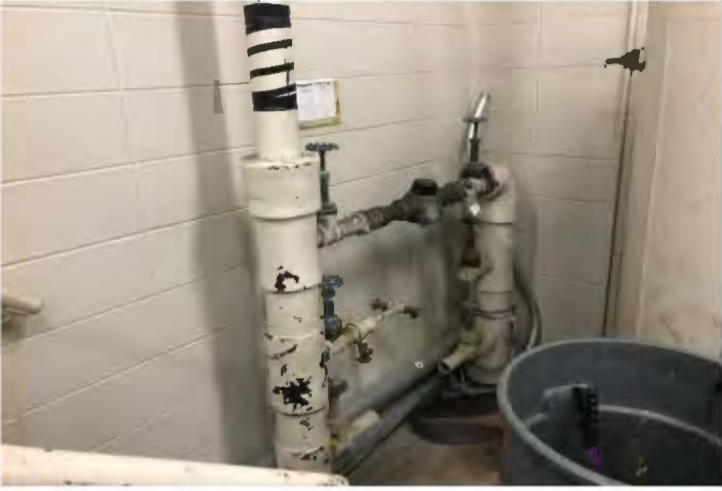
<p>Domestic reduced pressure principal backflow preventers need to be added.</p>
2

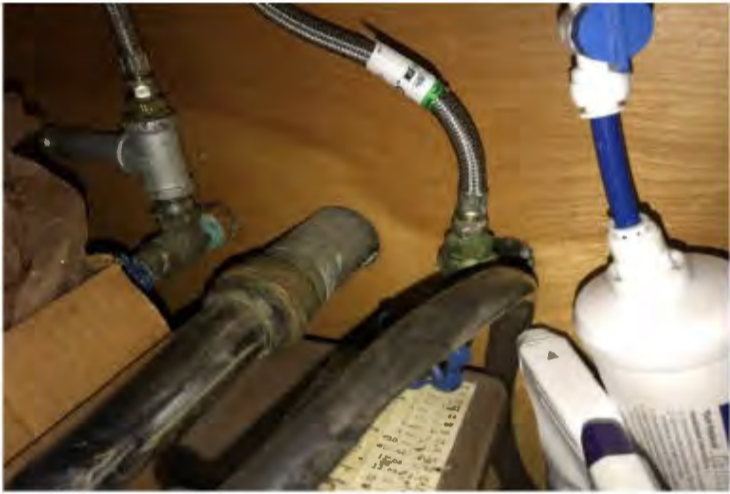
<p>All galvanized domestic and sanitary waste piping needs to be replaced.</p>
3

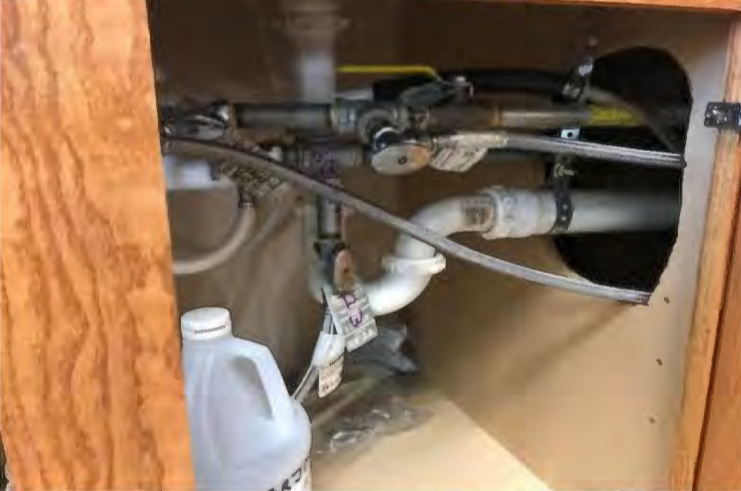
<p>Numerous locations were found where plumbing fixture rough-ins have been poorly installed, leaving large openings in walls and cabinets.</p>
4

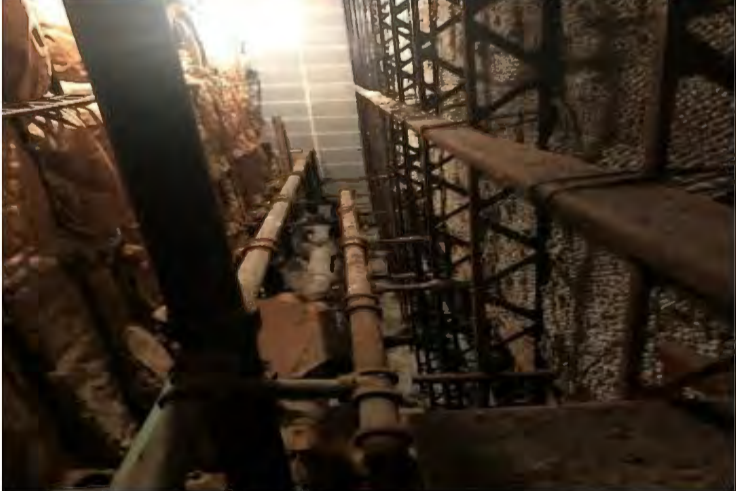
<p>All galvanized domestic and sanitary waste piping in chases needs to be replaced.</p>

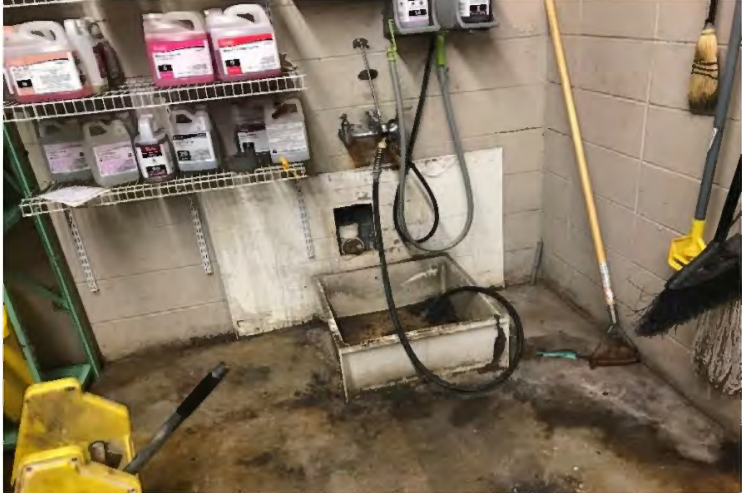
<p>Exposed wall openings at plumbing fixtures allow moisture collection and encourage mold development.</p>
6

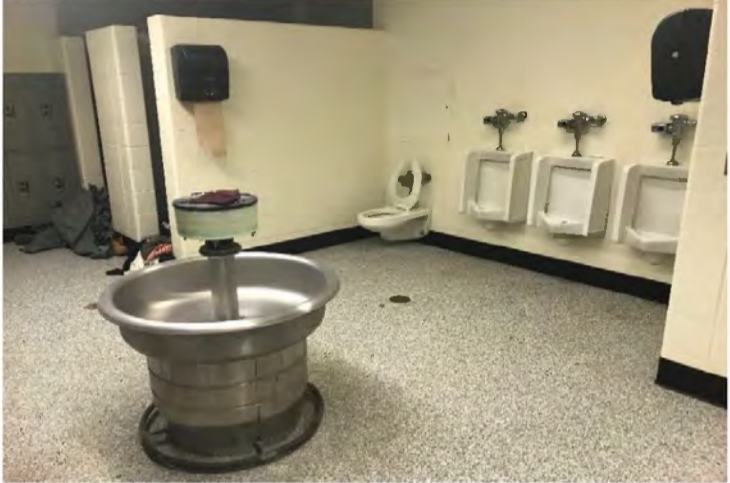
<p>Plumbing fixtures throughout shop areas are in poor condition.</p>
7

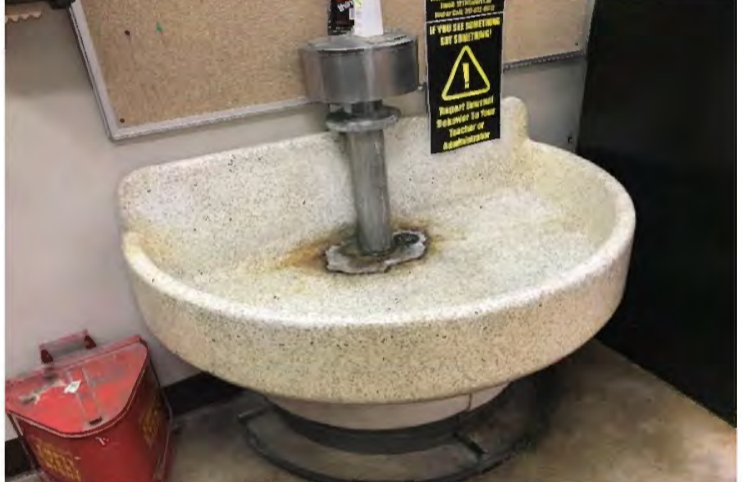
<p>Heavy corrosion and water stains were observed.</p>
8

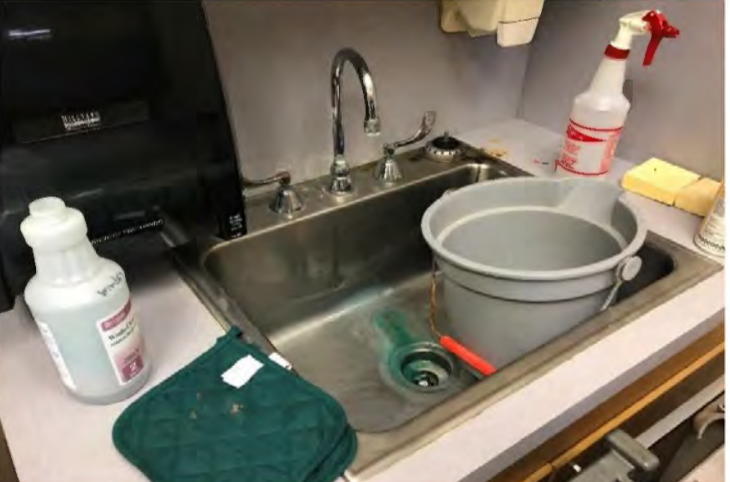
<p>Heavy calcium buildup on faucets and plumbing fixtures were observed. Softening the entire building is recommended.</p>
9

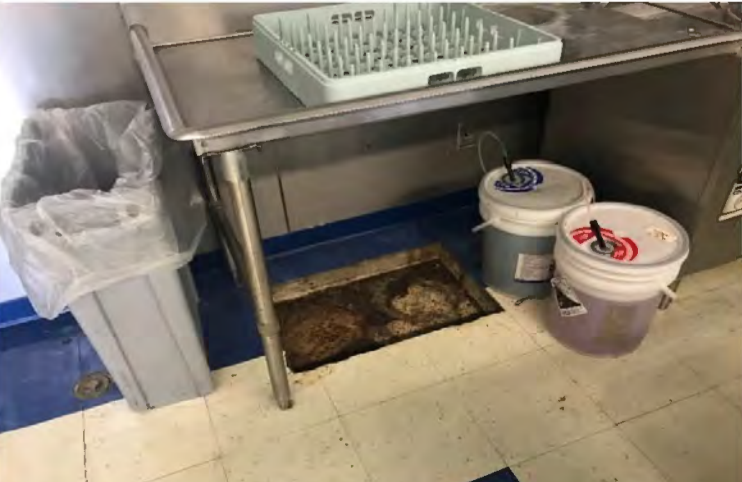
<p>Adding exterior grease interceptor with drainage from all grease generating fixtures and drains is needed per code. Interior finished surfaces need to be filled flush and sealed to accommodate proper sanitary cleaning.</p>

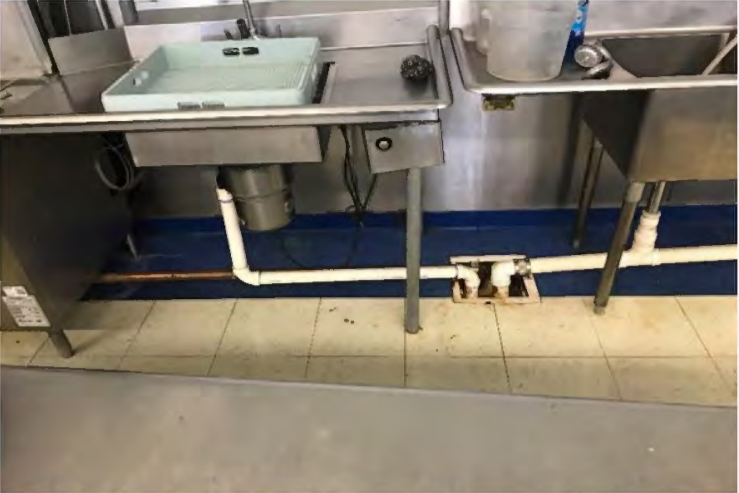
<p>Any waste from disposals must be directly connected to the sanitary waste system to comply with code. The disposal waste cannot connect to the grease waste system without a solids interceptor upstream of the grease interceptor. This photo represents a few code violations.</p>
11

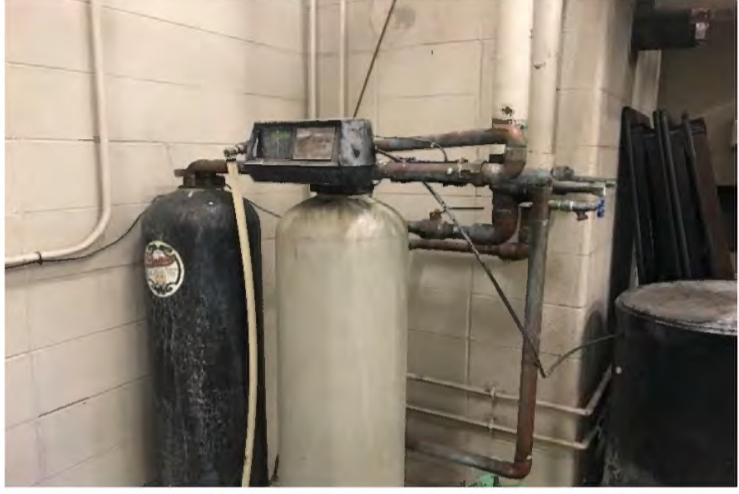
<p>The existing water softener is undersized and too old to be effective. Replace with a duplex system sized to soften the entire building.</p>
12

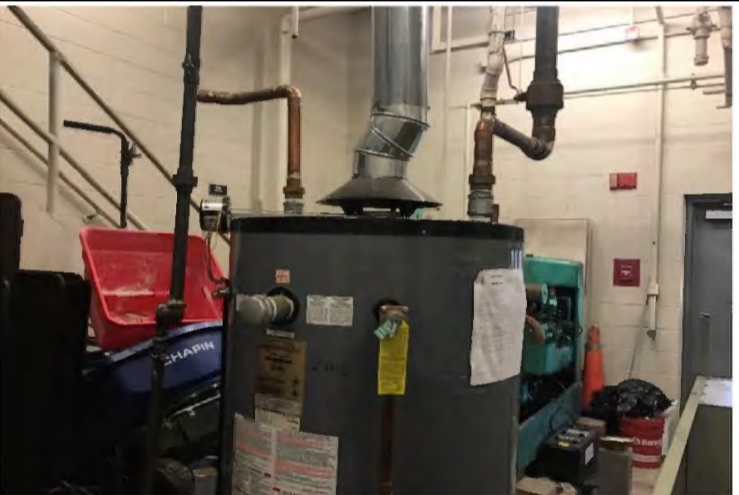
<p>The existing gas fired water heater is 10 years old and nearing the end of its life expectancy. This needs to be replaced with a high efficiency gas fired water heater and separate storage tank.</p>
13

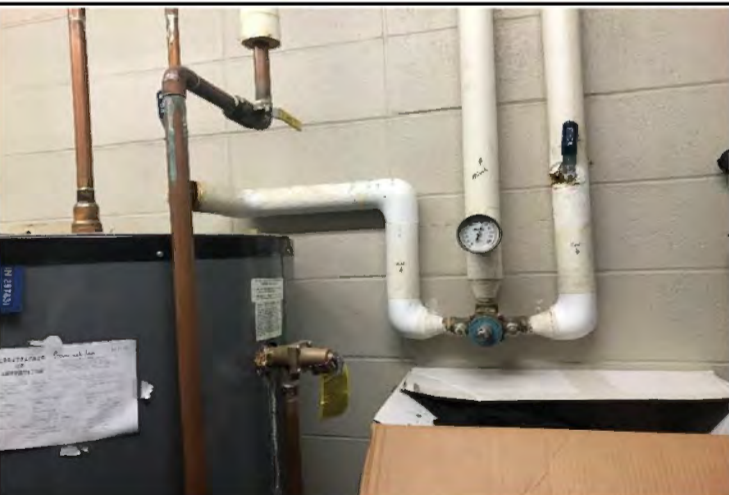
<p>The thermostatic mixing valve located at the Electric water heater serving Cosmetology was not installed with a heat trap. As a result, temperature creep is permitted as noted in the next photo.</p>
14

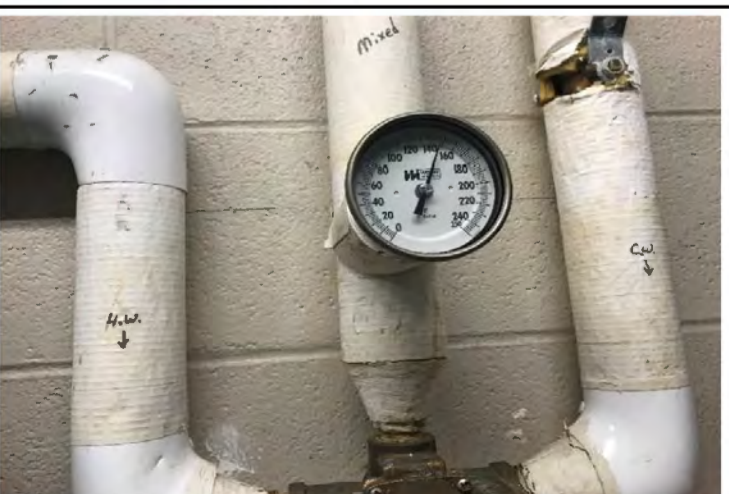
<p>The TMV delivery temperature has crept up to around 150 degrees and can scald individuals.</p>

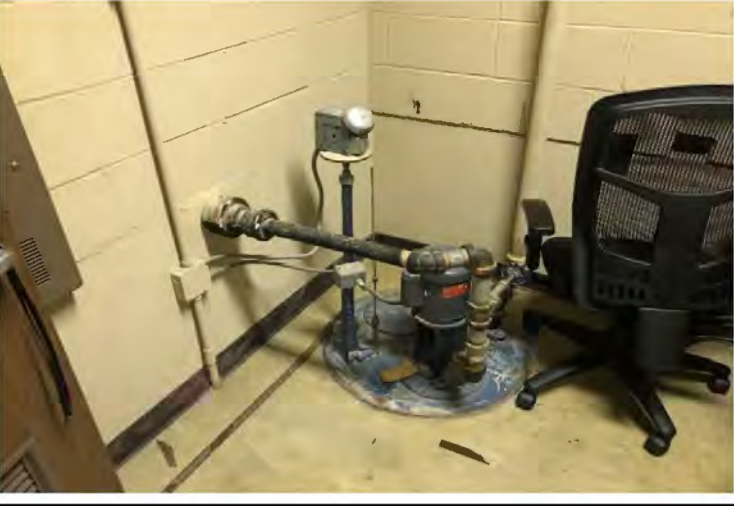
Sump pump.
16

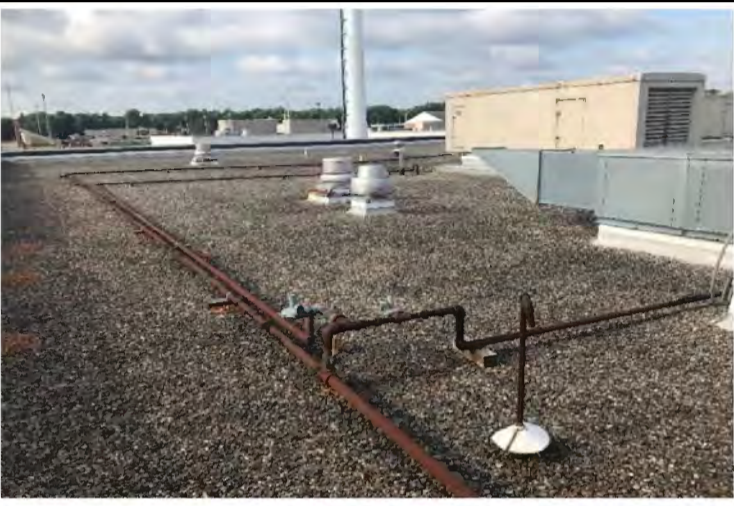
All exterior gas piping is heavily rusted.
17

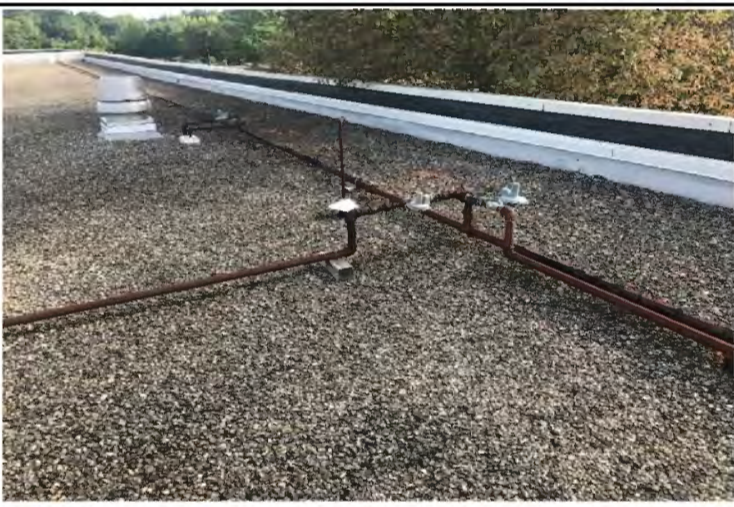
The rust from all exterior gas piping needs to be removed. The piping then needs to be painted with 1 coat of rust inhibitor and 2 coats of finish paint.
18

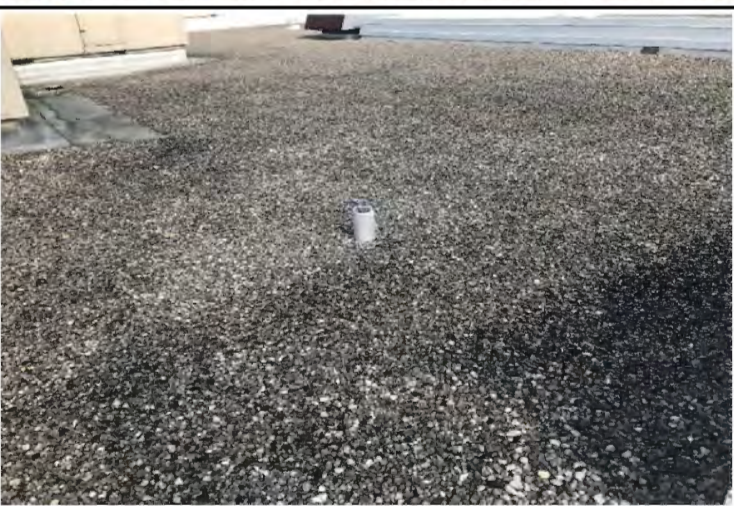
All sanitary vents need to be extended to a minimum of 12" above the finished roof.
19

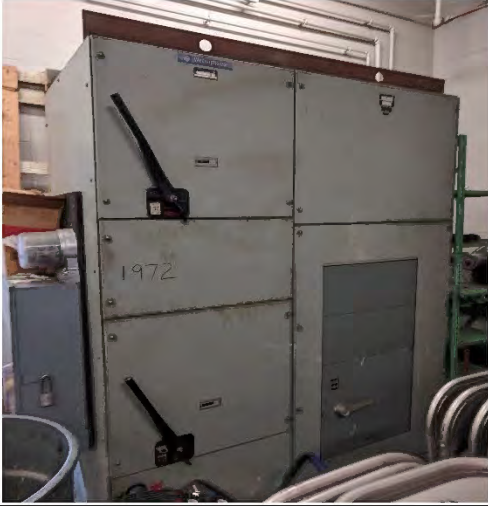
<p>1200A Service rated switchboard is at its end of life.</p>
3

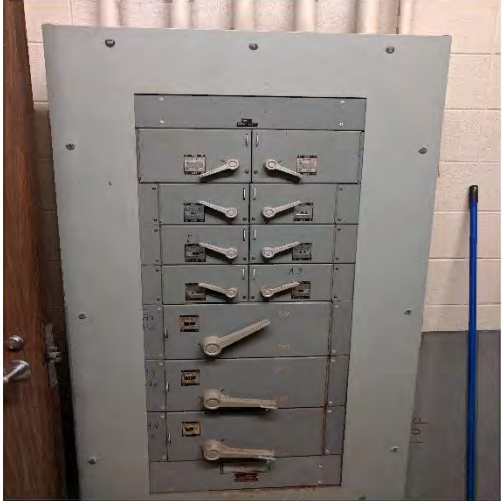
<p>(3) 600A distribution boards are at the end of their lives.</p>

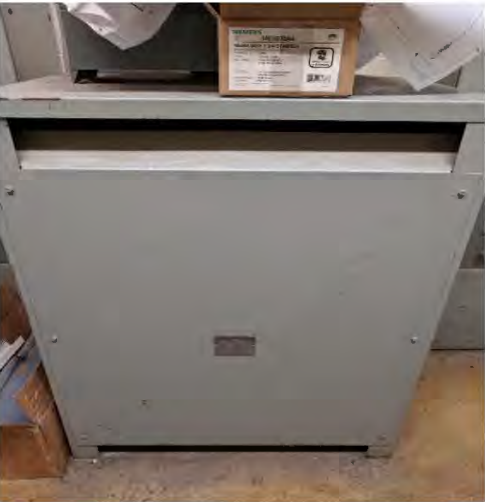
<p>(1) 300KVA and (1) 225KVA transformer are at the end of their lives.</p>
6

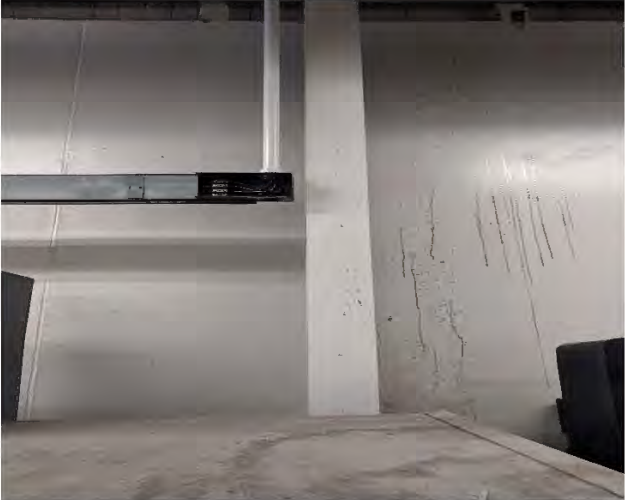
<p>Exposed wiring in the bus duct.</p>
7

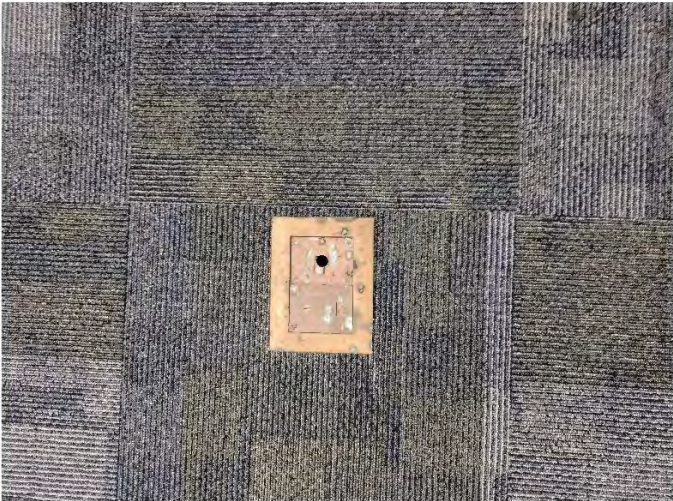
<p>Floor boxes in various rooms are at the end of their lives.</p>
8

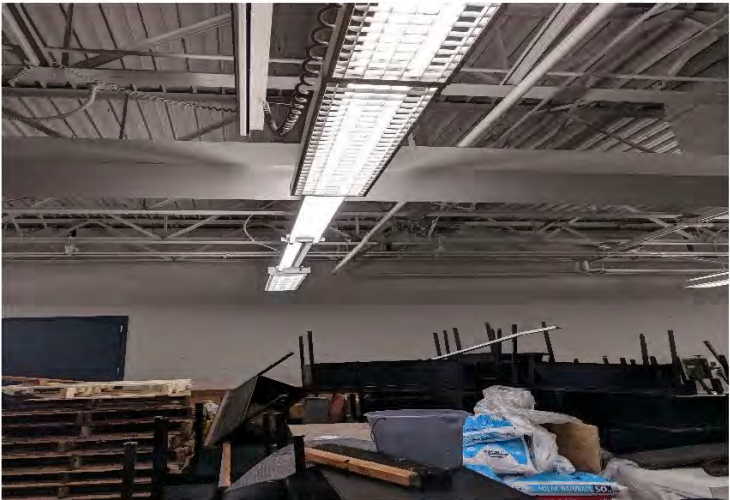
<p>Damaged light fixtures in Receiving H-328.</p>

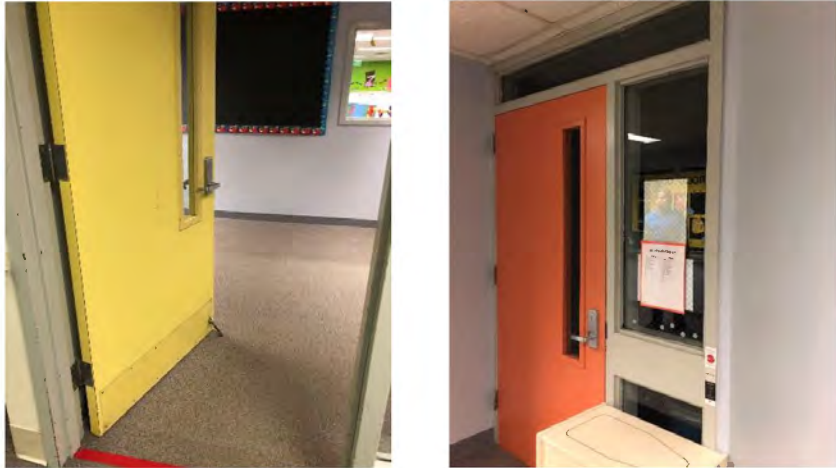
<p>Variety of laminated colors and lite styles on the doors. Some existing doorknobs, which are not accessible.</p>
3

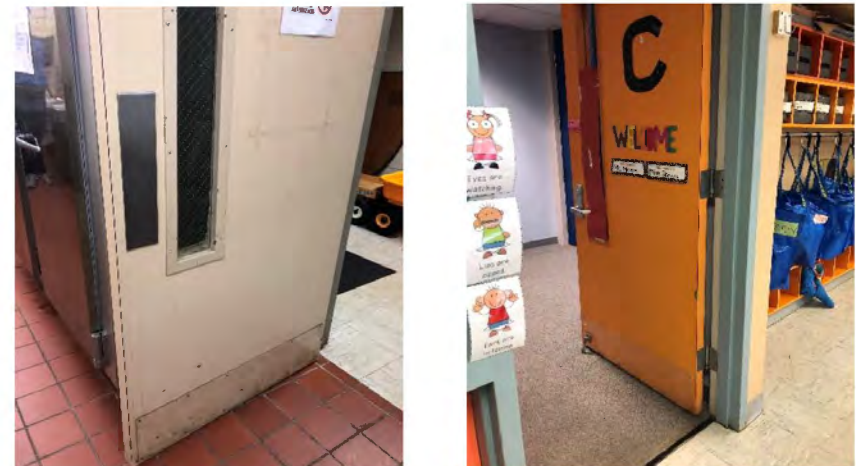
<p>Variety of laminated colors and lite styles on the doors. Some existing doorknobs, which are not accessible.</p>
4

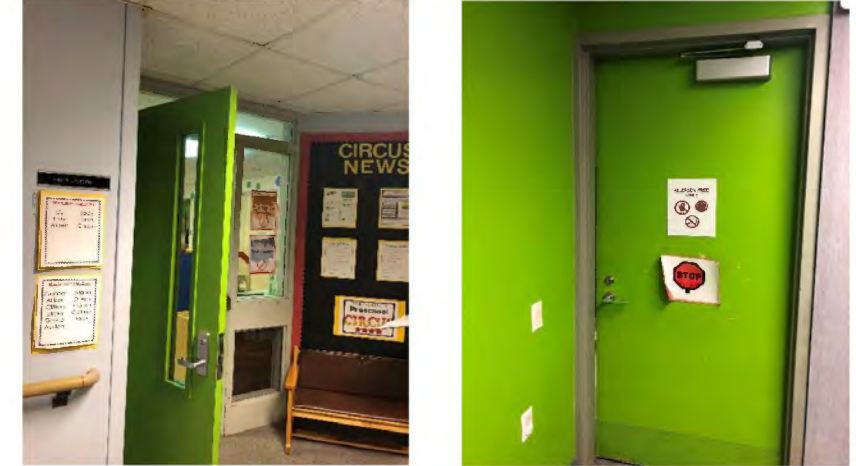
<p>Variety of laminated colors and lite styles on the doors. Some existing doorknobs, which are not accessible.</p>

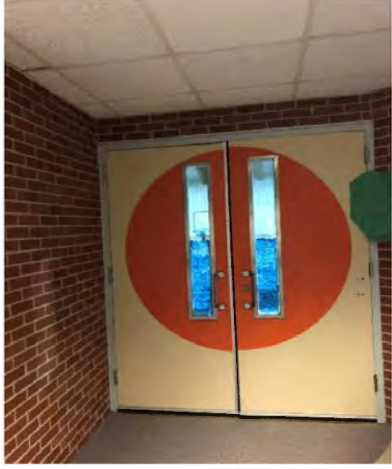
<p>Variety of laminated colors and lite styles on the doors. Some existing doorknobs, which are not accessible.</p>
7

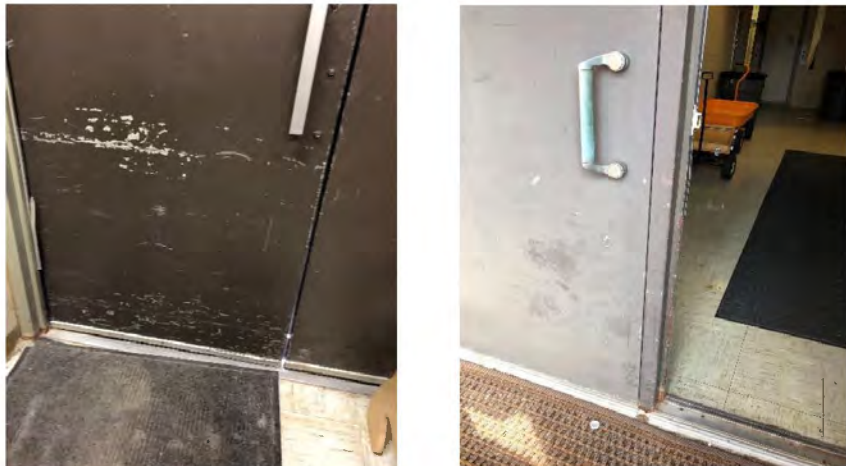
<p>Rust and corrosion on exterior doors.</p>

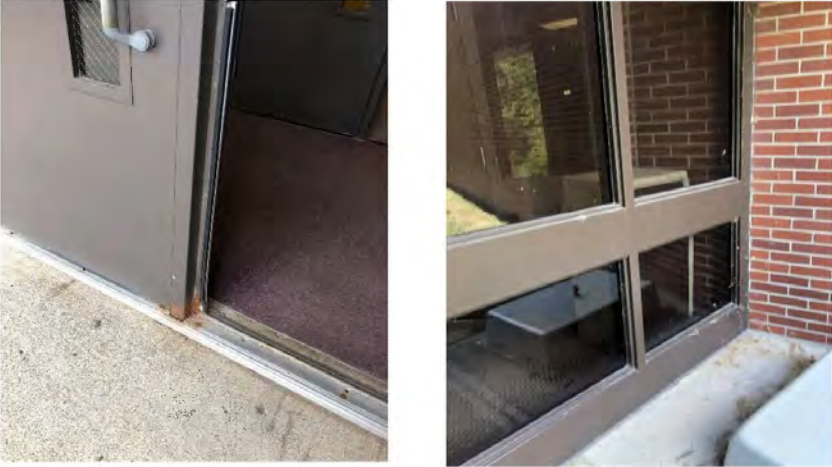
Rust and corrosion on exterior doors.
11

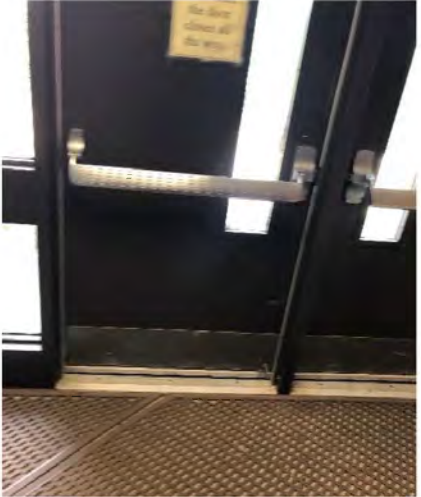
Rust and corrosion on exterior doors.
12

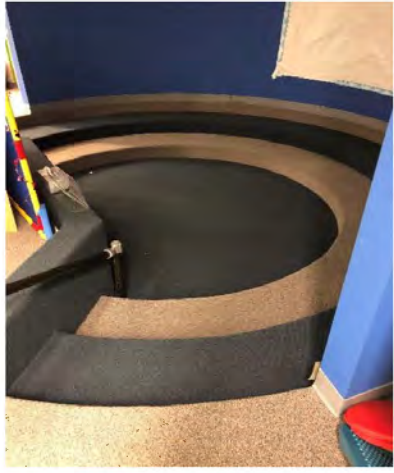
Reading pit in the classroom is not accessible.
21

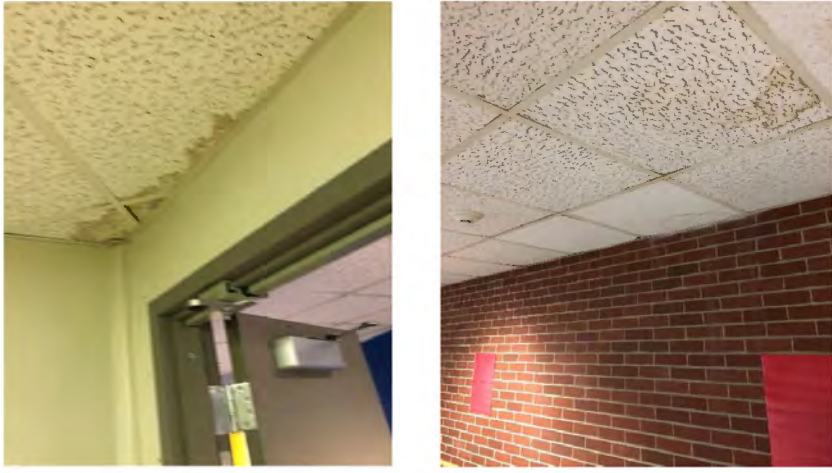
Water damage to ceiling tiles.
22

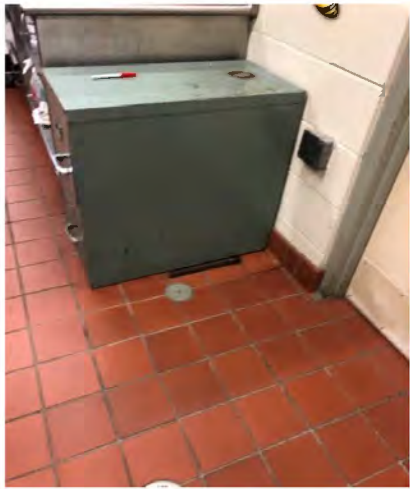
Mismatched floor tile patches.
27

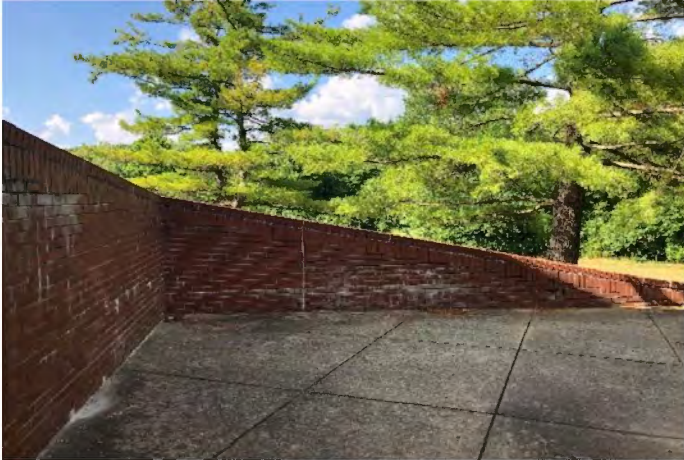
Efflorescence on the existing retaining walls.
28

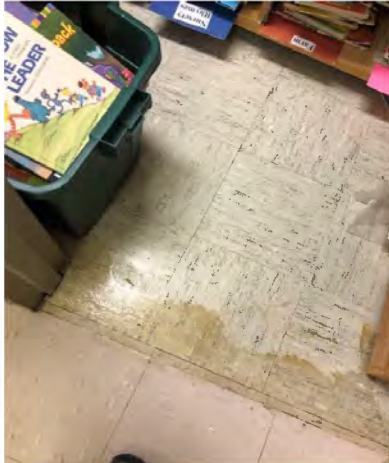
Floor tile is old and damaged.

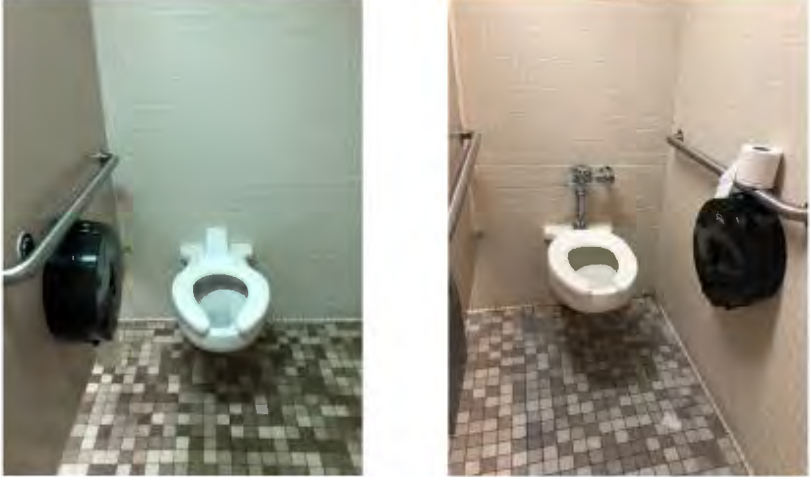
Accessible stalls do not have the current code required grab bars at the rear or an 18" vertical. Existing restroom layouts and clearances do not meet current code requirements.
32

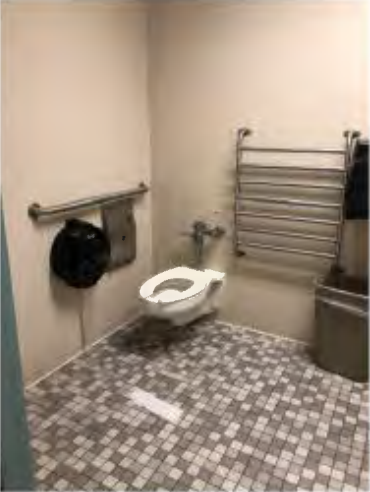
Accessible stalls do not have the current code required grab bars at the rear or an 18" vertical.
33

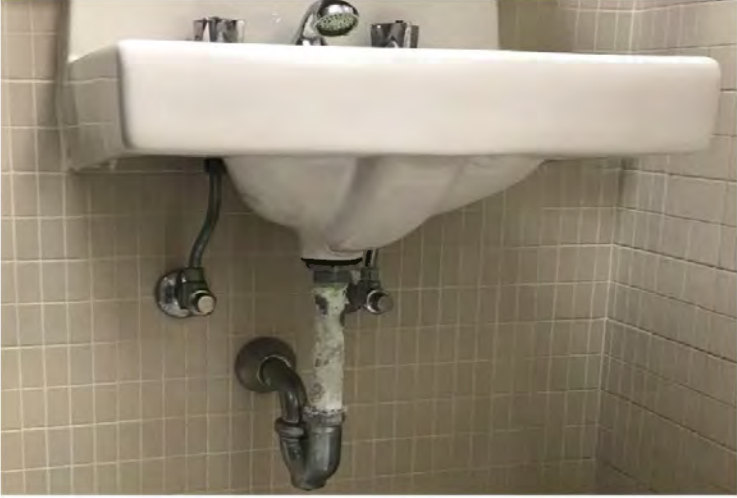
Heavy corrosion buildup on drain pipe.
6
