WASHINGTON
TOWNSHIP SCHOOLS

Secondary School Master Plan

SECONDARY SCHOOL FACILITY CONDITION ASSESSMENTS

EXISTING CONDITIONS ASSESSMENT SUMMARIES

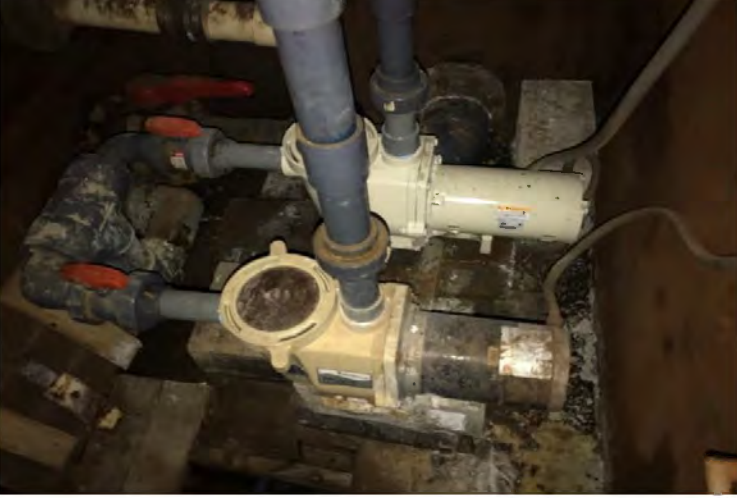
Pool pumps are outdated and in poor condition.
7

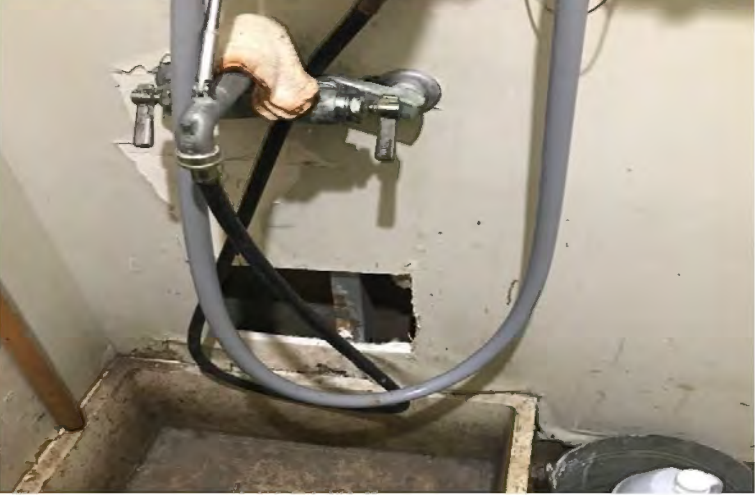
The wall is compromised and allowing water to buildup within the cavity.
8

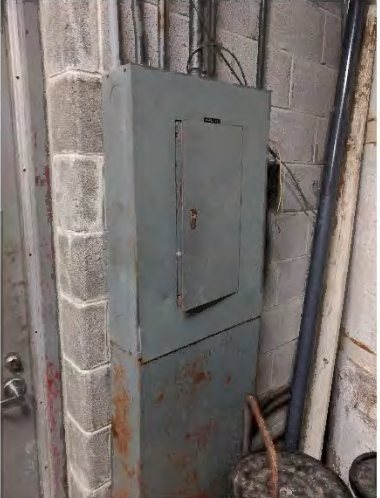
<p>(1) 400A, (2) 225A and (4) 100A Square-D panelboards located throughout the building are at the end of their lives.</p>
2

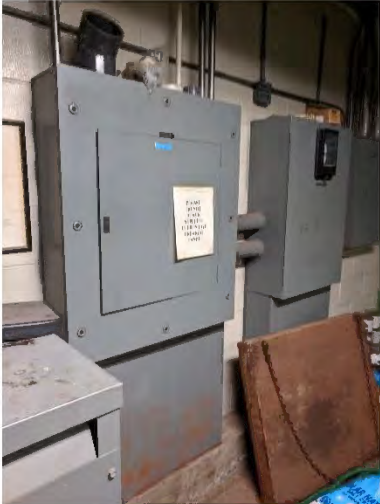
<p>600A Service rated switchboard is at its end of life.</p>
3

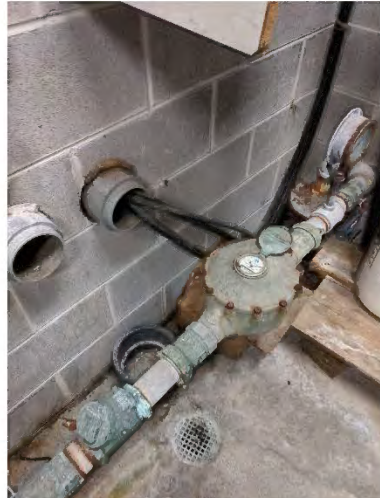
<p>Exposed secondary conductors.</p>
4

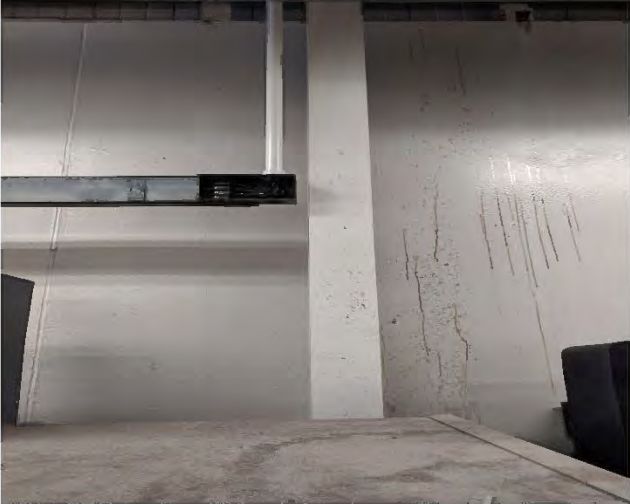
<p>Exposed wiring in the bus duct.</p>

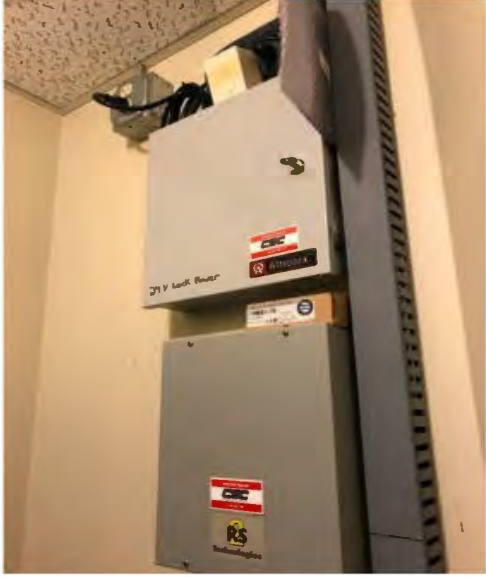
CSC security panel enclosures found in the MDF closet in the building.
13

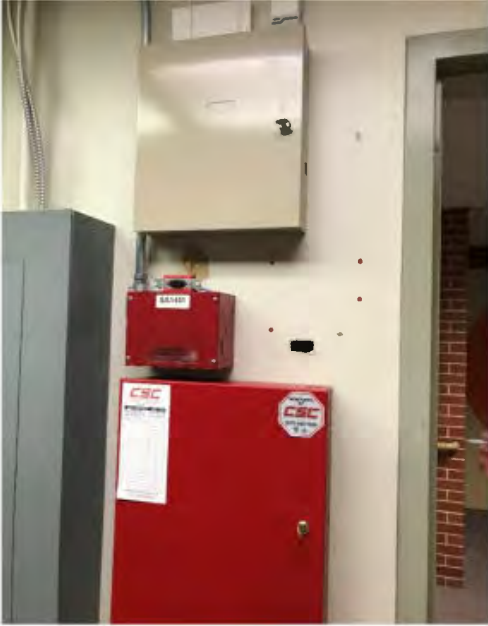
CSC fire alarm control panel found in the book storage room in the building.
14

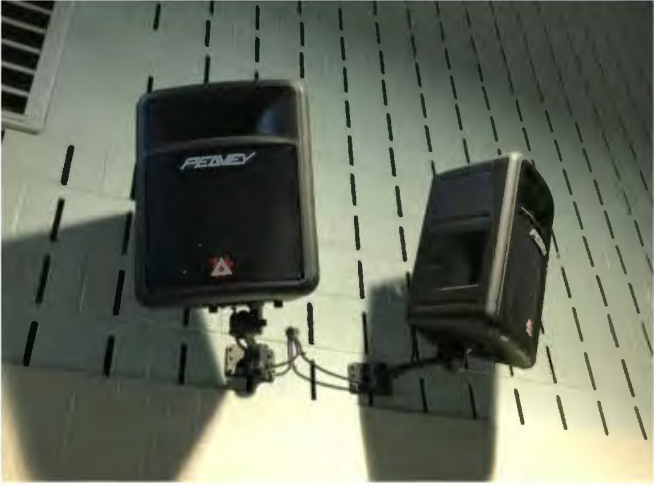
Wall mounted speakers located in the pool room in the building.
15

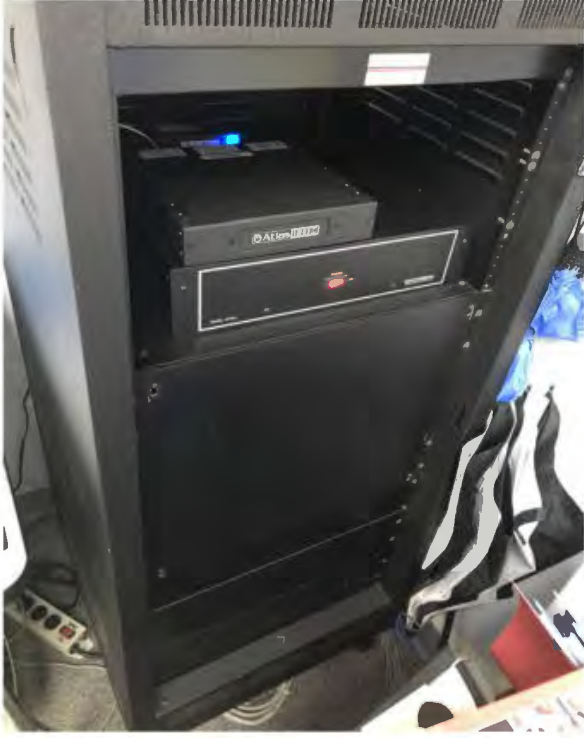
Paging and clock system rack located behind the reception desk in the main entryway.

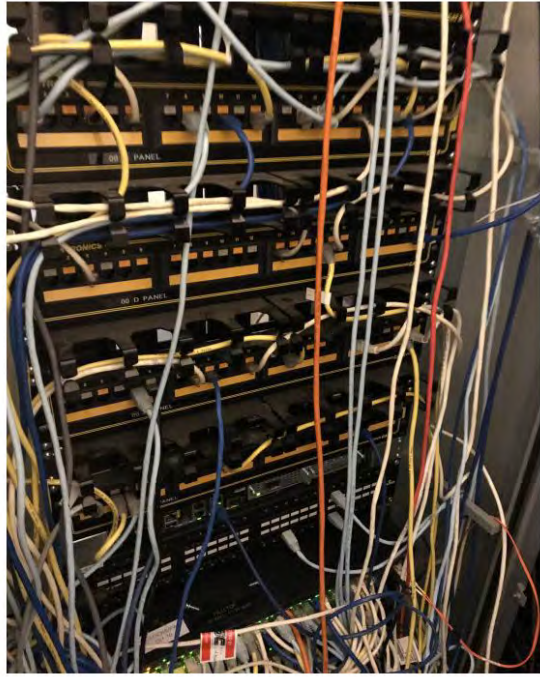
MDF location in Hilltop Developmental Preschool.

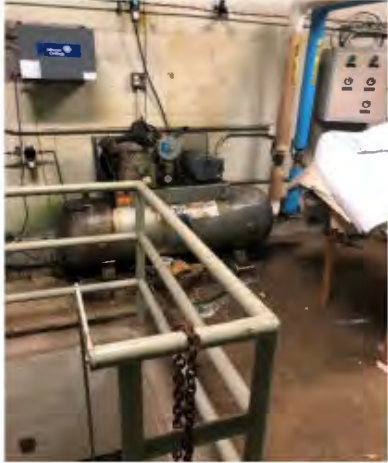
<p>Compressor and unused control panel that need proper demolition and upgrade to DDC control.</p>
3

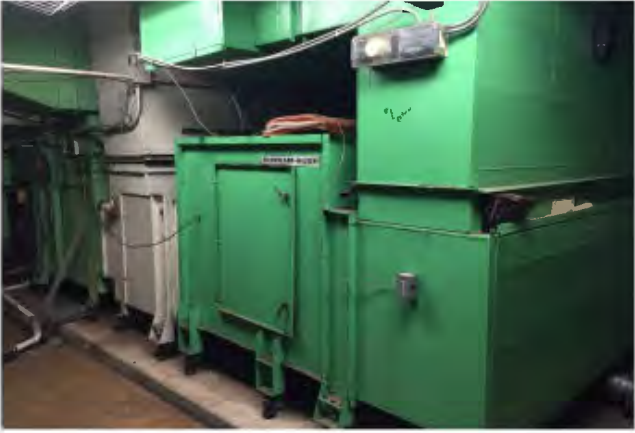
<p>Mechanical equipment needs replaced before putting new controls on the old equipment.</p>
4

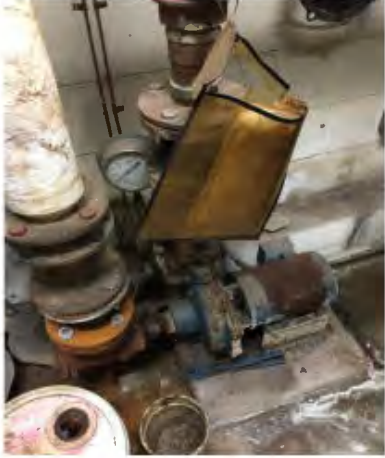
<p>Hydronic Pump that needs replaced before putting new controls on the old equipment.</p>
5

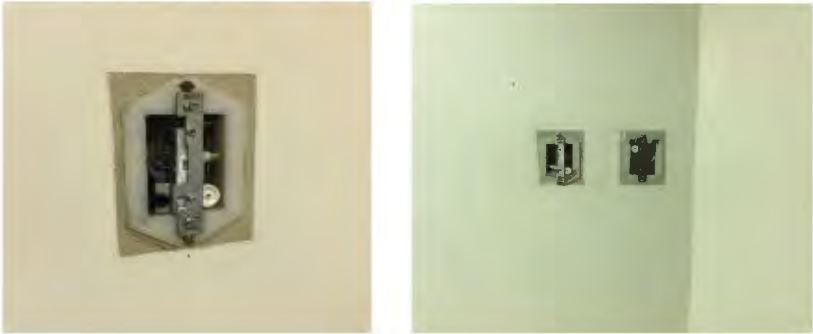
<p>Most pneumatic stats have their covers removed and should be replaced with DDC thermostats.</p>

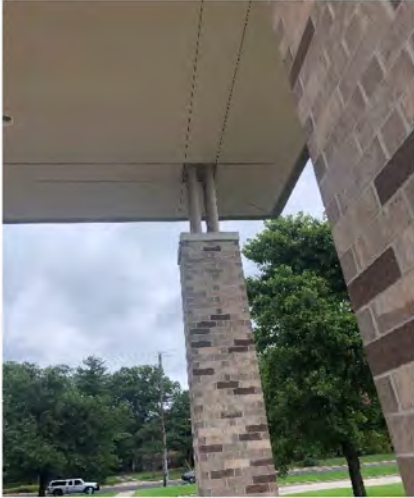
<p>Paint finish on exterior metal needs cleaned and new coatings.</p>
2

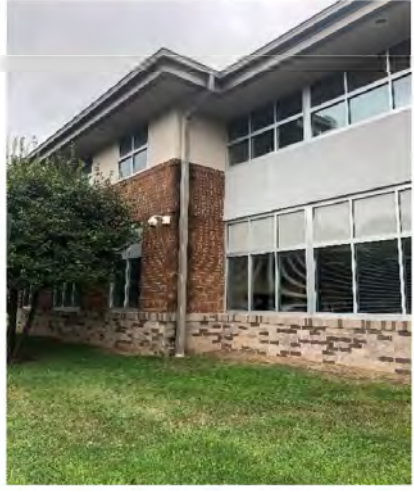
<p>The brick wall surface behind downspouts is holding water. There are no exterior door numbers.</p>
3

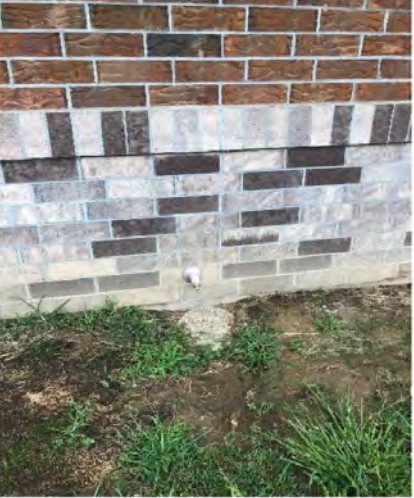
<p>Splash block at condensation line or old hose bib.</p>
4

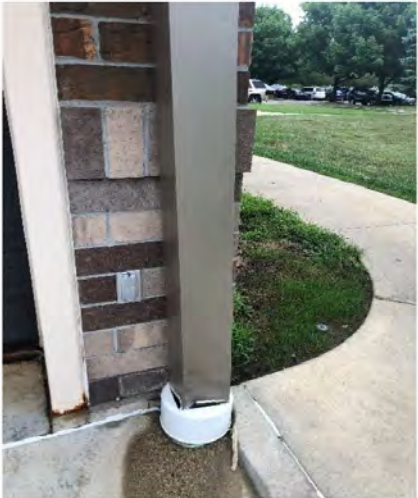
<p>The downspout to boot connection is not sealed. There's rust at the adjacent hollow metal frame.</p>

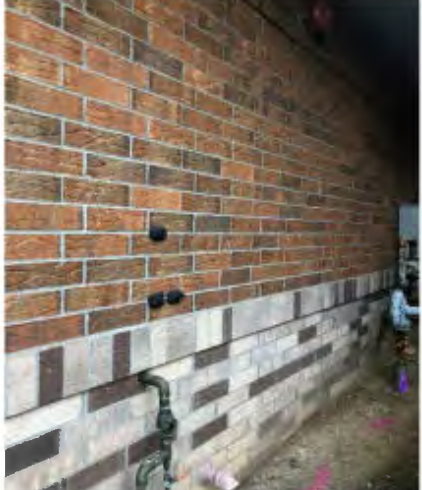
<p>Pipe connections on existing wall are sealed and abandoned.</p>
7

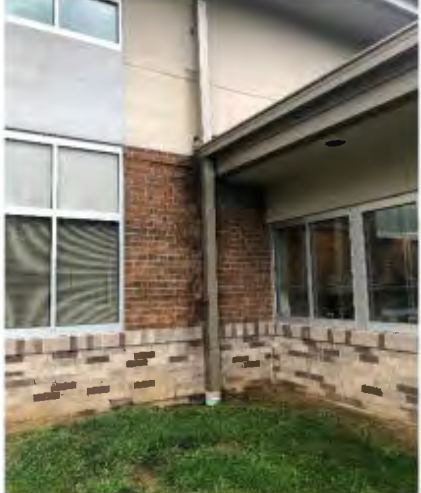
<p>There are water issues at the downspout to gutter connection.</p>
8

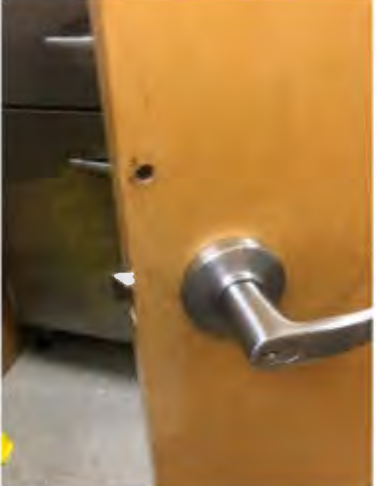
<p>Damaged wood door.</p>

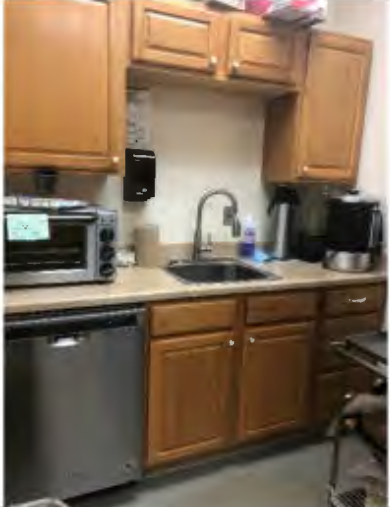
Residential grade kitchenette. The counter is not at an accessible height.
11

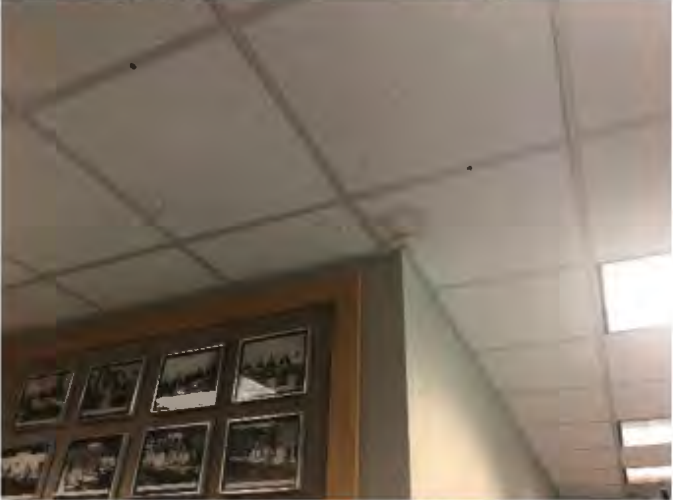
Water damage to ceiling tile.
12

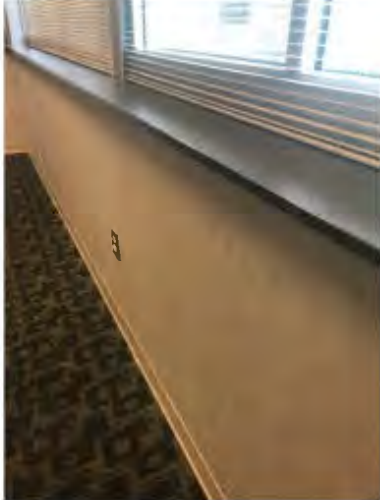
Worn wall covering in the Board Room.
13

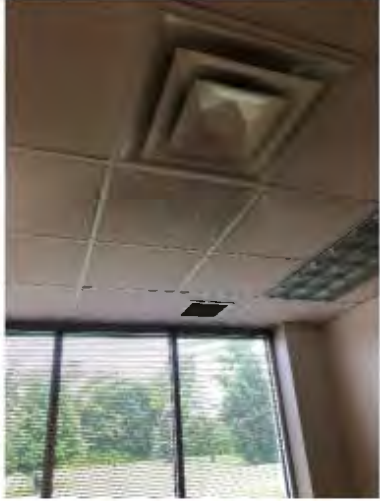
Diffuser stains on ceiling tile in the Break Room.
14

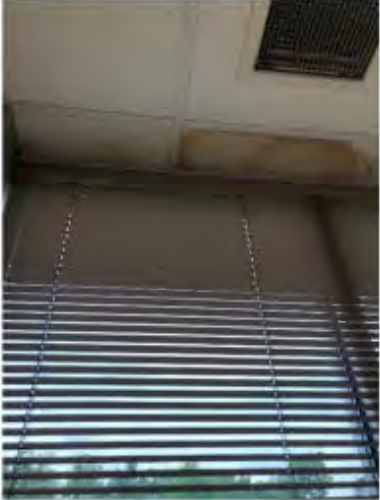
Water damage to ceiling tile.

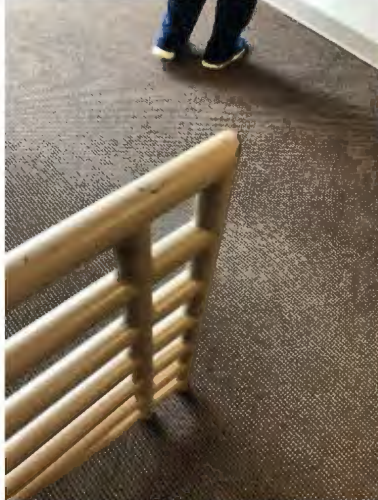
Finish on hand and guard rails is wearing. This is typical.
17

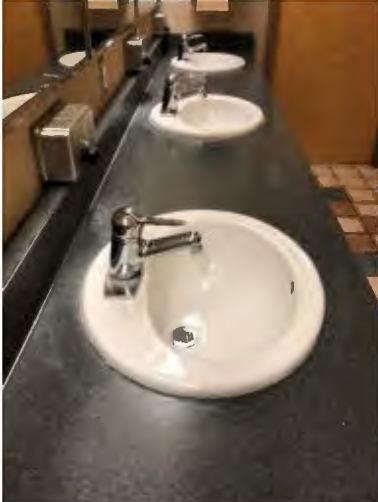
The solid surface counter top is fading. This is typical on the staff side. Abandoned waste recepticals.
18

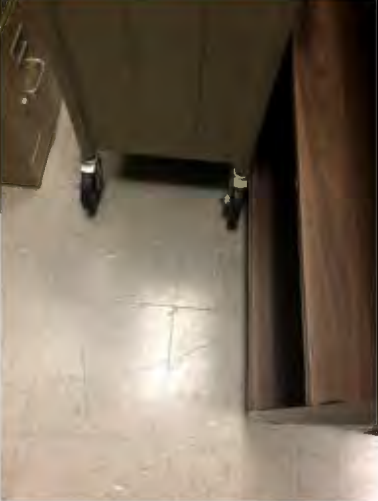
Cracks in the vinyl floor tile and a hole in the gypsum board behind the door to the janitor's closet.
19

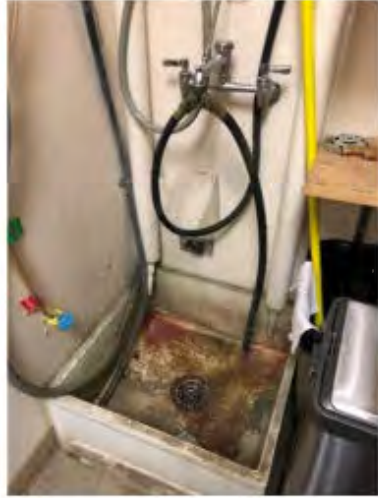
There's build-up and wear on the mop sink. There's damage to the walls surrounding the mop sink.

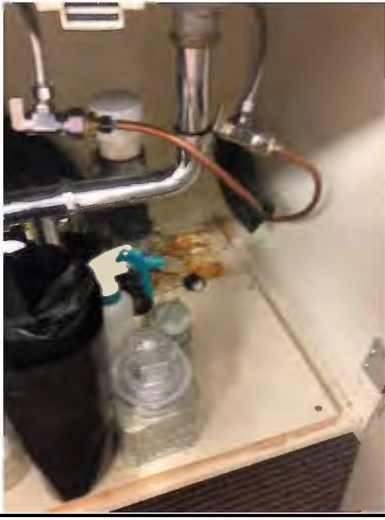
<p>Damage and corrosion under sink base in the Media Services/Technology area. It is hard to control the temperature of spaces near windows.</p>
21

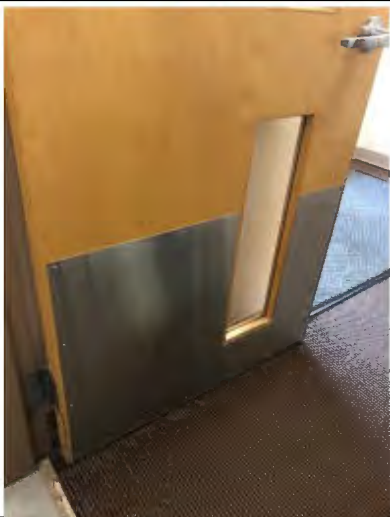
<p>Improper location for sidelite.</p>
23

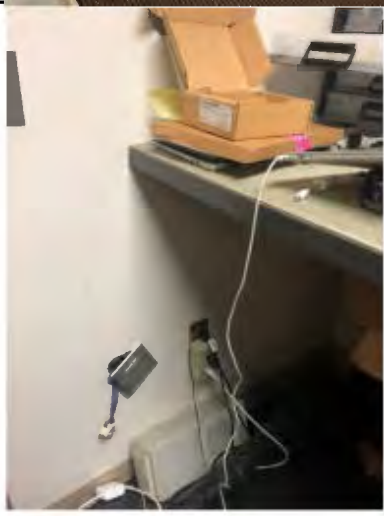
<p>Improper plate mounting/type.</p>
24

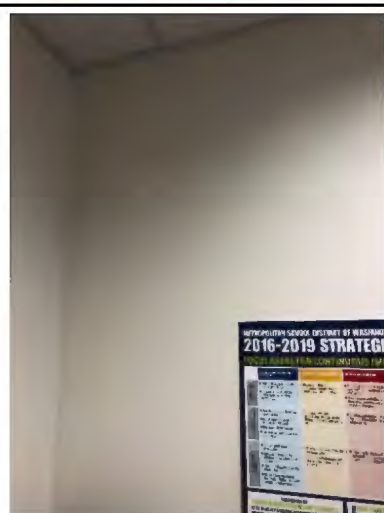
<p>There's a crack in the wall. It's hard to control the temperature in room. Operations.</p>

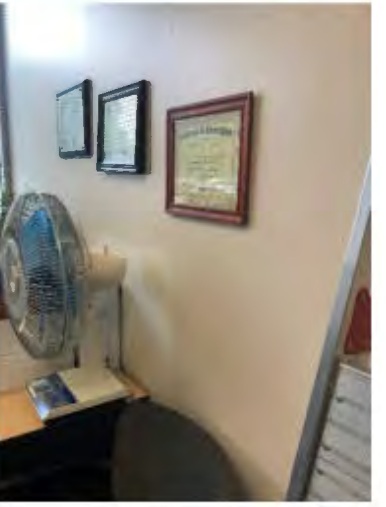
An area of wall that is unpainted.
28

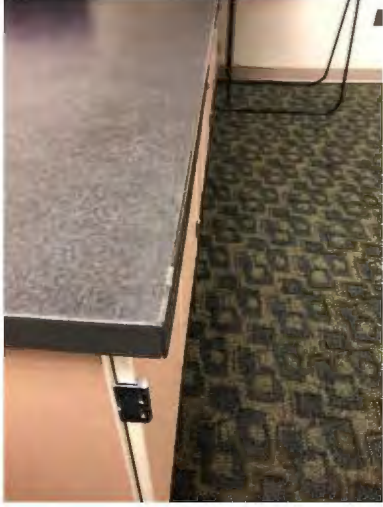
<p>Edgebanding is delaminating from the counter top in the 2nd floor Meeting Room.</p>
31

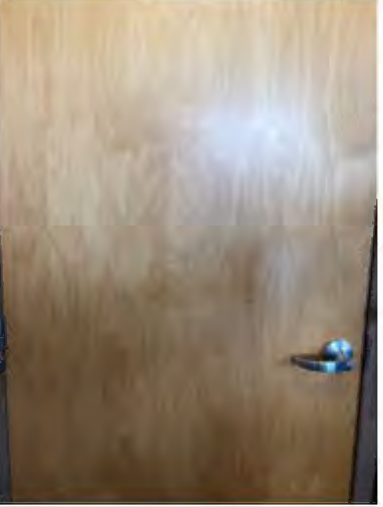
<p>Damage to the surface of the door.</p>
32

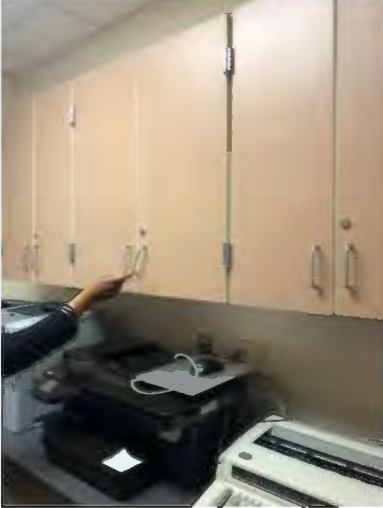
<p>A loose pull on casework.</p>
34

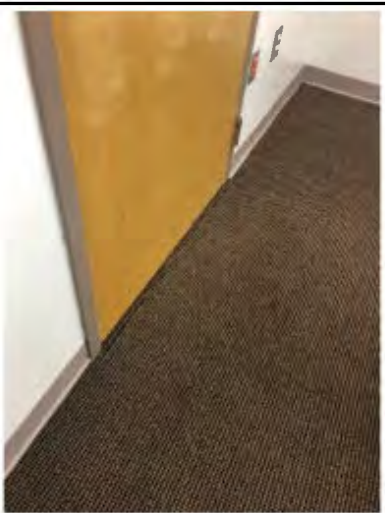
The carpet is worn at the door threshold.
37

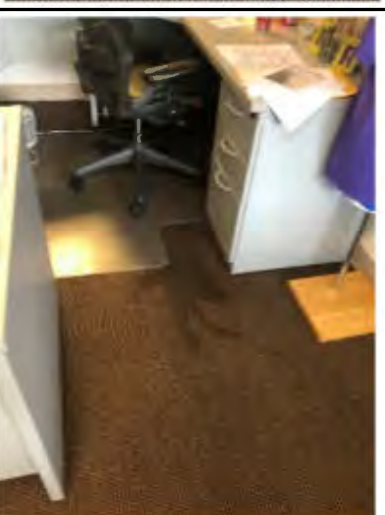
Damaged carpet.
38

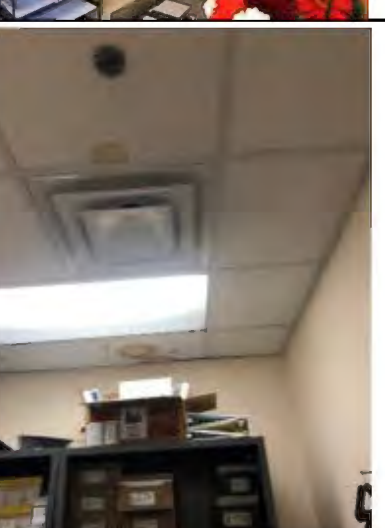
Damaged ceiling tile.

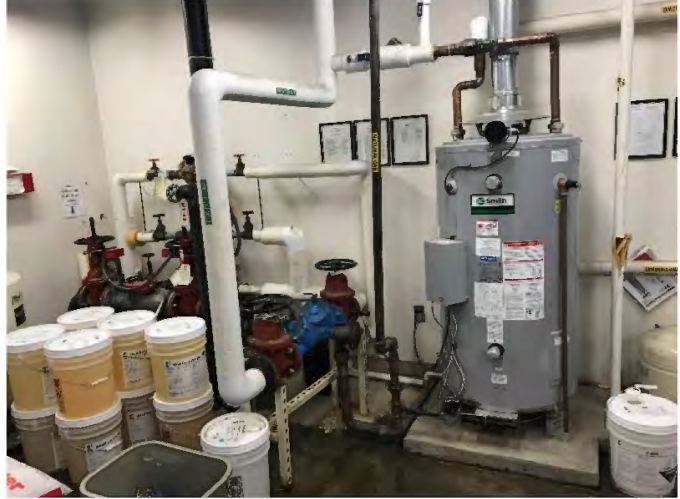
<p>The water service entrance with pressure in excess of 110 PSI is downstream of backflow preventers. Gas fired water heater is in fair condition.</p>
2

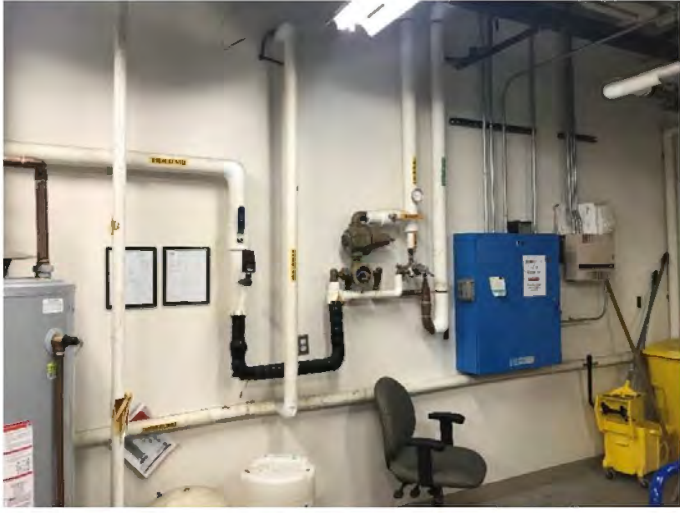
<p>The pressure regulator on the hot water system will be removed when the master pressure regulator is installed on upcoming service.</p>
3

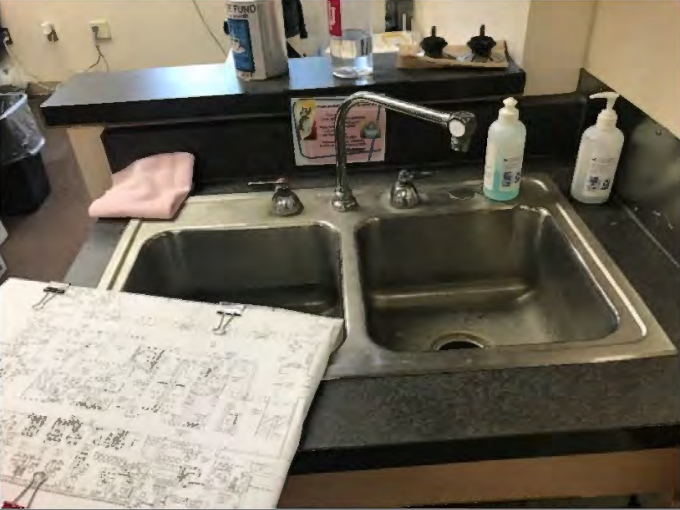
<p>Heavy water calcium buildup on plumbing fixtures.</p>
4

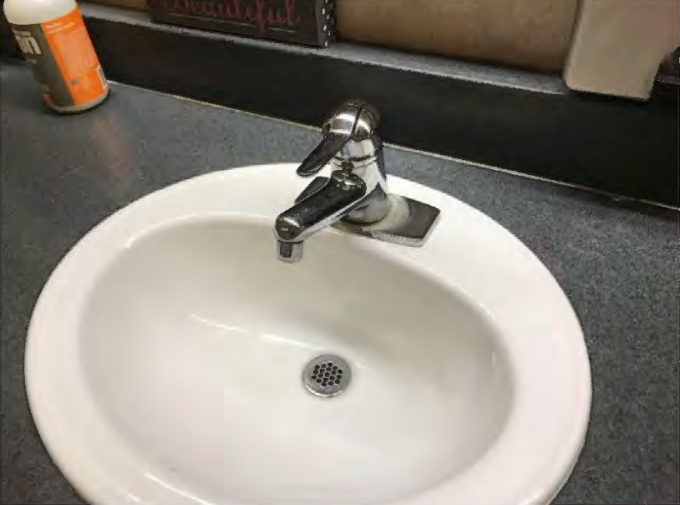
<p>Heavy calcium buildup on faucet.</p>

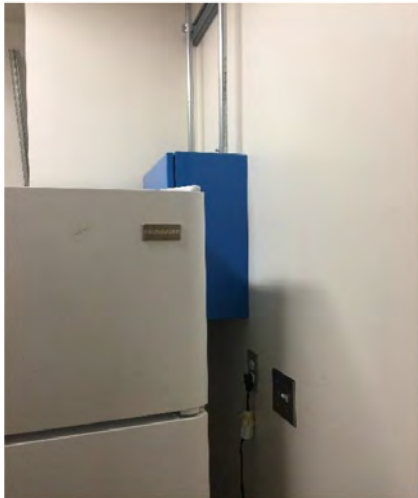
Control panel is blocked by the refrigerator.
2

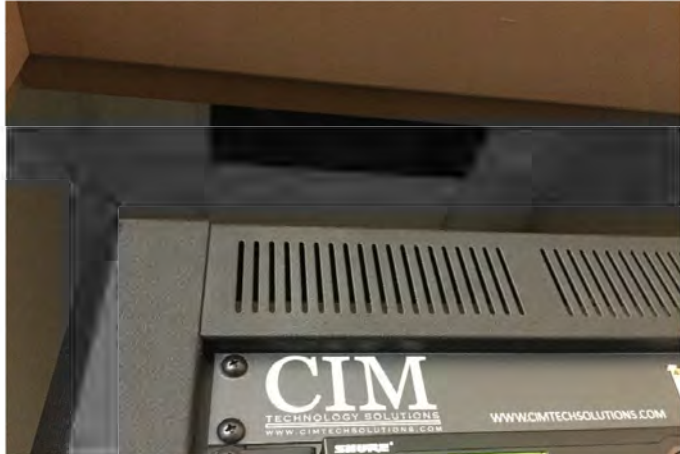
Board room technology closet is without supply or exhaust air; tile removed to allow heat to escape to the plenum.
3

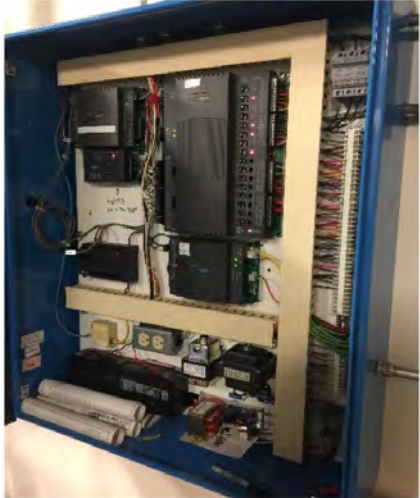
bCX and i2 920 controller that should remain if equipment is upgraded.

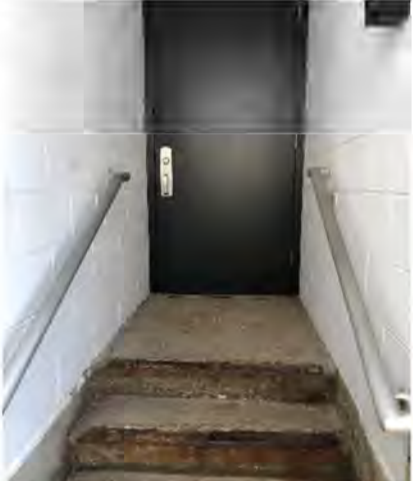
Exterior door has no clearance at the pull side of the door. The metal nosings in the steps are rusting.
3

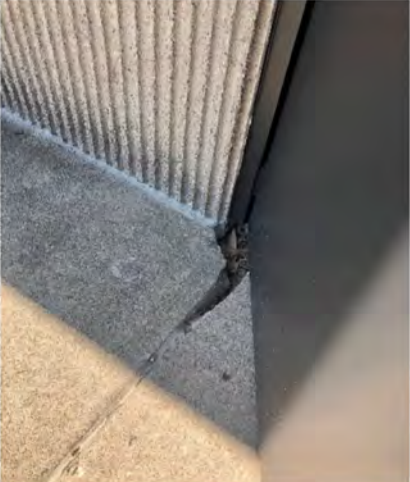
Concrete is damaged and cracking at the exterior door.

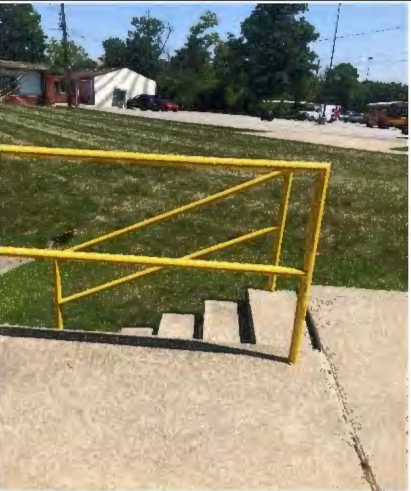
Concrete steps are pulling away from the concrete landing.
6

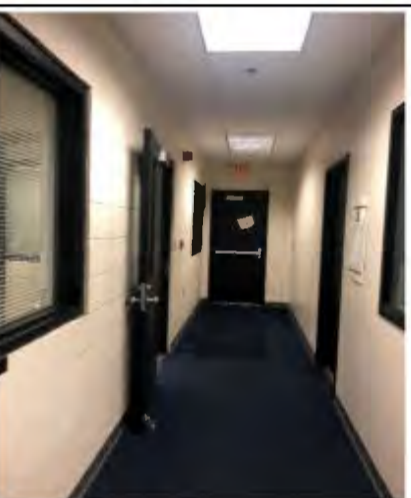
Clearances in hallway do not meet current code.
8

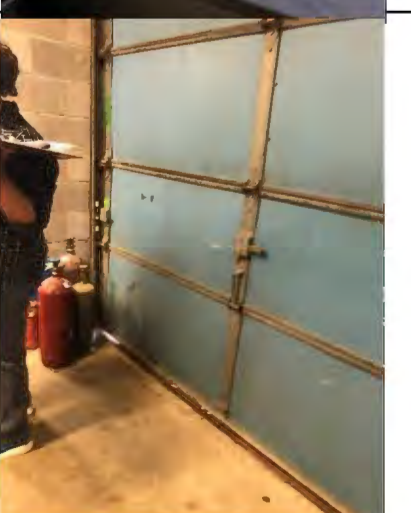
Overhead doors are rusted and corroded.

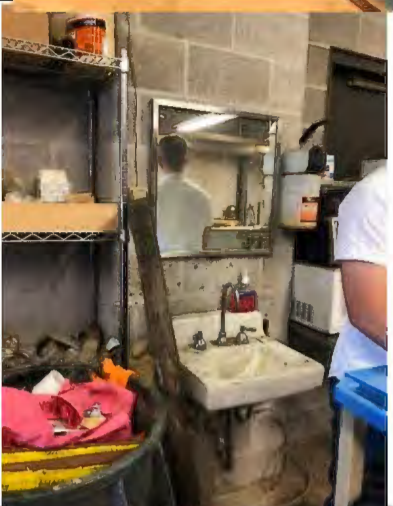
<p>The sink is well-used and worn.</p>
11

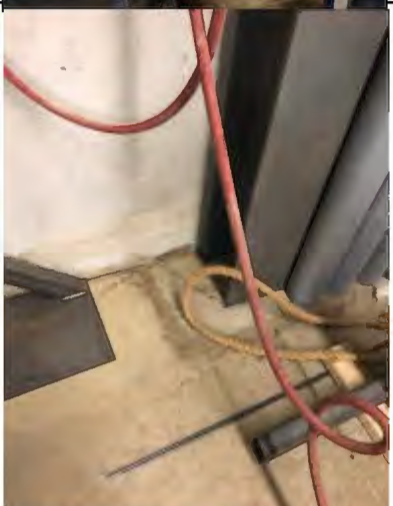
<p>Cracking in concrete slab at the column.</p>
12

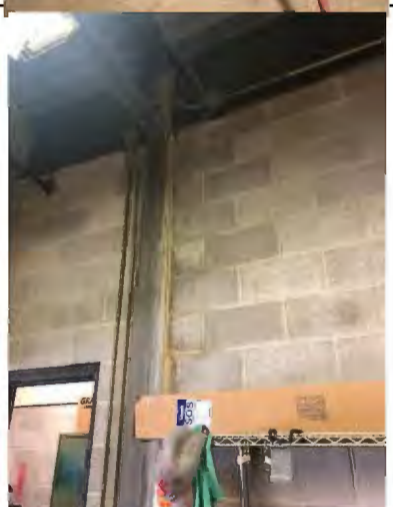
<p>Water damage to the wall and column paint finish.</p>
13

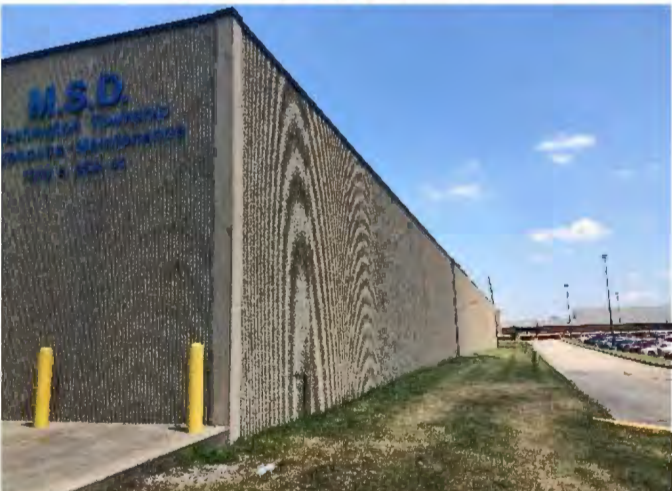
<p>Rust streaks on precast concrete panels.</p>
14

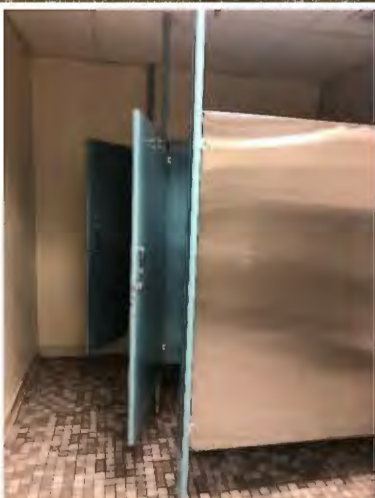
<p>Partitions are different materials. Restroom stalls are not accessible. The pathway to restrooms is not accessible.</p>

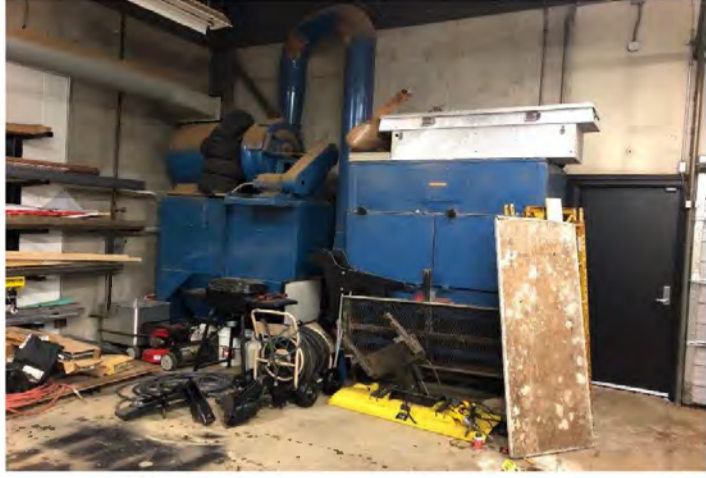
Dust Collector.
2

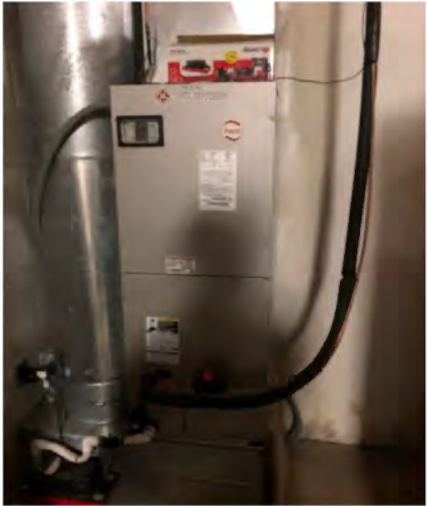
Residential Furnace.
3

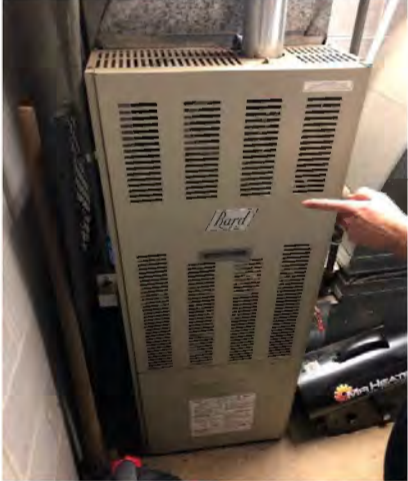
Residential Furnace.
4

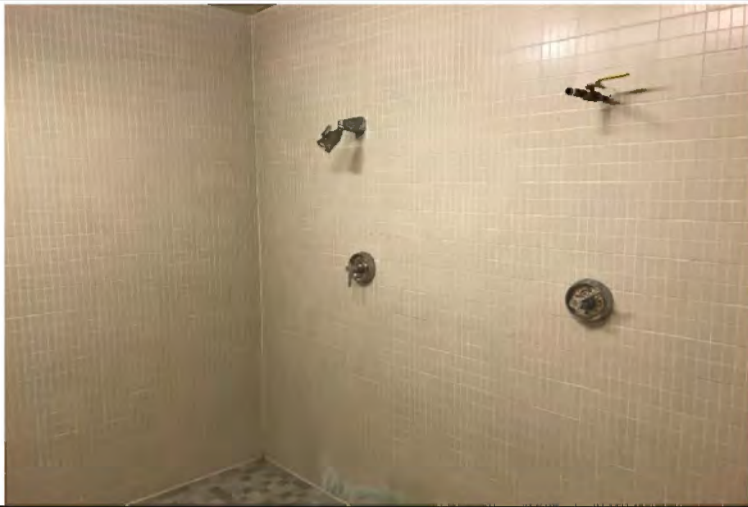
<p>Showers with a modified outlet.</p>
2

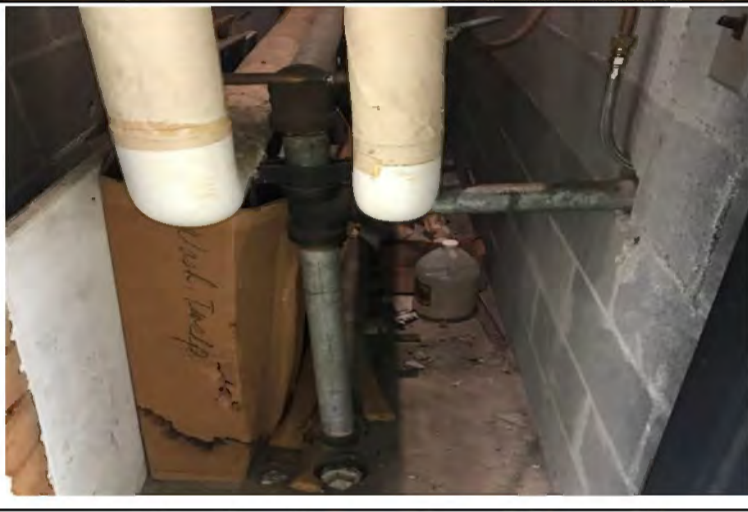
<p>Galvanized waste piping within plumbing chase.</p>
3

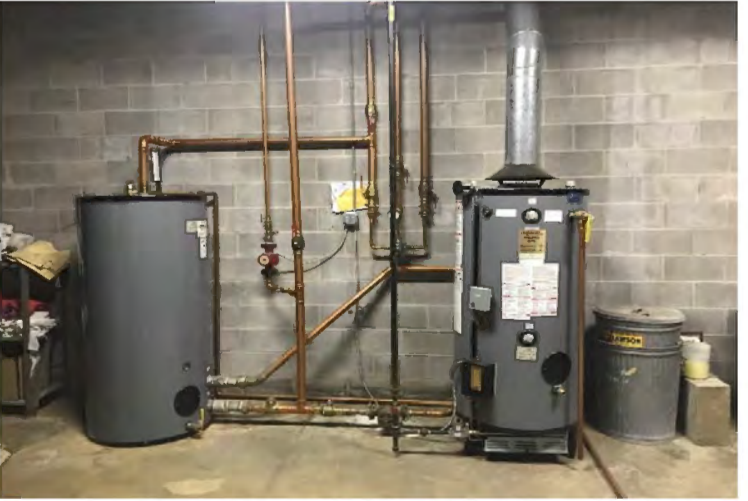
<p>Domestic piping should be insulated, and TMV should be piped with a heat trap.</p>

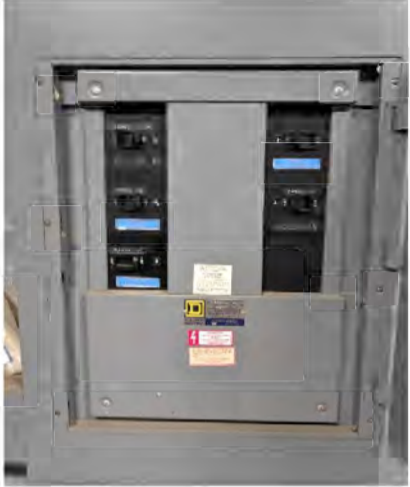
<p>600A Service rated switchboard is at the end of its life.</p>
2

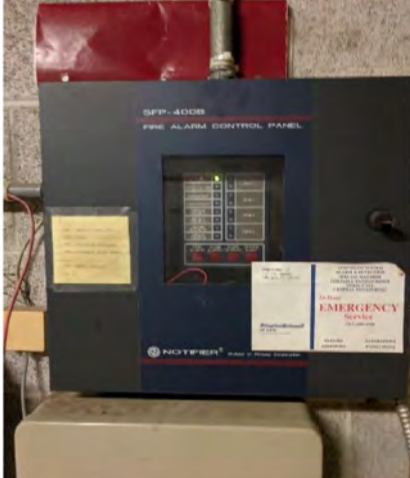
<p>Notifier SFP-400B (Vintage 1995) is at the end of its life.</p>

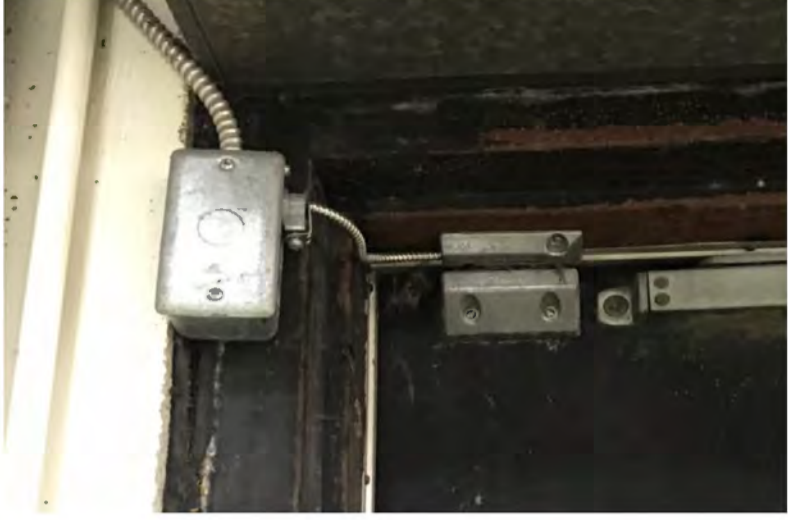
<p>Typical door contact sensor location. The sensor is found on nearly every door and garage door in the Operations building.</p>
2

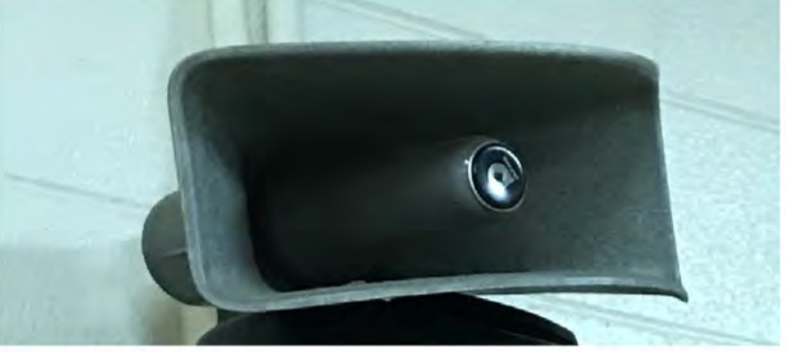
<p>Typical wall mounted paging speaker location. Speakers were more common in the warehouse, but spread throughout random rooms as well.</p>
3

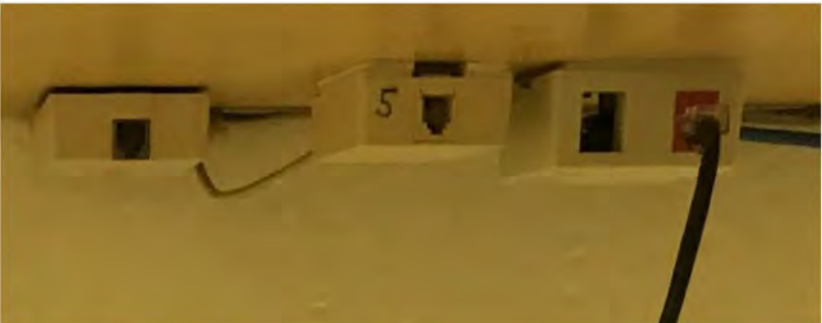
<p>Data voice location found randomly in the warehouse and typically one per room in the offices and dedicated work spaces. These instances are typically mounted on the wall, however none of the locations were flush with the wall.</p>
4

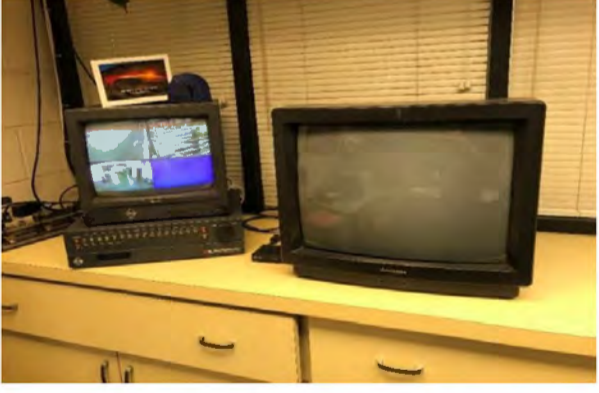
<p>Monitors used for security camera monitoring. The only other instance of a monitor in the warehouse was also of a similar type, obviously old and discontinued.</p>
5

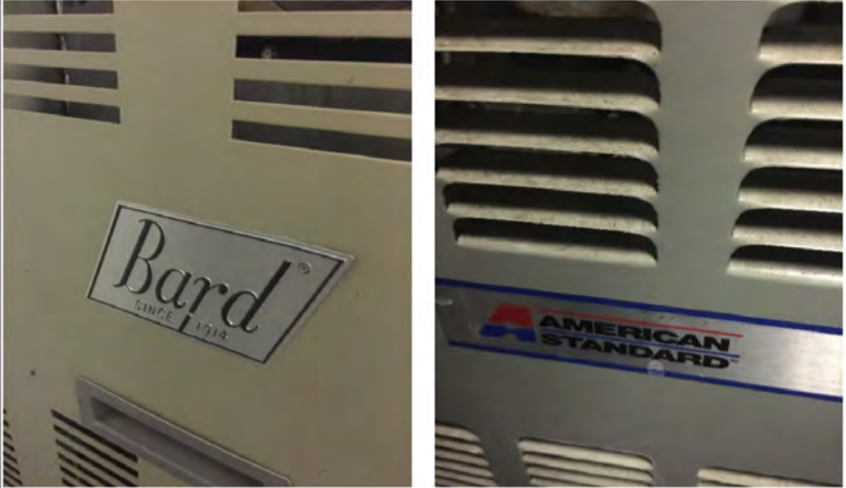
Residential style furnaces that are not monitored via the BMS.
2

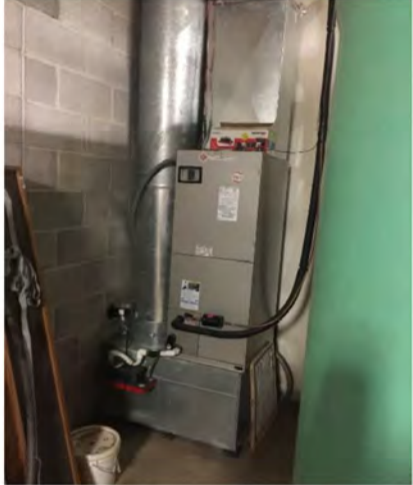
Residential style furnace that is not monitored via the BMS.

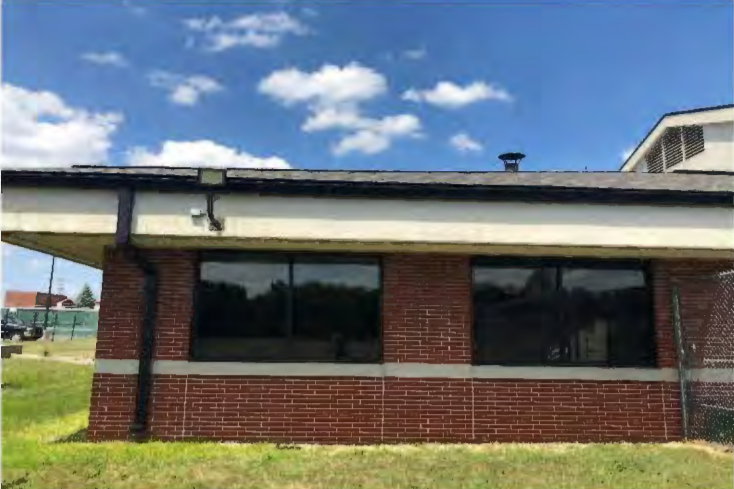
Fascia and siding need paint.
6

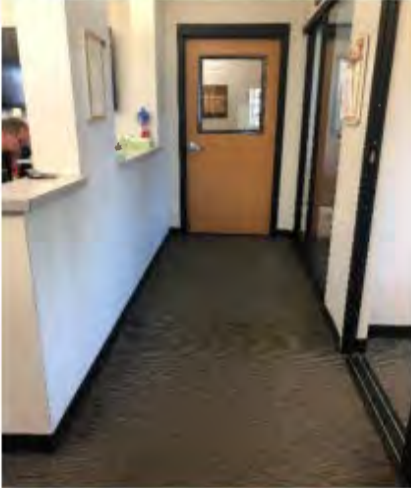
Clearance at doors does not meet current accessibility requirements. Clearance into offices is too narrow.
7

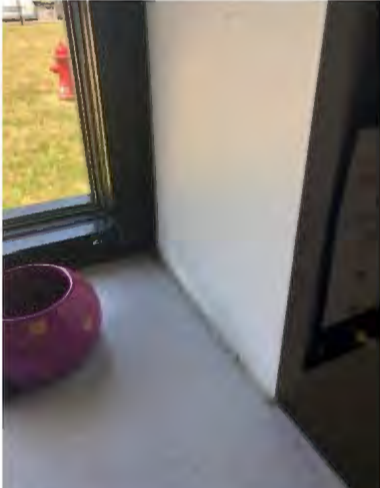
Caulk at window stools is failing.
8

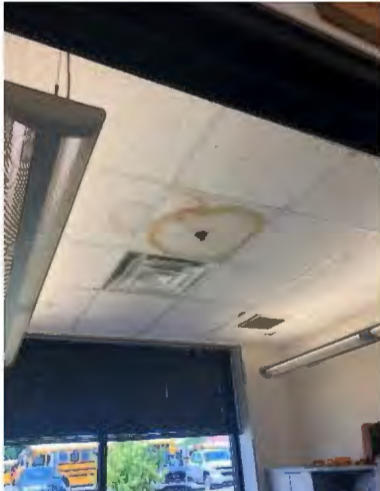
Damaged ceiling tiles.
9

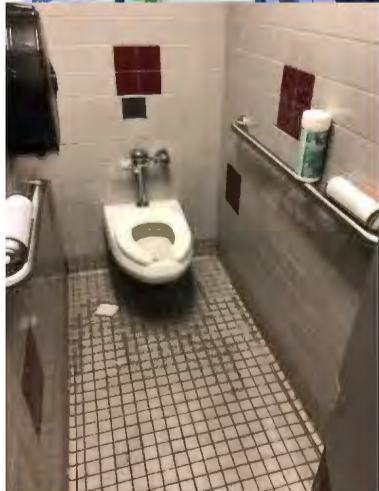
Accessible stall does not meet current code. The tile grout is stained.

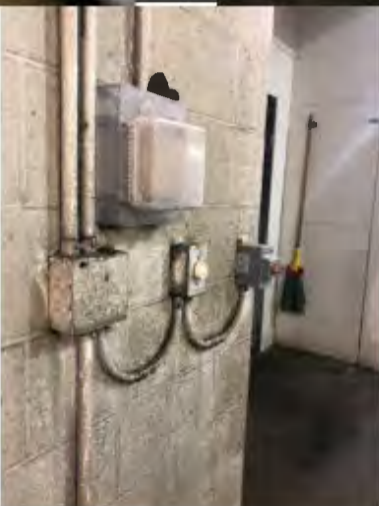
<p>Wash bay walls need to be cleaned and protected with high performance paint.</p>
12

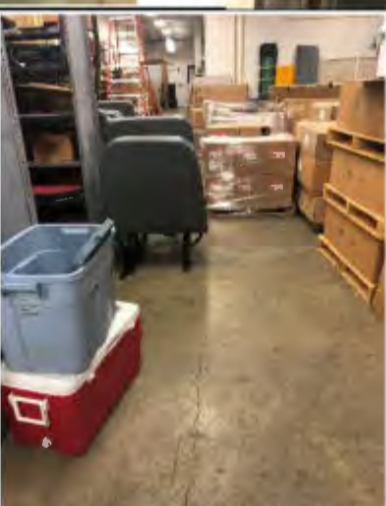
<p>Large crack in the concrete floor running the full length of the mezzanine.</p>
14

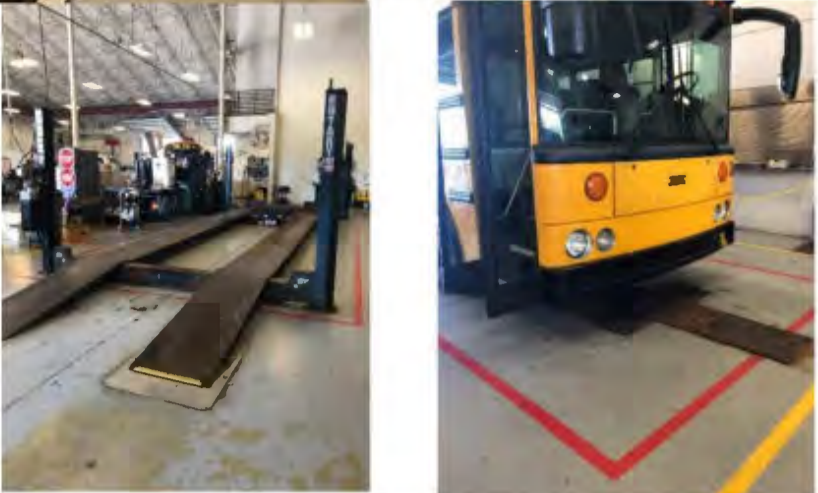
<p>The equipment is recessed and mounted to concrete slab.</p>
16

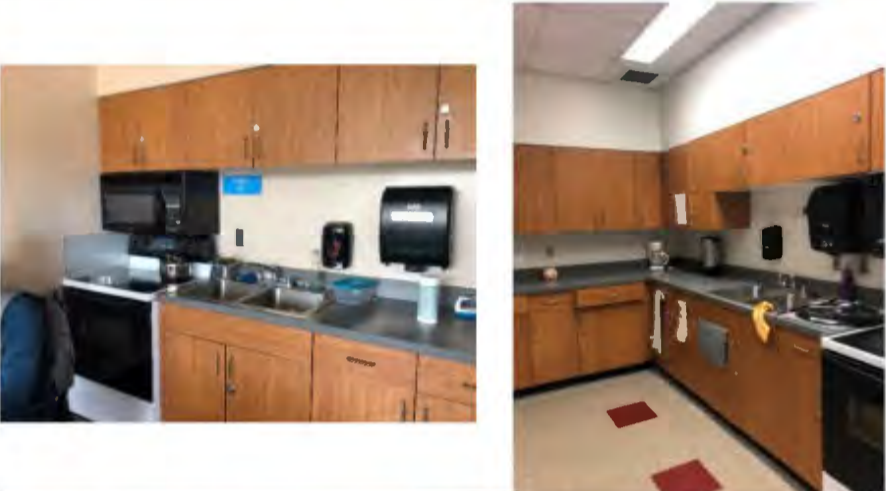
<p>Breakroom casework and equipment are not accessible.</p>
17

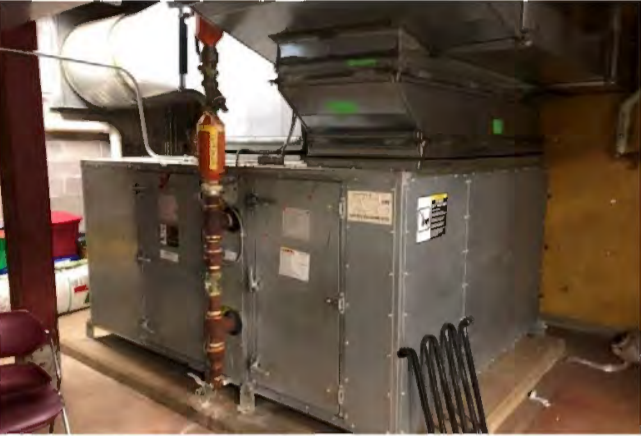
Indoor Air Handling Units.
2

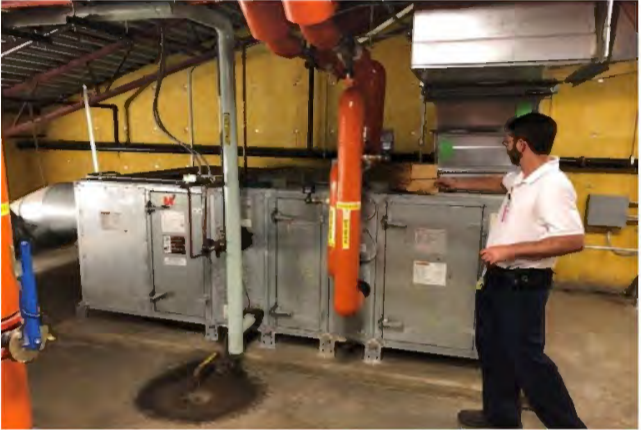
Indoor Air Handling Units.
3

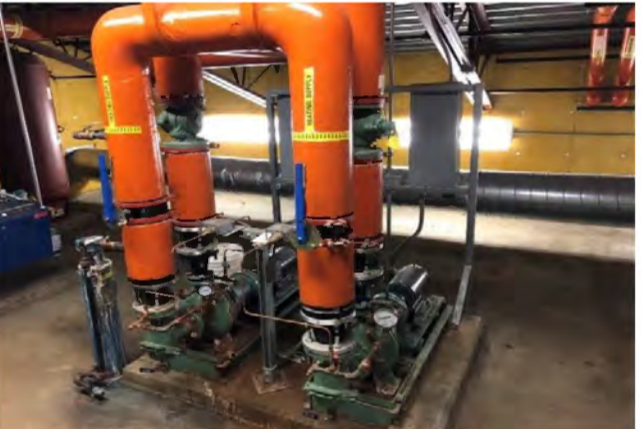
Heating Water Pumps.
4

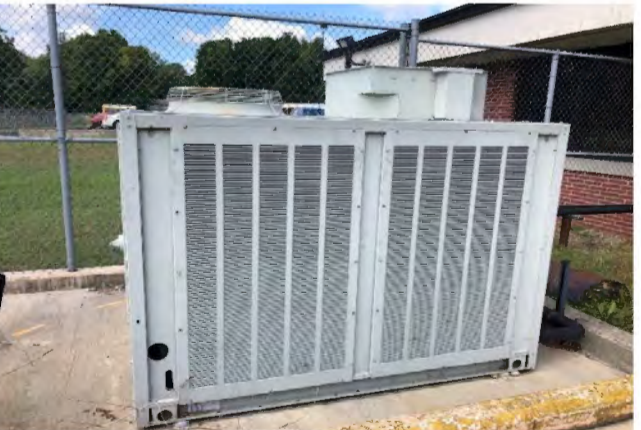
Condensing Unit.
5
