WASHINGTON
TOWNSHIP SCHOOLS

Secondary School Master Plan

SECONDARY SCHOOL FACILITY CONDITION ASSESSMENTS

EXISTING CONDITIONS ASSESSMENT SUMMARIES

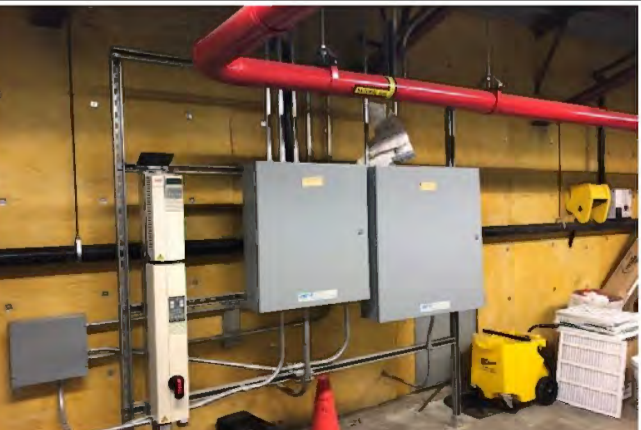
Temperature Control Panels and VFD.

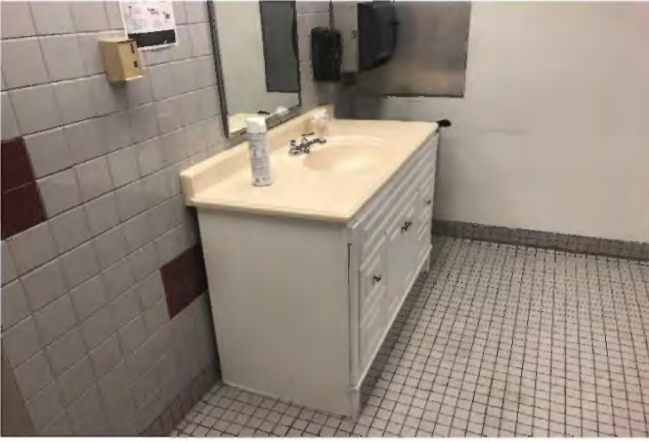
<p>Modified plumbing fixture in gang restroom.</p>
2

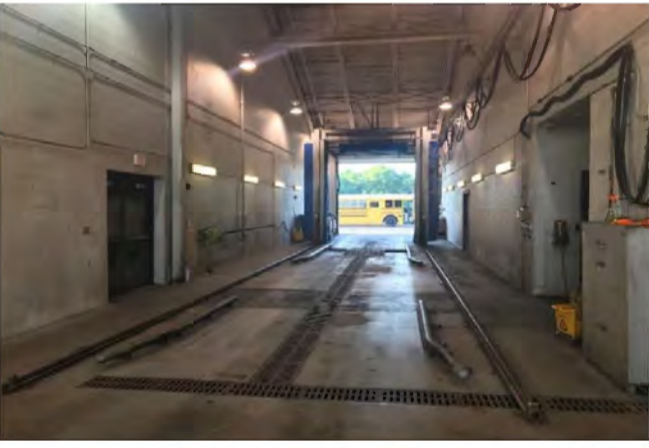
<p>The bus wash bay is in fair condition.</p>
4

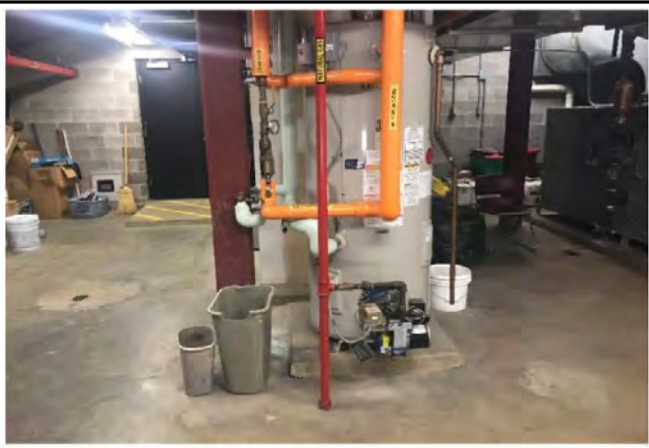
<p>Gas fired domestic water heater and TMV located above the locker area is in fair condition.</p>

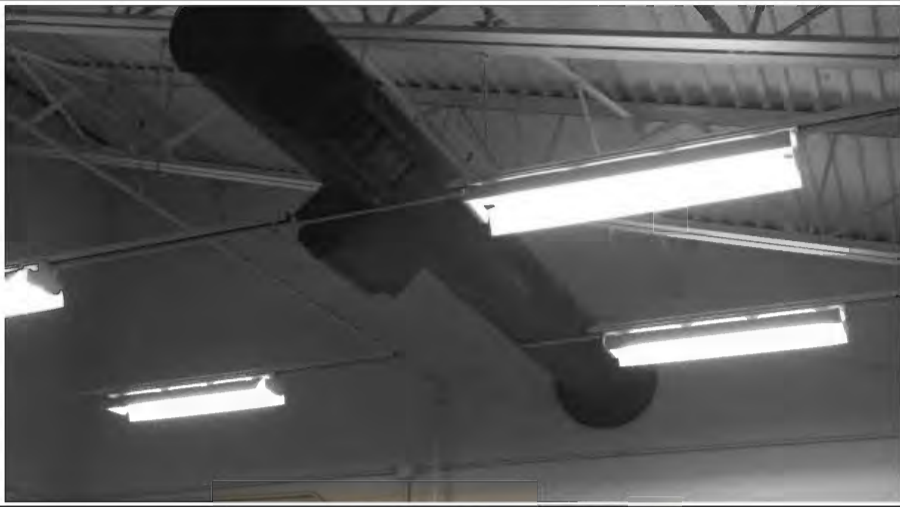
A photograph showing several long, rectangular fluorescent light fixtures mounted on a ceiling in a maintenance garage. The ceiling has exposed metal trusses and large black ductwork.	Fluorescent light fixtures.
2

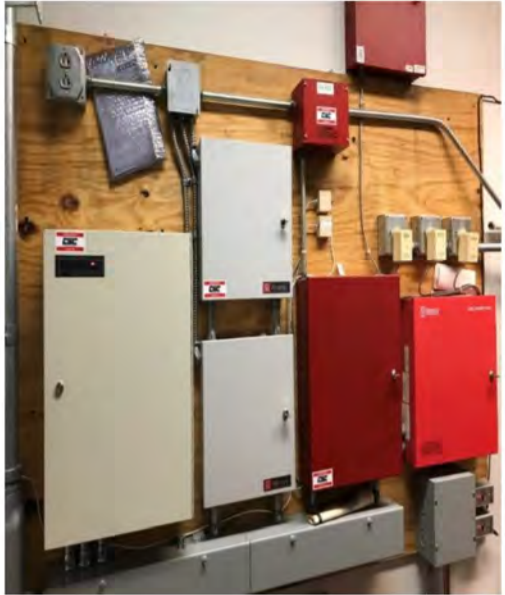
<p>CSC security panels and enclosures found in the MDF room in the building.</p>
7

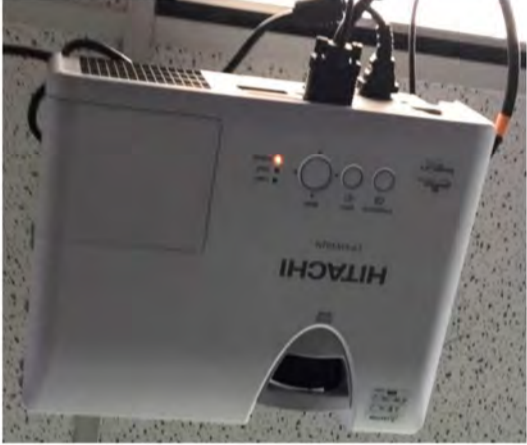
<p>Projector utilized in the lounge/training room.</p>
8

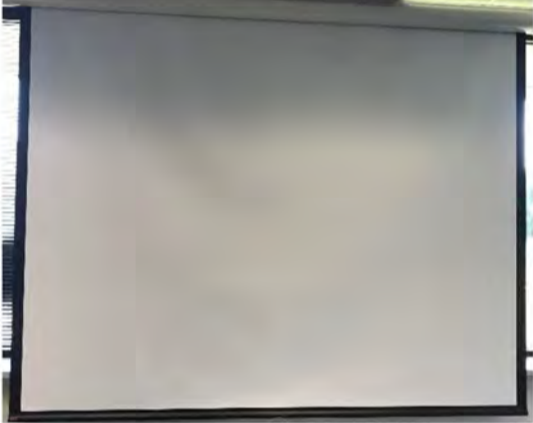
<p>Projector screen utilized in the lounge/training room.</p>
9

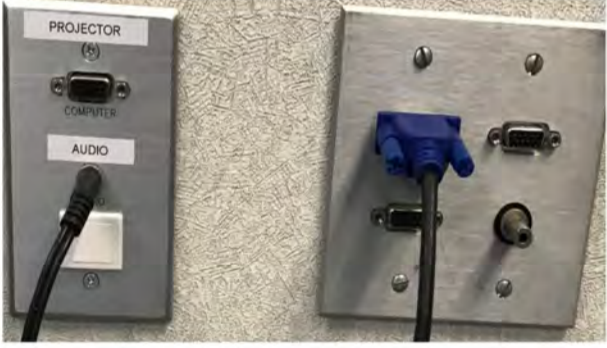
<p>AV inputs found in the building. Typically they contained audio (usually LR) connectivity as well as VGA inputs.</p>
10

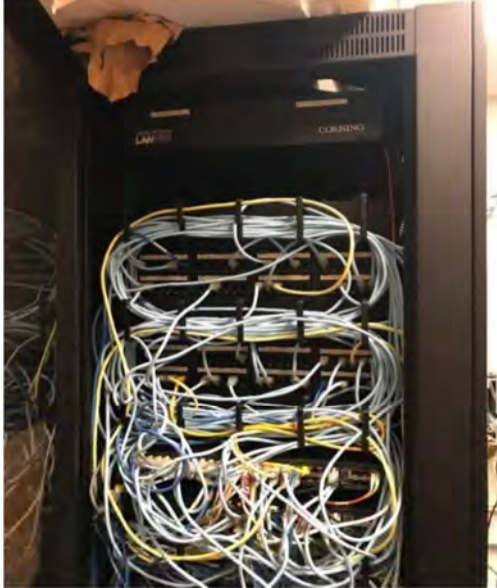
<p>Internal view of the MDF located in the MDF room adjacent to the workroom space.</p>

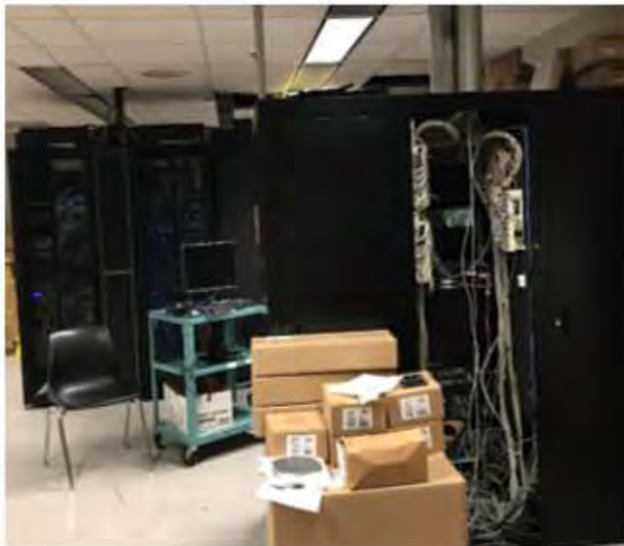
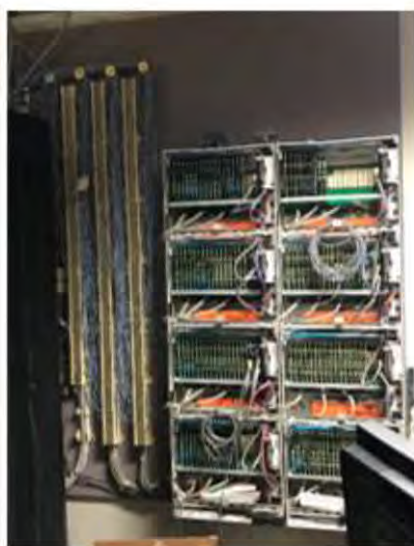
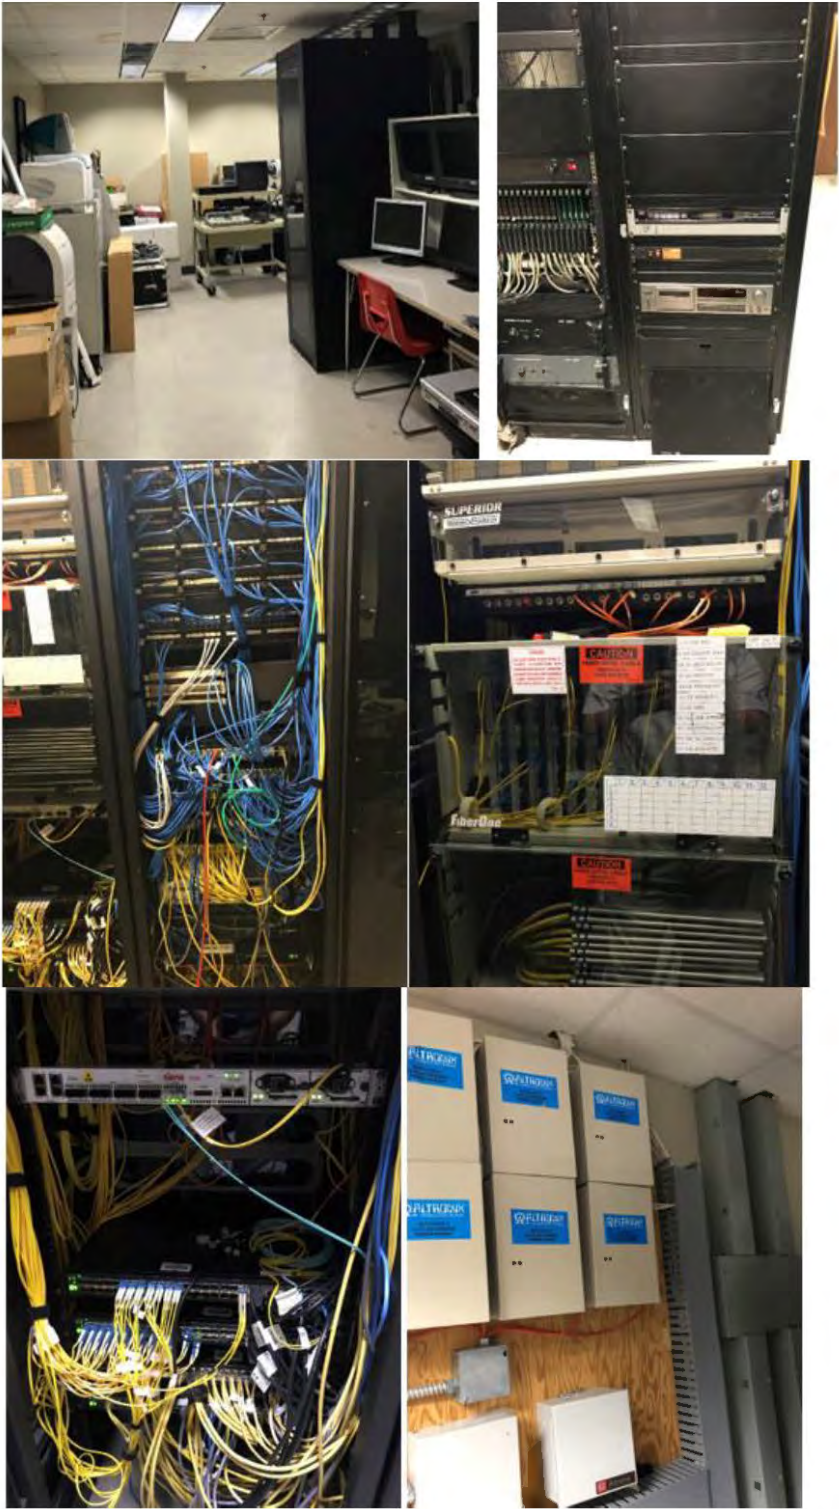
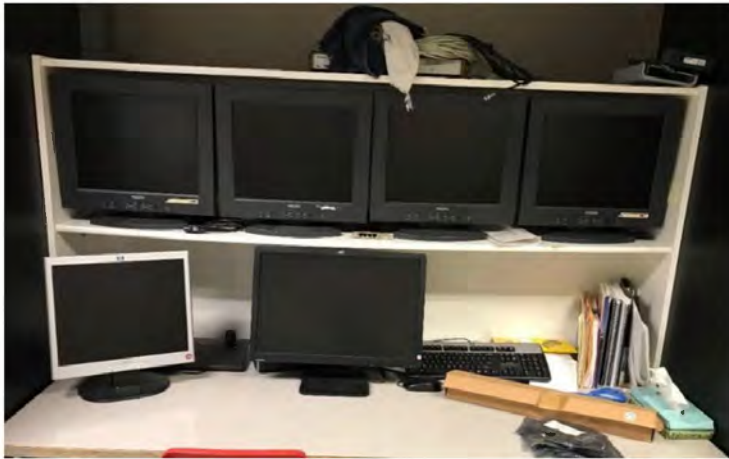
MDF (IDF 23) – Electronic & Storage Rooms A512

The MDF is located on the 2nd floor in a dedicated electronic and storage room adjacent to the information center and the IT desk in the building. The room contained the paging system rack, several cooling systems, security panels, terminal blocks, and telecom racks. The room incorporated an ACT ceiling and had a rack completely dedicated to fiber distribution for the North Central campus. There was also a section of the room set aside for security camera viewing, although the functionality of the area was not confirmed.

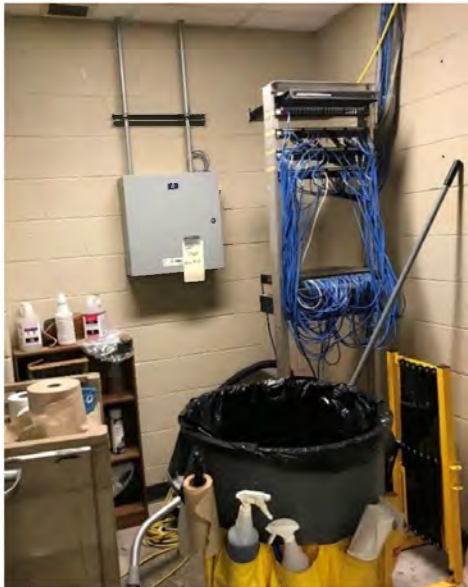
IDF 1 – Custodial Closet J195A

IDF 1 is located in a custodial closet in corridor J on the 1st floor of the building. The room contains the 2-post telecom rack as well other janitorial supplies and an ACT ceiling. The IDF has approximately 75 ports that have been terminated.

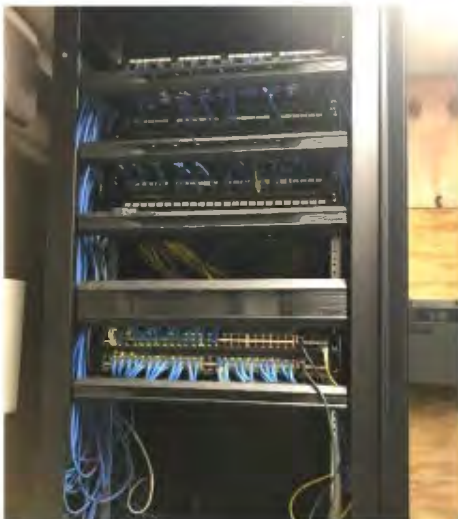
IDF 3 – Custodial Closet L258E

IDF 3 is located on the 1st floor in a custodial closet in the office spaces near the reception area. The IDF rack is mounted to TR plywood on the wall of the room along with a single mode fiber enclosure. The room contained other janitorial supplies and an ACT ceiling. The IDF has approximately 100 ports that have been terminated.

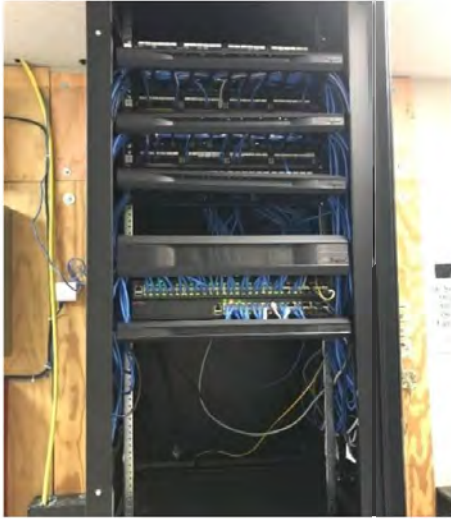
IDF 4 – Storage Room B122B

IDF 4 is located on the 1st floor in a storage room adjacent to open office spaces near the reception desk. The IDF rack is mounted to TR plywood on the wall of the room along with a single mode fiber enclosure and other security and fire alarm panels. The room contained other general office supplies and an ACT ceiling. The IDF has approximately 110 ports that have been terminated.

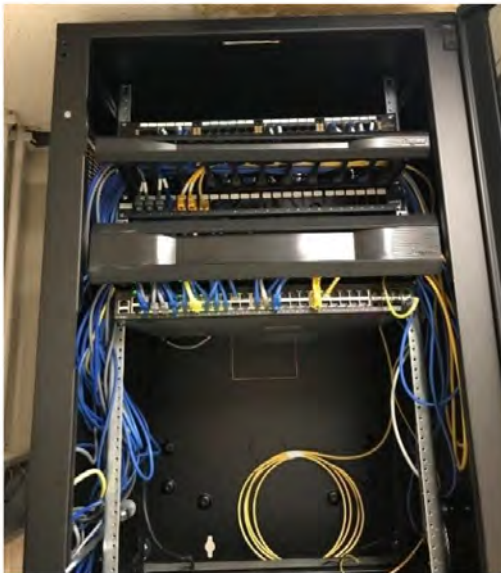
IDF 5 – Storage Closet L252A

IDF 5 is located on the 1st floor in a storage closet attached to a narrow passage adjacent to the auditorium. The room only housed a wall mounted rack on TR plywood with a single mode fiber enclosure and electrical panels. The room had the ACT layout installed, but had several tiles missing from the ceiling. The IDF has approximately 30 ports that have been terminated.

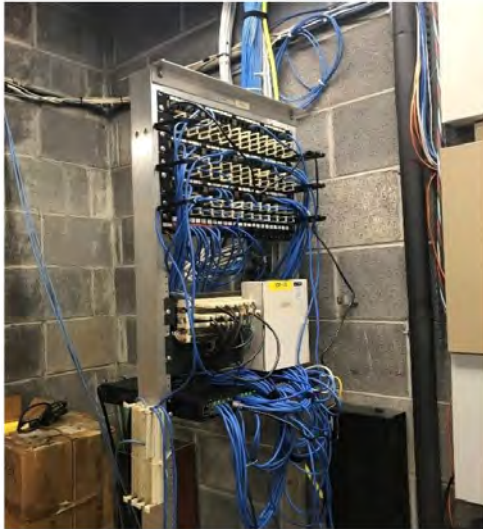
IDF 6 – Unlabeled Telephone Equipment Room inside the Boiler Room

IDF 6 is located on the 1st floor in a dedicated telephone equipment room located inside the buildings main boiler room located centrally in the building. The IDF is a 2-post rack located in the back-right corner of the room. The room did not have an ACT ceiling and did not have its own separate cooling system from the boiler room. The telephone equipment room incorporated security panels and terminal blocks on TR plywood with a single mode fiber enclosure. The IDF has approximately 80 ports that have been terminated.

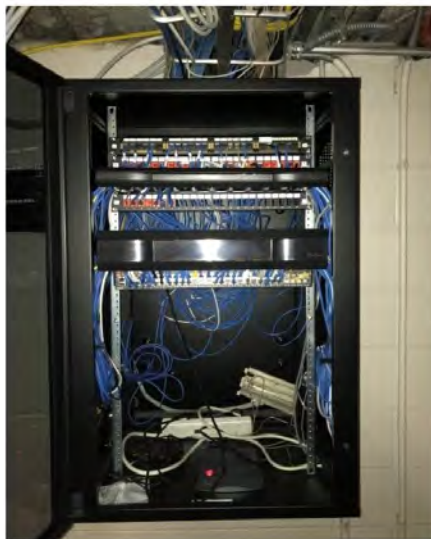
IDF 7 – P.E. Storage D139C

IDF 7 is located on the 1st floor in a P.E. Storage room attached to the main gymnasium. The room is used for general physical education equipment storage and does not have an ACT ceiling. The rack is wall mounted in the front-right corner of the storage room along with a single mode fiber enclosure. The IDF has approximately 50 ports that have been terminated.

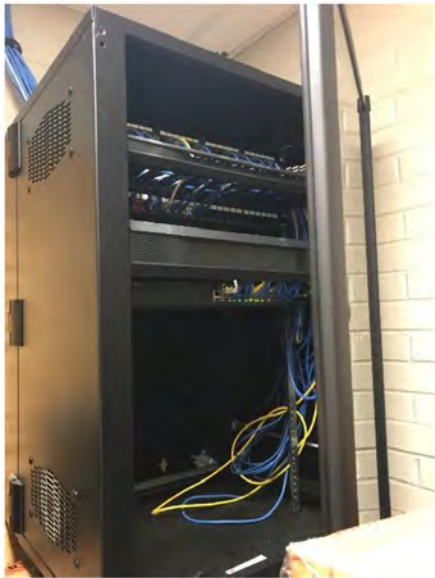
IDF 8 – Storage Closet F170

IDF 8 is located on the 1st floor in a storage closet to the East of the auxiliary gymnasium. The room is used for general physical education equipment storage and included lockers as well as an ACT ceiling. The rack is wall mounted in the back-left corner of the storage closet along with a single mode fiber enclosure mounted on TR plywood. The IDF has approximately 35 ports that have been terminated.

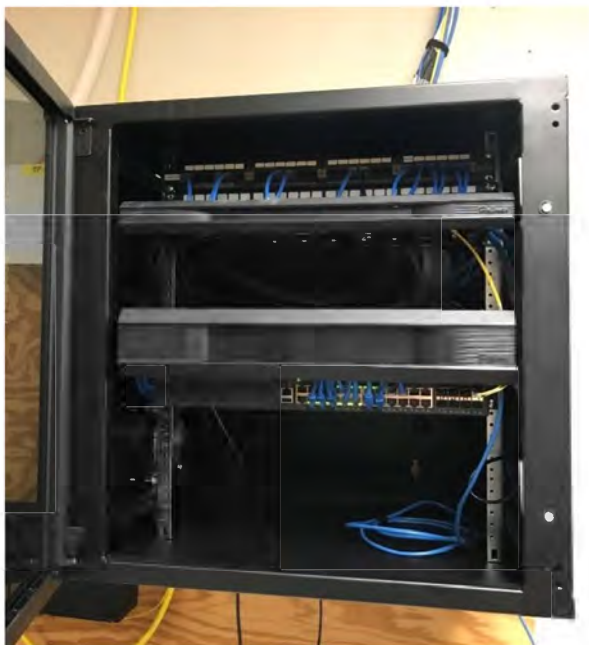
IDF 9 – Storage Room H184

IDF 9 is located on the 1st floor in a storage room in corridor H. The room is used for general table and event storage and incorporated an ACT ceiling. The rack is wall mounted on the North wall of the storage room along with a single mode and multimode fiber enclosure mounted on TR plywood. The IDF has approximately 25 ports that have been terminated.

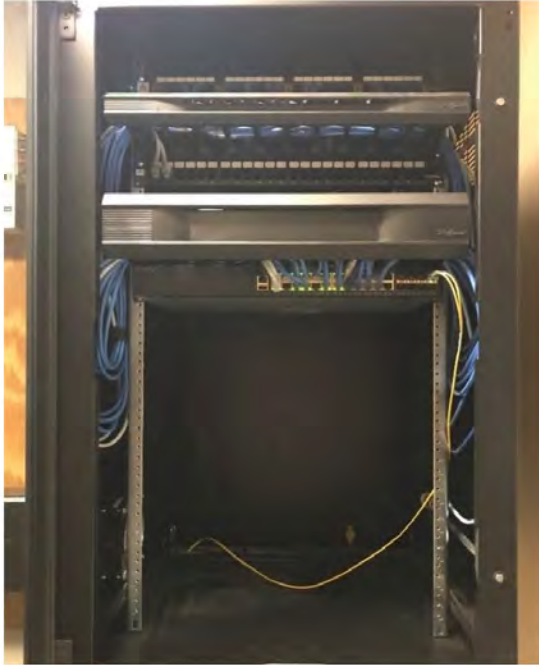
IDF 10 – Custodian Closet A116

IDF 10 is located on the 1st floor in a custodial closet in the Northeast corner of the building. The room contains custodial supplies and a mop sink as well as an ACT ceiling. The rack is wall mounted in the back wall of the custodial closet along with a single mode fiber enclosure mounted on TR plywood. The IDF has approximately 25 ports that have been terminated.

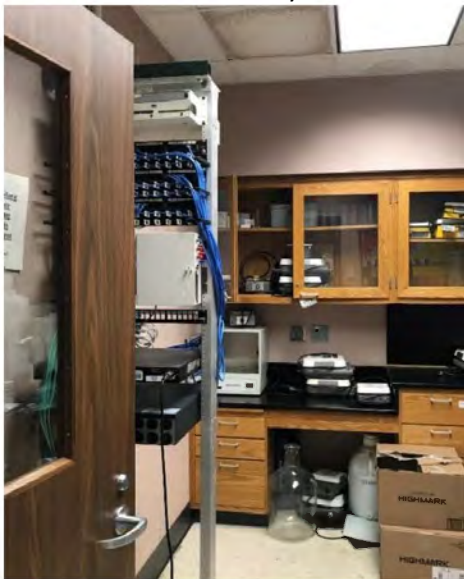
IDF 11 – Individual Study N287

IDF 11 is located on the 1st floor in an individual study room in corridor N in the West side of the building. The room contains cabinets and countertops as well as general science supplies in storage and an ACT ceiling. The IDF is a 2-post rack that is located adjacent to the left wall of the room along with a wall mounted single mode fiber enclosure. The IDF has approximately 80 ports that have been terminated.

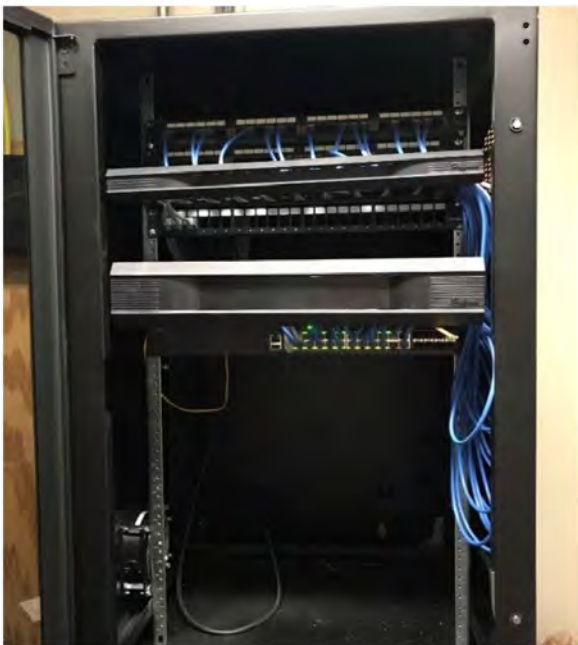
IDF 13 – Custodial Closet C556

IDF 13 is located on the 2nd floor in a custodial closet. The room was used for janitorial and cleaning supplies and incorporated an ACT ceiling. The IDF is mounted to TR plywood on the West wall of the room along with a single mode fiber enclosure. The IDF has approximately 50 ports that have been terminated.

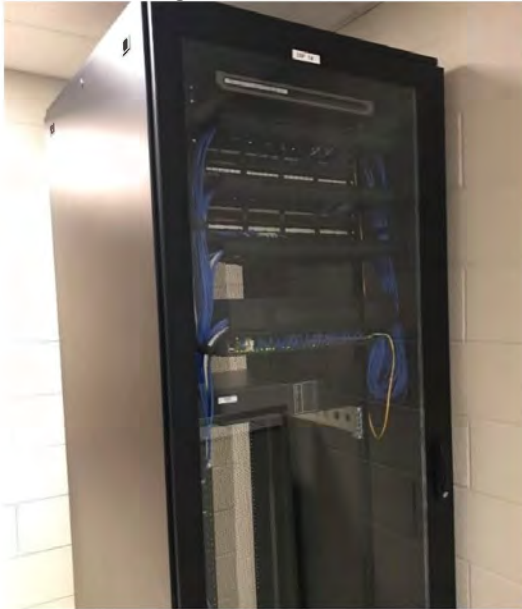
IDF 14 – Storage Closet D579

IDF 14 is located on the 2nd floor in a storage room adjacent to an open office space. The room was used for general storage and incorporated an ACT ceiling. The IDF is contained in a floor standing equipment cabinet, and while it could not be opened since it required a different key that we did not have access to, it is assumed that it has approximately 50 ports that have been terminated.

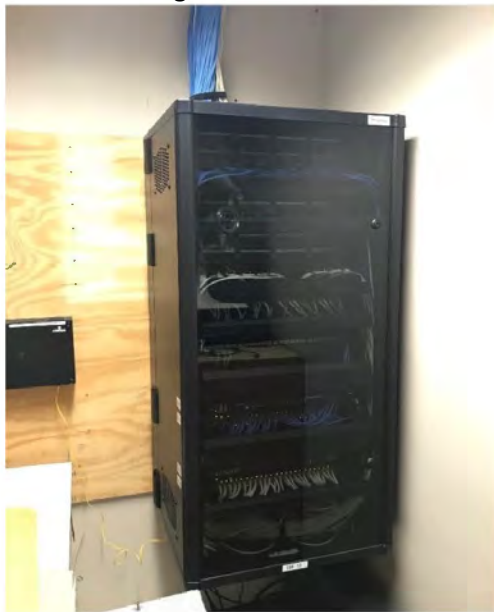
IDF 15 – Storage Closet D579

IDF 15 is located on the 2nd floor in a small work room adjacent to a multimedia and recording laboratory. The room was used for general storage and incorporated an ACT ceiling. The IDF is wall mounted on TR plywood which also include a single mode fiber enclosure. While the IDF could not be reached due to the quantity of heavy items blocking it, it is assumed that it has approximately 100 ports that have been terminated.

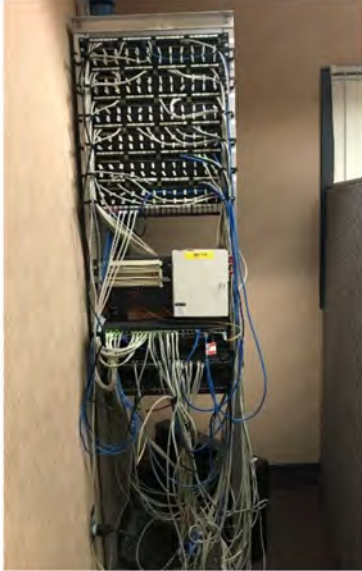
IDF 16 – Conference Room A501

IDF 16 is located on the 2nd floor in a conference room attached to the resource center. The room incorporates a typical conference room style layout, with a long conference table, video projection, audio amplification, and an ACT ceiling. In the Southwest corner of the room behind a moveable 6-foot divisible wall is the 2-post telecom rack. Adjacent to the telecom rack is a wall mounted single mode fiber enclosure. The IDF has approximately 150 ports that have been terminated.

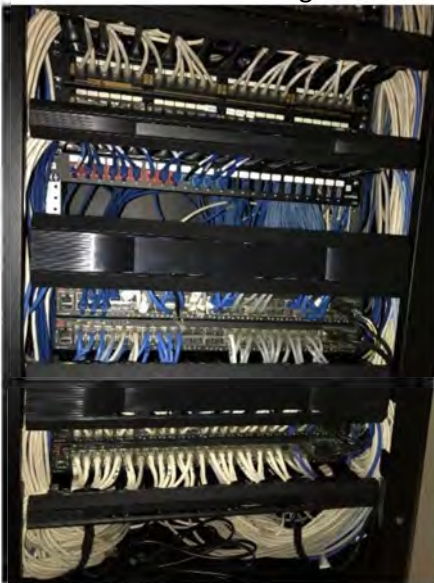
IDF 18 – Unlabeled Storage Room Attached to English Classroom

IDF 18 is located on the 2nd floor in a storage room attached to an English classroom. The storage room is used solely for the IDF, which is mounted to TR plywood along with a single mode and multimode fiber enclosure on the South wall of the room. The room is fitted with an ACT ceiling layout but is missing several ceiling tiles. The IDF has approximately 150 ports that have been terminated.

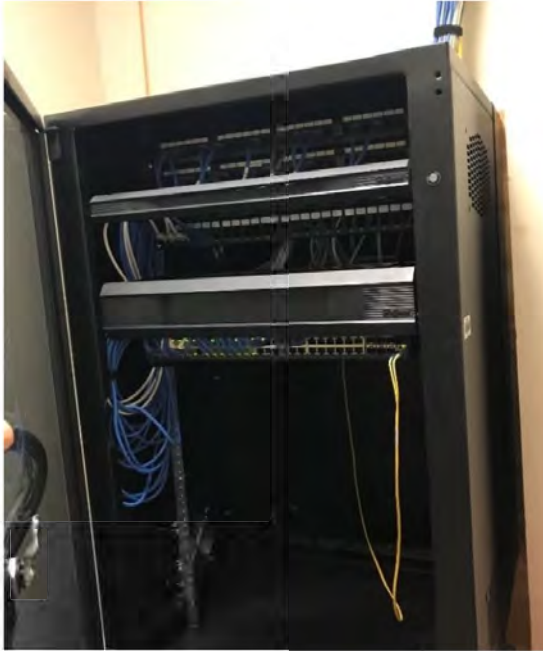
IDF 19 – Storage Closer H590

IDF 19 is located on the 2nd floor in a storage closet outside of a lecture room in the Southeast corner of the building. The room is used for chair and desk storage, while incorporating the IDF and an ACT ceiling. The IDF is mounted to TR plywood on the South wall of the room along with a multimode fiber enclosure. The IDF has approximately 50 ports that have been terminated.

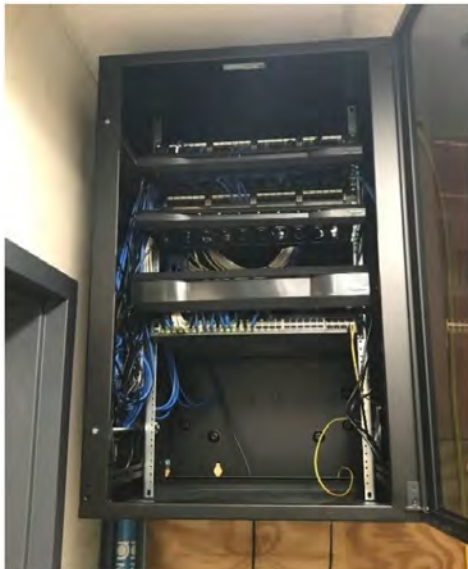
IDF 20 – Electrical Room H616

IDF 20 is located on the 2nd floor in an electrical closet at the back of a conference room in the Northeast section of the building. The small closet incorporates electrical panels and an ACT ceiling. The IDF is located on the North wall of the closet mounted to TR plywood along with a single mode fiber enclosure. The IDF has approximately 50 ports that have been terminated.

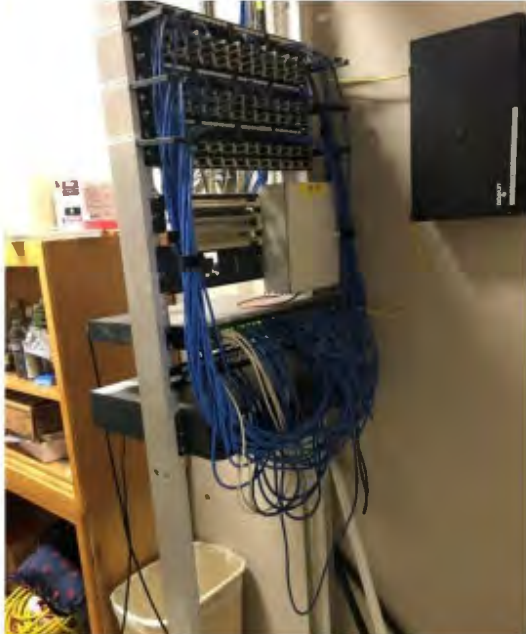
IDF 21 – Electrical Room H616

IDF 21 is located on the 2nd floor in a custodial room in the Southwest section of the building. The room contains several janitorial and cleaning supplies and an ACT ceiling, along with the 2-post telecom rack. The rack is located on the East wall of the room along with a single mode fiber enclosure. The IDF has approximately 75 ports that have been terminated.

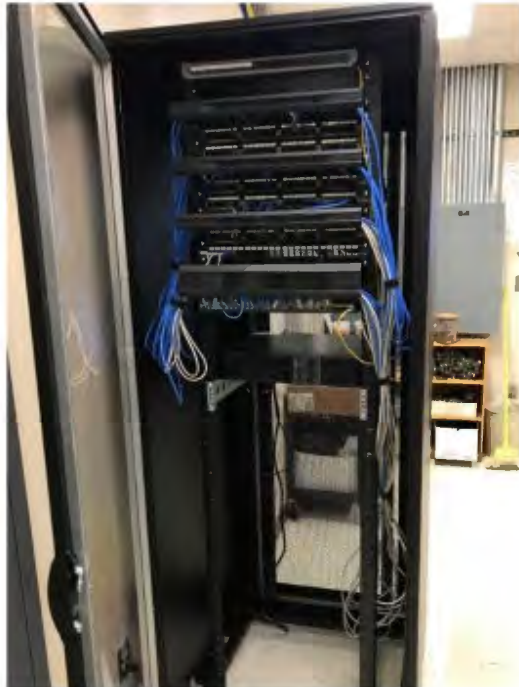
IDF 22 – Storage Room Attached to a Computer Lab

IDF 22 is located on the 2nd floor in a storage room in the Northwest section of the building. The room is used for general technology equipment storage along with an ACT ceiling and the telecom equipment enclosure on the East wall. The IDF has approximately 100 ports that have been terminated.

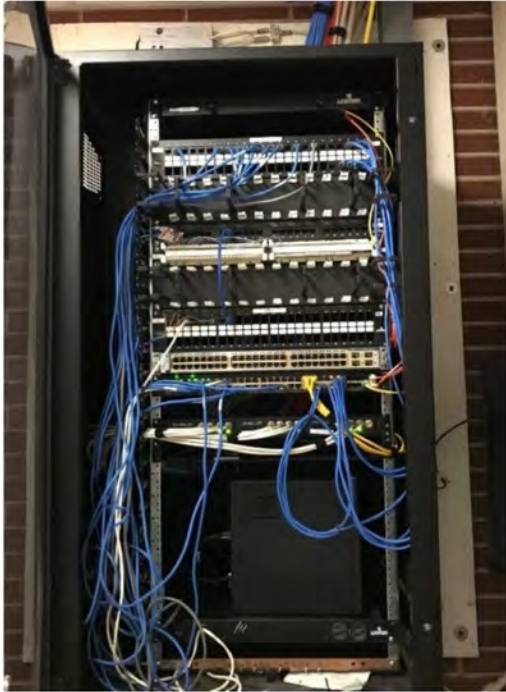
IDF 24 – Storage Room P101C

IDF 24 is located on the 1st floor in a storage room in the Natatorium section in the South of North Central. The room is used for general storage as well as a break room for the staff. The room incorporates an ACT ceiling, security panels, fire alarm panels, and TR plywood which the IDF is mounted to. The IDF has approximately 50 ports that have been terminated.

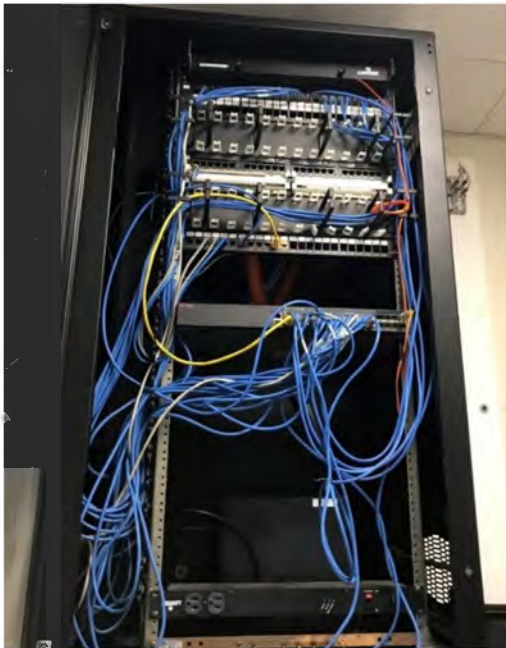
IDF 25 – Swim Club Office P202

IDF 25 is located on the 1st floor in the swim club office in the Natatorium section in the South of North Central. The room is a typical office space with an ACT ceiling. The IDF is wall mounted on TR plywood about 6 inches below the ceiling. The IDF has approximately 50 ports that have been terminated.

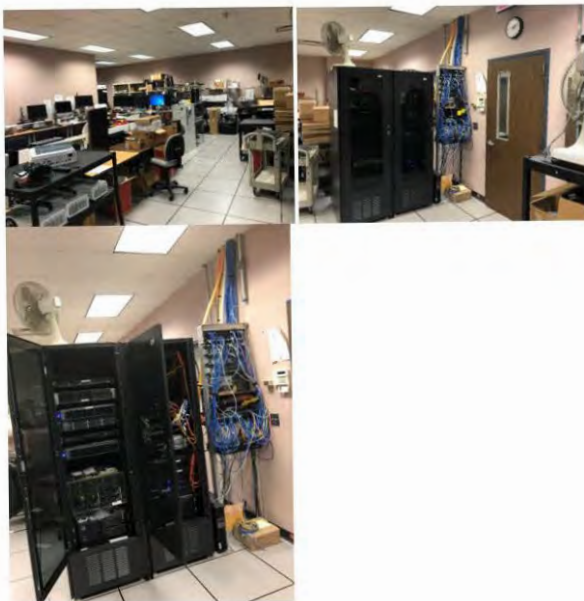
IDF 1 – Data Center

IDF 1 is located in the Data Center room. The room contains the 2-post telecom rack as well as 2 Liebert equipment racks. The 2-post telecom rack is labeled IDF 6 but has since been absorbed into IDF 1. The room is used as the hub and storage for a lot of broken or unused AV equipment. The 2 Liebert equipment racks were added at a later install time, consisting of several switches, security equipment, and a large fiber drawer that sends a fiber connection to the Community and Education Center.

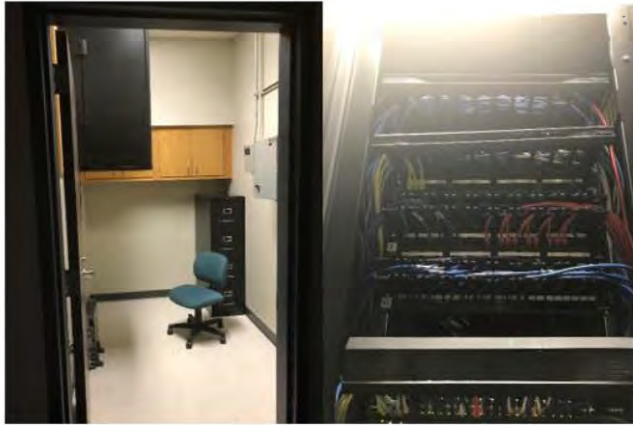
IDF 2 – Storage Room Connected to the Dental Lab

IDF 2 is located in a storage closet connected to a dental lab and classroom. The room incorporates the wall mounted TR equipment enclosure in addition to electrical paneling, wooden storage cabinets, and an ACT ceiling.

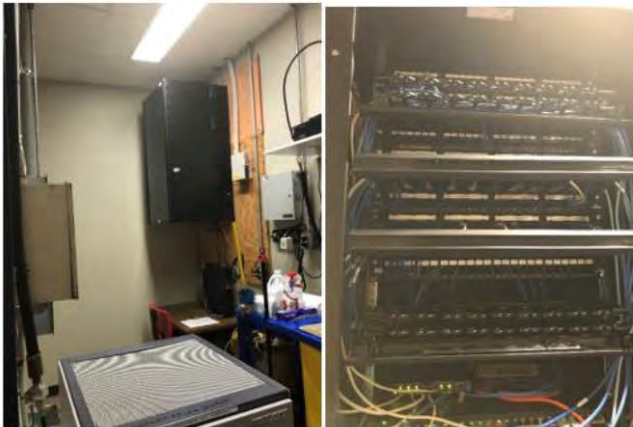
IDF 3 – Storage Closet in D Hallway

IDF 3 is located in a medium sized storage closet, seemingly used for general and custodial storage. The room contained the wall mounted TR equipment cabinet, electrical and CSC security panels.

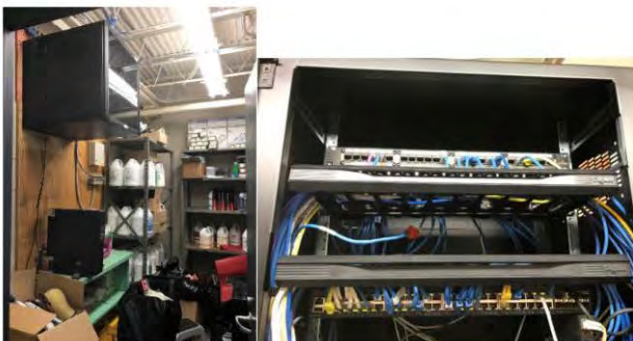
IDF 4 – Storage Closet in E Hallway E349

IDF 4 is located in a storage closet in the E Hallway outside of the Cosmetology rooms. The room is used for chemical storage and cosmetology supplies. It incorporates a wall mounted TR equipment cabinet with an open ceiling.

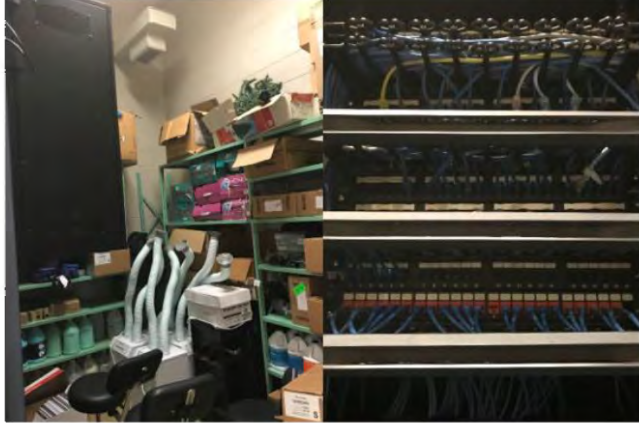
IDF 5 – Storage Closet in H Hallway H326

IDF 5 is located in the storage closet in H hallway across from the receiving room. The room is used for general and chemical storage. It incorporates a wall mounted TR equipment cabinet.

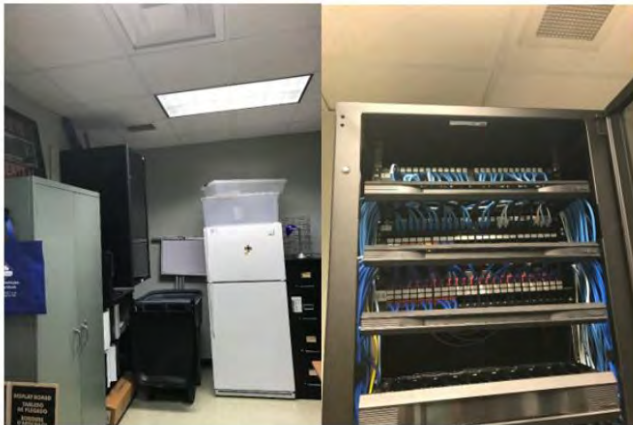
IDF 7 – Storage Room Between G333 and G334

IDF 7 is located in a storage room shared by two surrounding classrooms. The room is used as a general storage / office space, as it incorporates desks, a refrigerator, and an ACT ceiling. The wall mounted TR rack in the room is labeled “IDF 7” and not IDF 6 since IDF 6 was absorbed into IDF 1 (See IDF 1 picture for details).

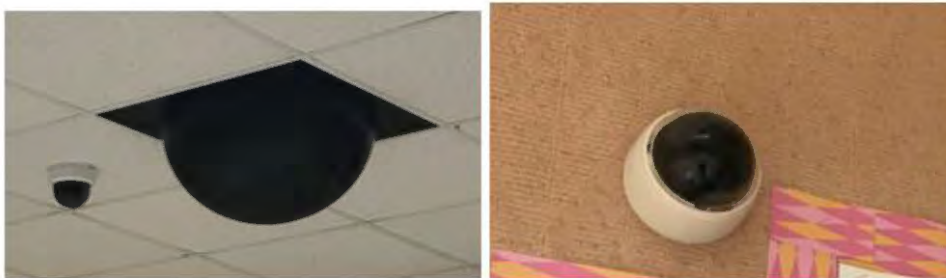
During the assessment of the J. Everett Light Career Center, 20 security cameras were located. 19 of these cameras were found in the hallways and near the main entryway, sufficiently covering every accessible hallway to a student. Only one security camera could be located outside of the building at the time of visit. It is unknown how many of the cameras are functional.

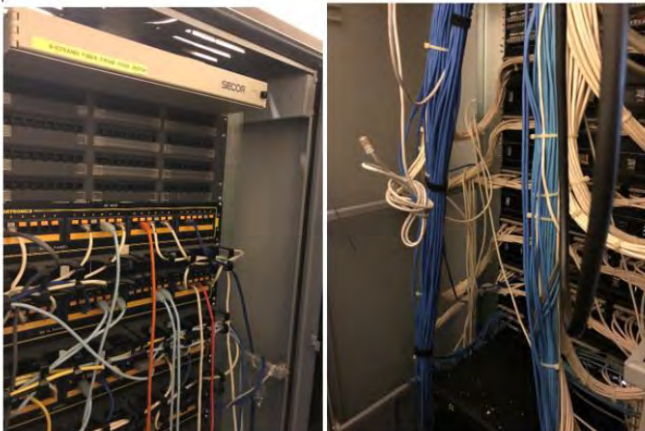
MDF – Unlabeled closet in the student lounge room

MDF is located in the student lounge area in the closet. The room itself was no larger than 4' x 5' and incorporated a low ACT ceiling. The room also housed CSC security panels for the building. A zoomed out view of the room could not be captured due to the very small size of the room in addition to the door blocking the view.

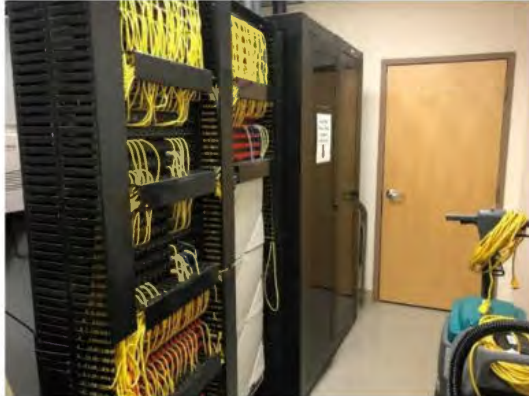
MDF-0 – Room labeled “M.D.F.”

MDF-0 located in dedicated MDF room. Room incorporates an ACT ceiling and contains a couple of janitorial supplies.

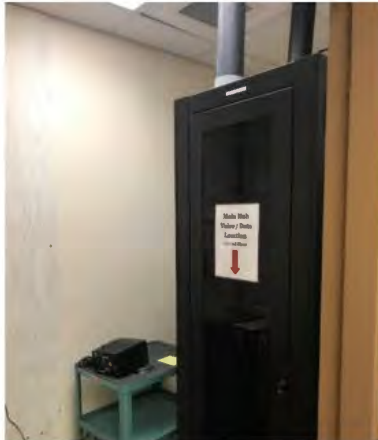
IDF-1 – Room labeled “I.D.F.”

IDF-1 located in dedicated IDF room. Room incorporates an ACT ceiling and contains an AV rack for audio amplification / paging system.

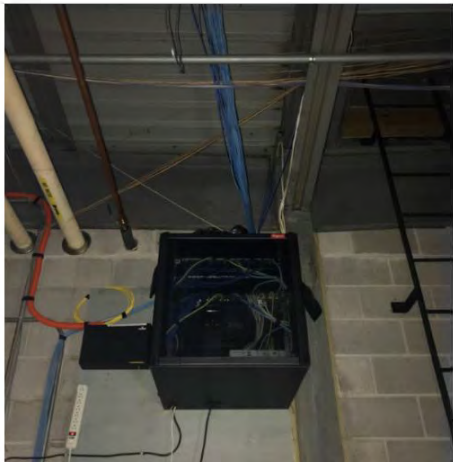
MDF – Room labeled “Mechanical / Electrical / Telephone Room”

MDF located in the mechanical / electrical / telephone room. Workers moved the MDF to a higher elevation, roughly 13 feet, wall mounting for “better security.” They had also placed a plastic trash bag over the top of the rack to prevent it from getting wet due to water leaking from the ceiling on rainy days.

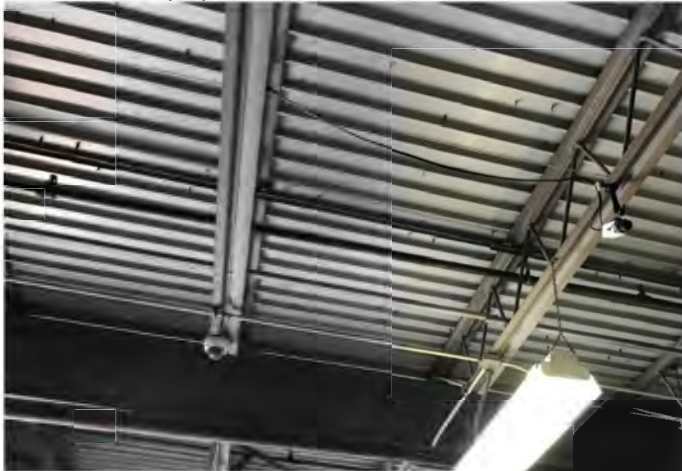
Video Security System (VSS)

The Operations building contained a total of 9 security cameras.

The 7 interior cameras were two different types and had been installed at two different times.

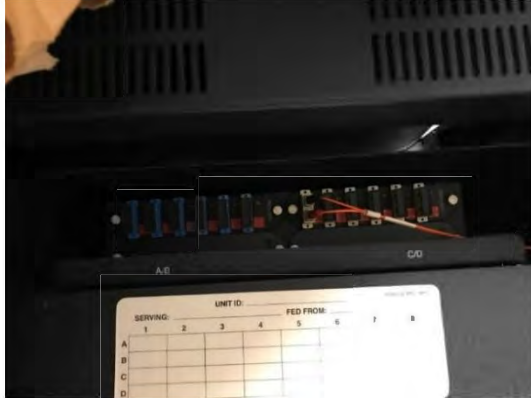
Telecommunications Entrance Services

During our walkthrough we were unable to locate the fiber entrance. However, it is believed to enter in the North end of the building, which is the closest part of the building to North Central High School. It is known that the fiber connection for the Transportation & Bus Barn stems from the connection brought into North Central High School across the campus. Below is documentation of the fiber entrance at the warehouse as well as for the North Central campus

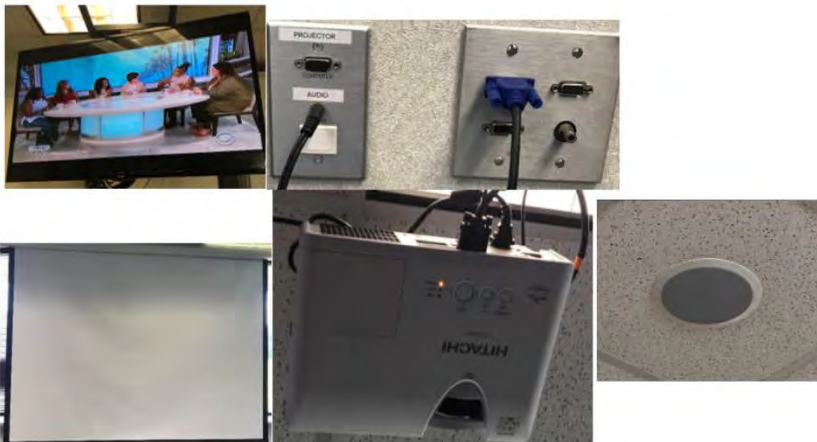
Lounge / Training Room

- One (1) Ceiling mounted projector for image display
- One (1) Ceiling mounted projection screen
- Three (3) monitor locations used for general cable television viewing
- One (1) Volume control knob
- One (1) ceiling mounted wireless access point
- Six (6) program audio speakers to sound amplification
- Multiple data voice locations containing varying amounts of data
- AV Input locations containing LR Audio and VGA connectivity
